# Extensive main engine damage due to broken lube oil (LO) filter

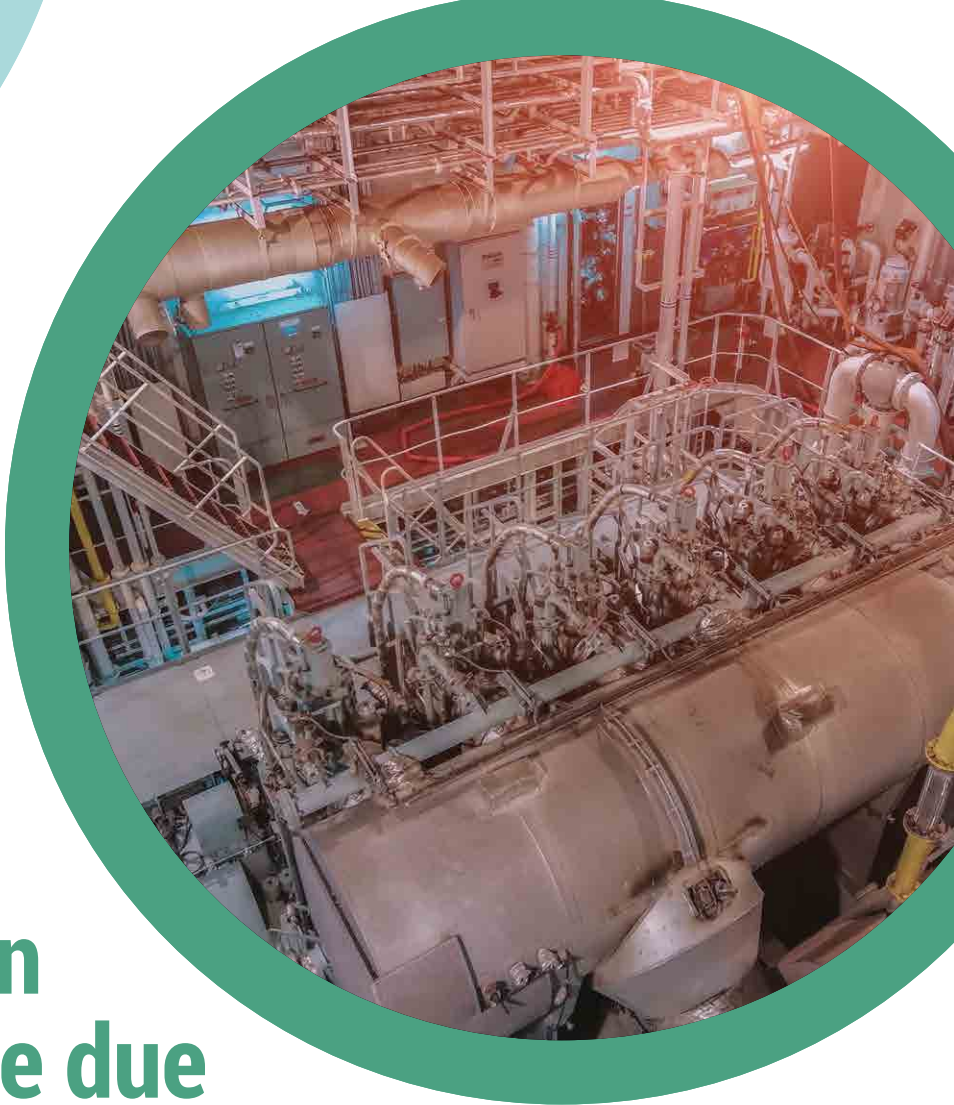
A container vessel experienced extensive main engine damage due to broken lube oil (LO) filter candle mesh wires. Initial signs appeared in mid-January (wire fragments in the sump tank strainer), followed by repeated discoveries of mesh wires and metal fines through February, March, and April. By May, significant contamination was confirmed, with metal fragments embedded in bearings, crankpins, turbochargers, and other vital components. Starting late May, the vessel went off-hire at a lay-by berth in Singapore. Repairs focused on dismantling and cleaning major engine components, polishing crankshaft journals, and replacing or overhauling bearings, liners, filters, pumps, and other damaged parts. Delays arose primarily from the need for critical spares such as new bearing shells.

- Filter Candle Failure - The LO auto filter candles broke (potentially due to design, manufacturing, or handling

issues). Wire fragments circulated throughout the lube oil system, causing bearing scratches and scoring.

- Immediate System Flushing - If a filter fails or foreign particles are detected, promptly flush and clean the entire LO system (piping, coolers, sump, bearings) to prevent further spread.

- **Correct Filter Elements** - Use filter candles that meet the engine maker's specifications. Avoid mixing brands or mesh sizes without explicit approval.
- **Routine Condition Monitoring** - Conduct regular lube oil analysis, crankcase inspections, and sump checks to detect early signs of contamination or wear.
- **Crew Training & Vigilance** - Train personnel to investigate even minor indications of LO contamination, filtration or bearing issues. Proper handling of spare filter elements can prevent damage before installation.
- **Collaboration with Makers & Class** - Engage the engine manufacturer early in the troubleshooting process to mitigate and resolve issues quickly.
