# Injury of an Able Seaman while working aloft

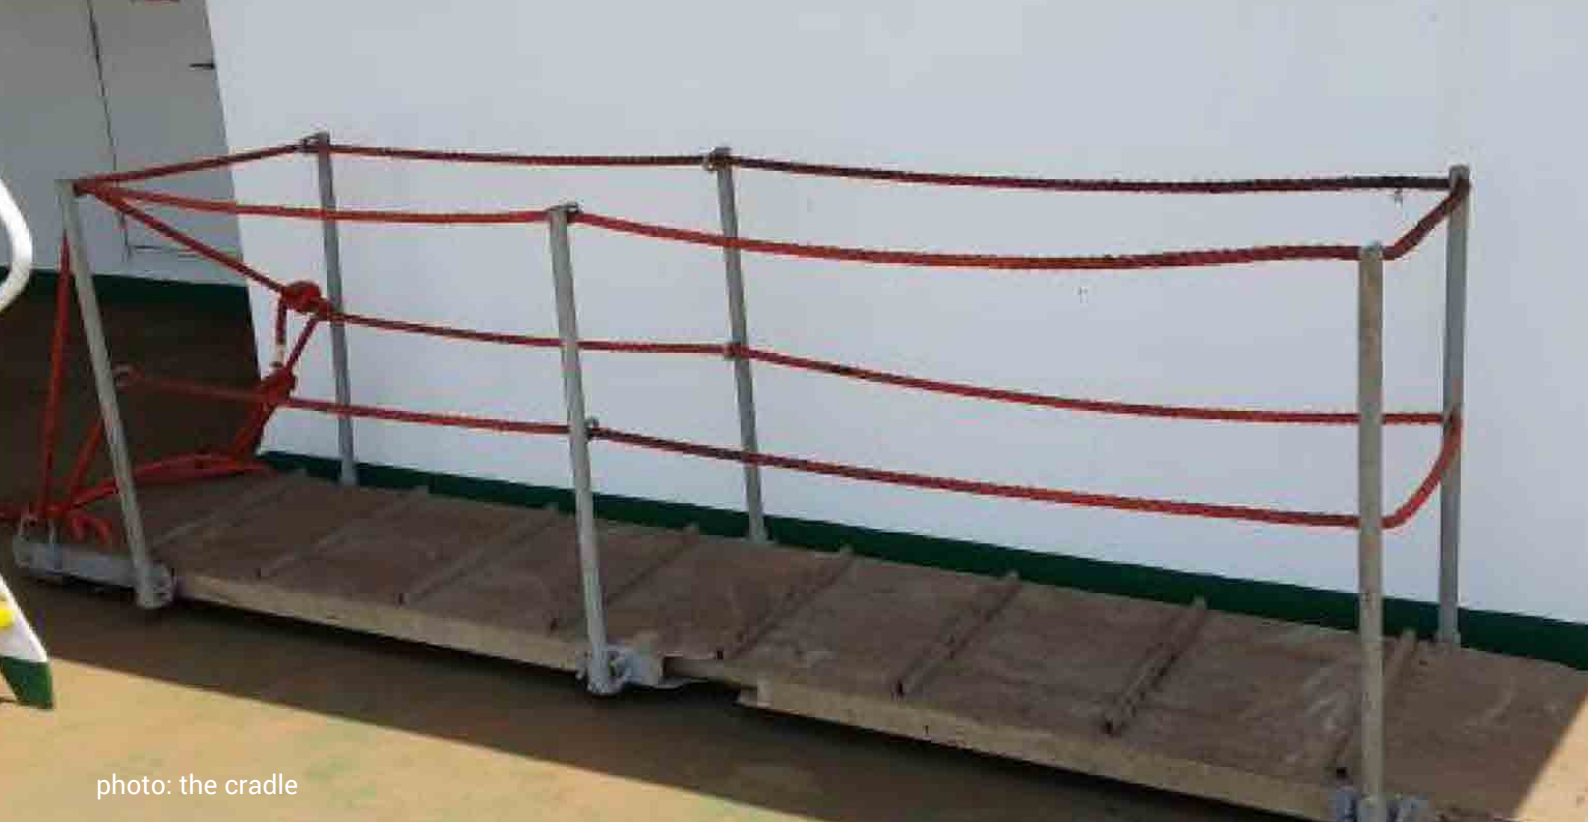
photo: the cradle

On the morning of the incident, the vessel was at sea. The weather was calm, with slight seas and a gentle breeze. Work had been planned on the funnel's exterior to address a job order for repainting and correcting the company logo. Prior to commencing this job, a homemade cradle, essentially a narrow segment of gangway rigged with ropes for handrails, had been prepared by the crew under the supervision of the chief officer, who verified its apparent suitability for the job.

Shortly after 10:00, both men paused for a coffee break. After resuming work around 10:30, the AB on the cradle focused on the forward side of the funnel, continuing cleaning. While repositioning himself on the cradle, he unclipped his safety harness momentarily to move from one end of the platform to the other. In the seconds that followed, he appeared to lose his balance, possibly because his right foot slipped off the edge or became entangled. As a result, he fell from an estimated height of 6 meters onto the deck below. The other AB who had been assisting, saw him strike a portion of the railing or funnel deck structure before landing.

4. When repositioning aloft, what techniques or equipment (e.g., double lanyards) can help us maintain continuous fall protection?
5. At what point do changing environmental conditions (wind, swell, poor visibility) make it unsafe to continue working aloft, and who decides to suspend operations?
