1.6

Grains: Ship's sweat caused cargo damage

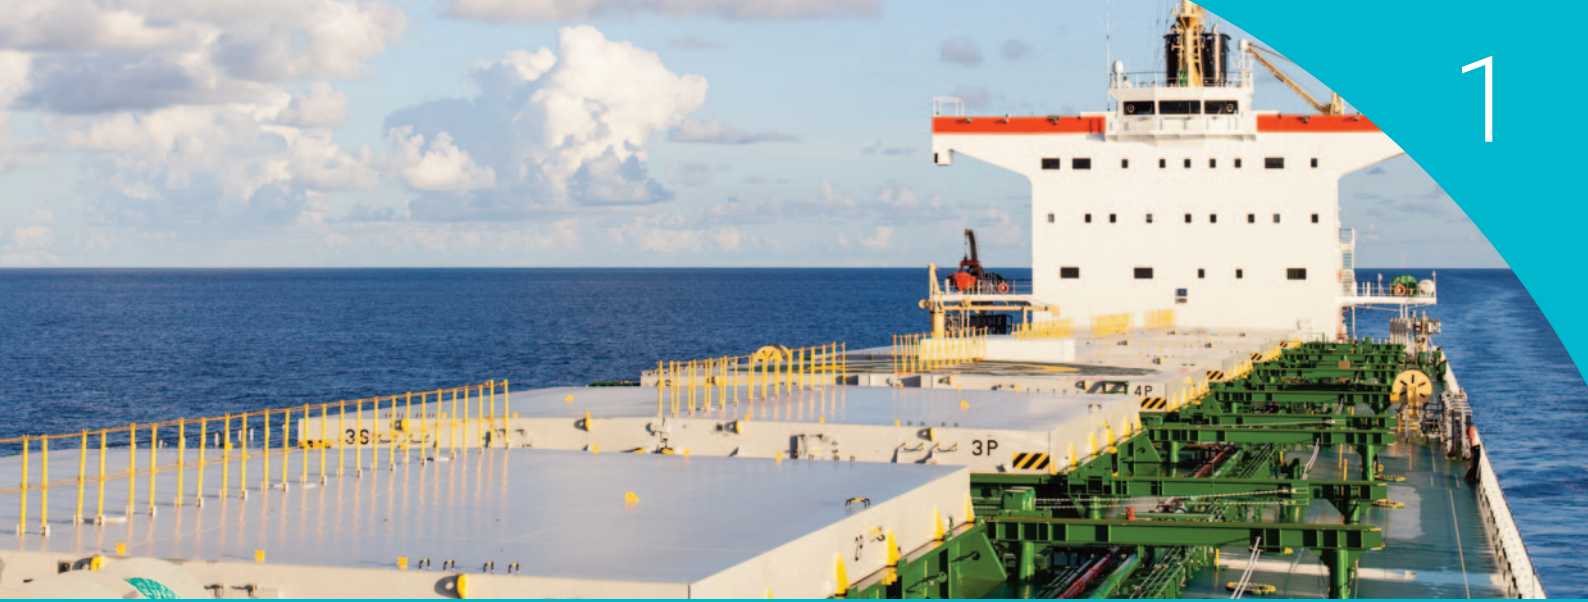
Damaged cargo

On arrival at the first discharge port, the surface of the stow in all holds was found to be mouldy, condensation stains could be seen on the hatches and hatch coaming, and maize had germinated in areas of heavy wetting. This was a clear example of ship's sweat where moisture inside the hold space condenses on the interior steelwork due to the difference in temperature and then drips or runs into the cargo.

The surface layers of damaged cargo were manually segregated by stevedores and by grab. Once the surface layer of mould damage was removed the remaining cargo was discharged in sound condition.

- The mould damage to the surface due to condensation wetting could have been prevented or minimised if the holds were ventilated after a more typical fumigation exposure period (often 10 days).
- It is important to clarify the ventilation instructions with the fumigators and charterers, as the fumigation instructions are focused on achieving an effective fumigation and do not account for the changes in environmental conditions the vessel may experience during a voyage.
