Accident during Man Overboard drill

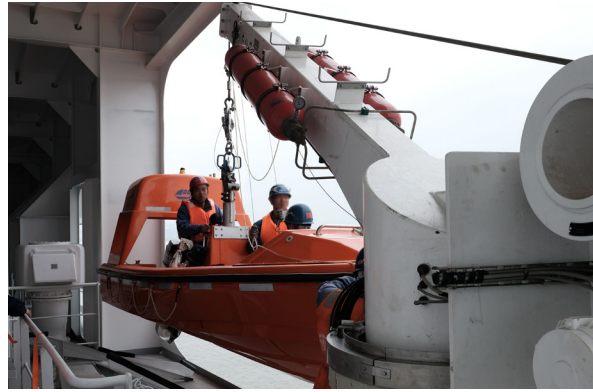
speed option. The boat came in hard to the davit, which caused the boat to hit the davit hard and this caused the fall wire to part and the rescue boat fell into the water with the crew. The three crew members were still secured to the boat with their safety harnesses, the AB and 2nd Engineer had fallen into the water and their lifejackets inflated, however the 2nd Officer had fallen straight on to the boat.

The failure of the wire was caused by the sudden excess load when the boat hit the davit. This was caused by the davit's proximity switch not working properly, as it should have stopped the wire hoisting. Hoisting the boat should stop before the proximity switch is activated, but in this case it was not as the bosun continued to hoist the boat. ■
