Lack of communication caused serious main engine damage

Main Engine Lubricating Oil Outlet diaphragm

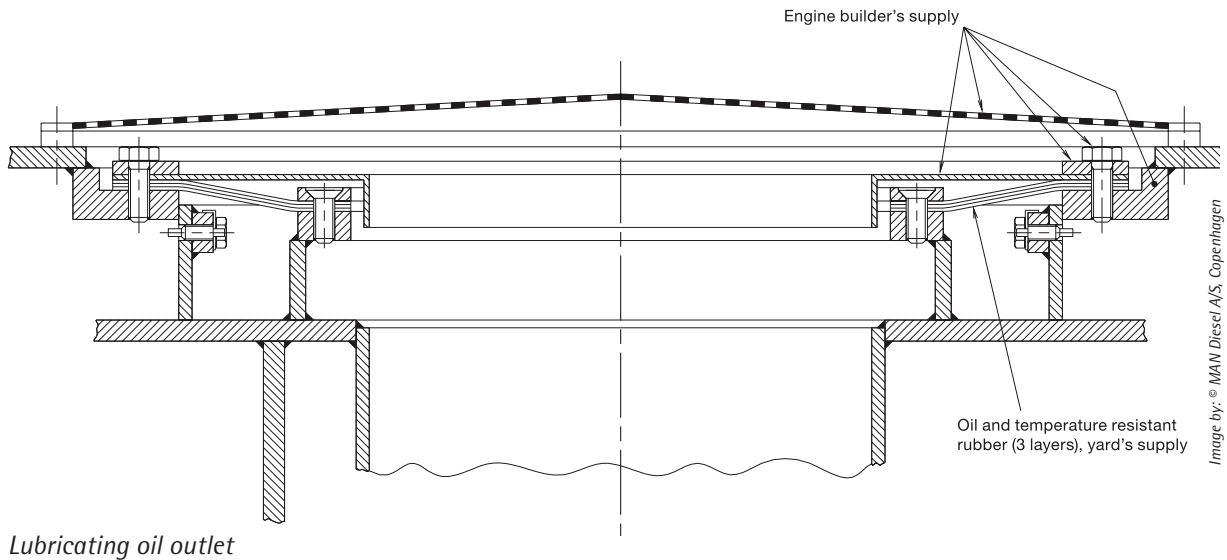
In all cases excessive quantities of water on the tank top have entered the main engine sump tank via the defective diaphragm and subsequently contaminated the main engine lubricating oil system, resulting in severe damage to the main engine bearings and journals.

Deteriorated diaphragm

- ▶ Inspect the diaphragm sealing in the crankcase oil outlet every 32,000 hours of operation, and replace the diaphragm if indicated by the inspection.

In line with the recommendation issued by MAN Diesel A/S, Copenhagen, we recommend that all diaphragms are replaced in connection with every relevant scheduled inspection of the ship.
