Dealing with
**engine
room
fires**

By **Peter Stålberg**
Senior Technical Advisor

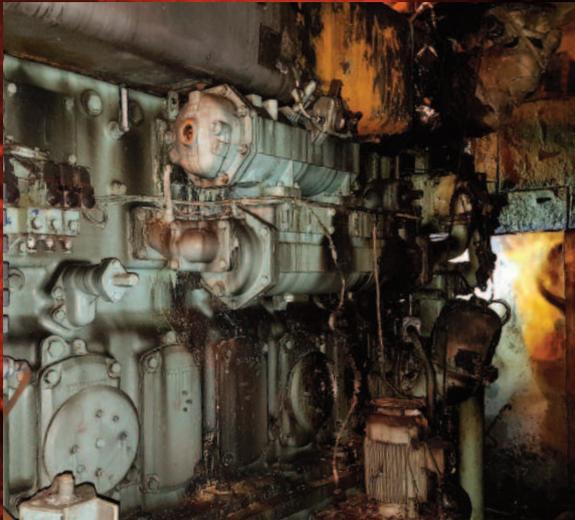
Cause

The fire was triggered by a diesel oil leak from the port side engine coming into contact with the hot metal of the engine. This leak was caused by a broken pipe from the return line of cylinder fuel pump no. 3 of the port side main engine.

This was a disaster. While the root cause of the damage, i.e. the broken pipe, may be difficult to establish, it's clear that the response from the crew was one of confusion and mistakes.

They saw the fire and tried to put it out, but the flames were high and that didn't work. So they shut the quick-closing valves and went to release the CO₂, but half of the CO₂ was not released, so there was not enough to completely extinguish the fire. If a fire like that doesn't die out immediately, the oxygen will come back in and it will start burning again.

Were the crew properly trained and familiar with the onboard systems? It really is all about training, to ensure that the crew can respond – they are the last barrier. We have so many other barriers, including double-skinned pipes, insulation of hot surfaces, detection systems, automatic shutdowns, but when a fire breaks out it is up to the individual to handle it. So it's therefore vital to ensure that the crew is trained in the firefighting system on the ship, and that the system is in very good condition.
