Main Engine Lubricating Oil Outlet diaphragm

In 2007, the Swedish Club published a Member alert, The "Forgotten" Rubber membrane, where we reported about a number of main engine claims caused by water contaminated lubricants. The incidents caused by failure of the lubricating oil outlet diaphragm connecting the main engine crankcase and sump tank.

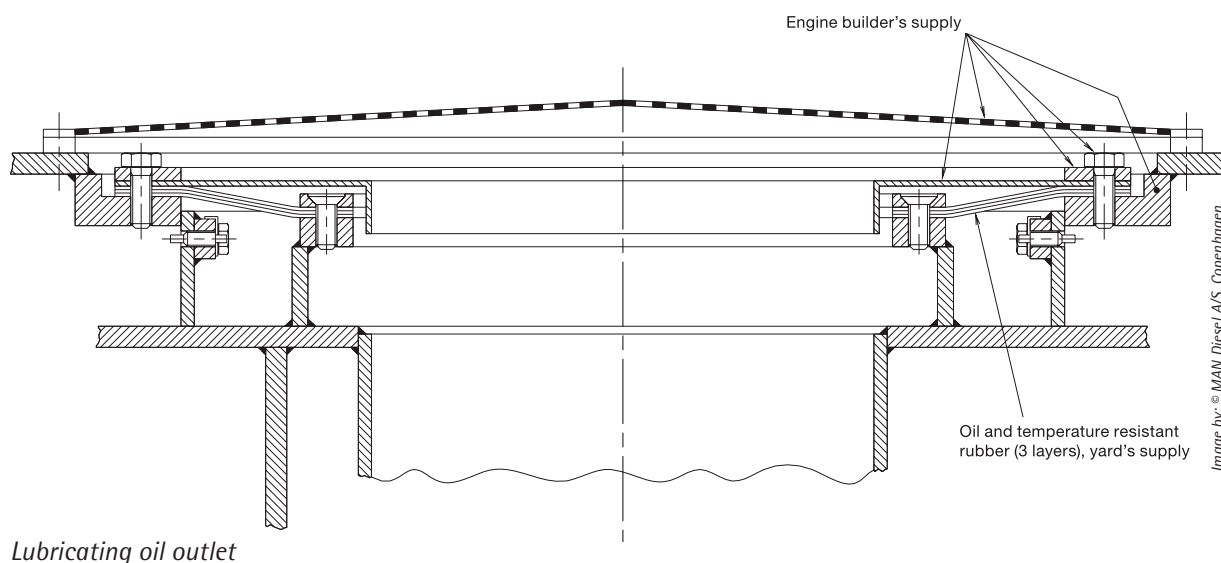
In all cases excessive quantities of water on the tank top have entered the main engine sump tank via the defective diaphragm and subsequently contaminated the main engine lubricating oil system, resulting in severe damage to the main engine bearings and journals.

It should be stated that during construction of the ship, the parts in question are supplied by the yard, and not by the engine manufacturers.

In line with the recommendation issued by MAN Diesel A/S, Copenhagen, we recommend that all diaphragms are replaced in connection with every relevant scheduled inspection of the ship.

We would recommend to owners that spare diaphragms are kept onboard at all times.
