The
Swedish
Club

engine damage

Introduction

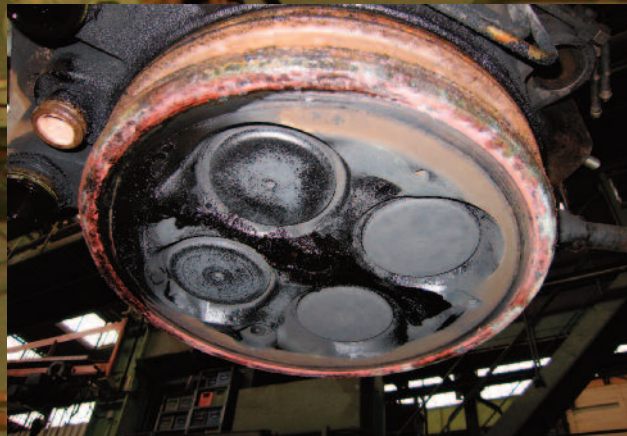
A few hours later I heard a knocking noise and saw a leak coming from the no. 2 cylinder cover on the no. 1 diesel generator. We were worried that the valves were misaligned and so we shut down the diesel generator and stopped the main engine.

“A few hours later I heard a knocking noise and saw a leak coming from the no. 2 cylinder cover on the no. 1 diesel generator.”

This damage is about poor fuel management in combination with sloppy maintenance routines.

The primary cause of the breakdown was failure of the purifiers. With both purifiers having damaged seals, it is highly probable that the impurities and water contained within the fuel oil were not removed before being burnt by the main engine and diesel generators. Finally, the purifiers were stopped and the vessel continued to consume the fuel without any purification. As a result, the engines were not able fully to burn the fuel being fed and suffered overheating and internal damage

Another important aspect of this series of events is the lack of spare parts on board. It seems that the engine crew did not have full control of their inventory of consumables which hindered them in carrying out relatively simple repairs to the purifiers.

It is also recommended that the effectiveness of the fuel oil treatment system is periodically verified by analysing fuel oil samples taken before and after treatment.
