9

Injury

For more information about The Swedish Club Casebook
please contact Loss Prevention Team at
lossprevention@swedishclub.com

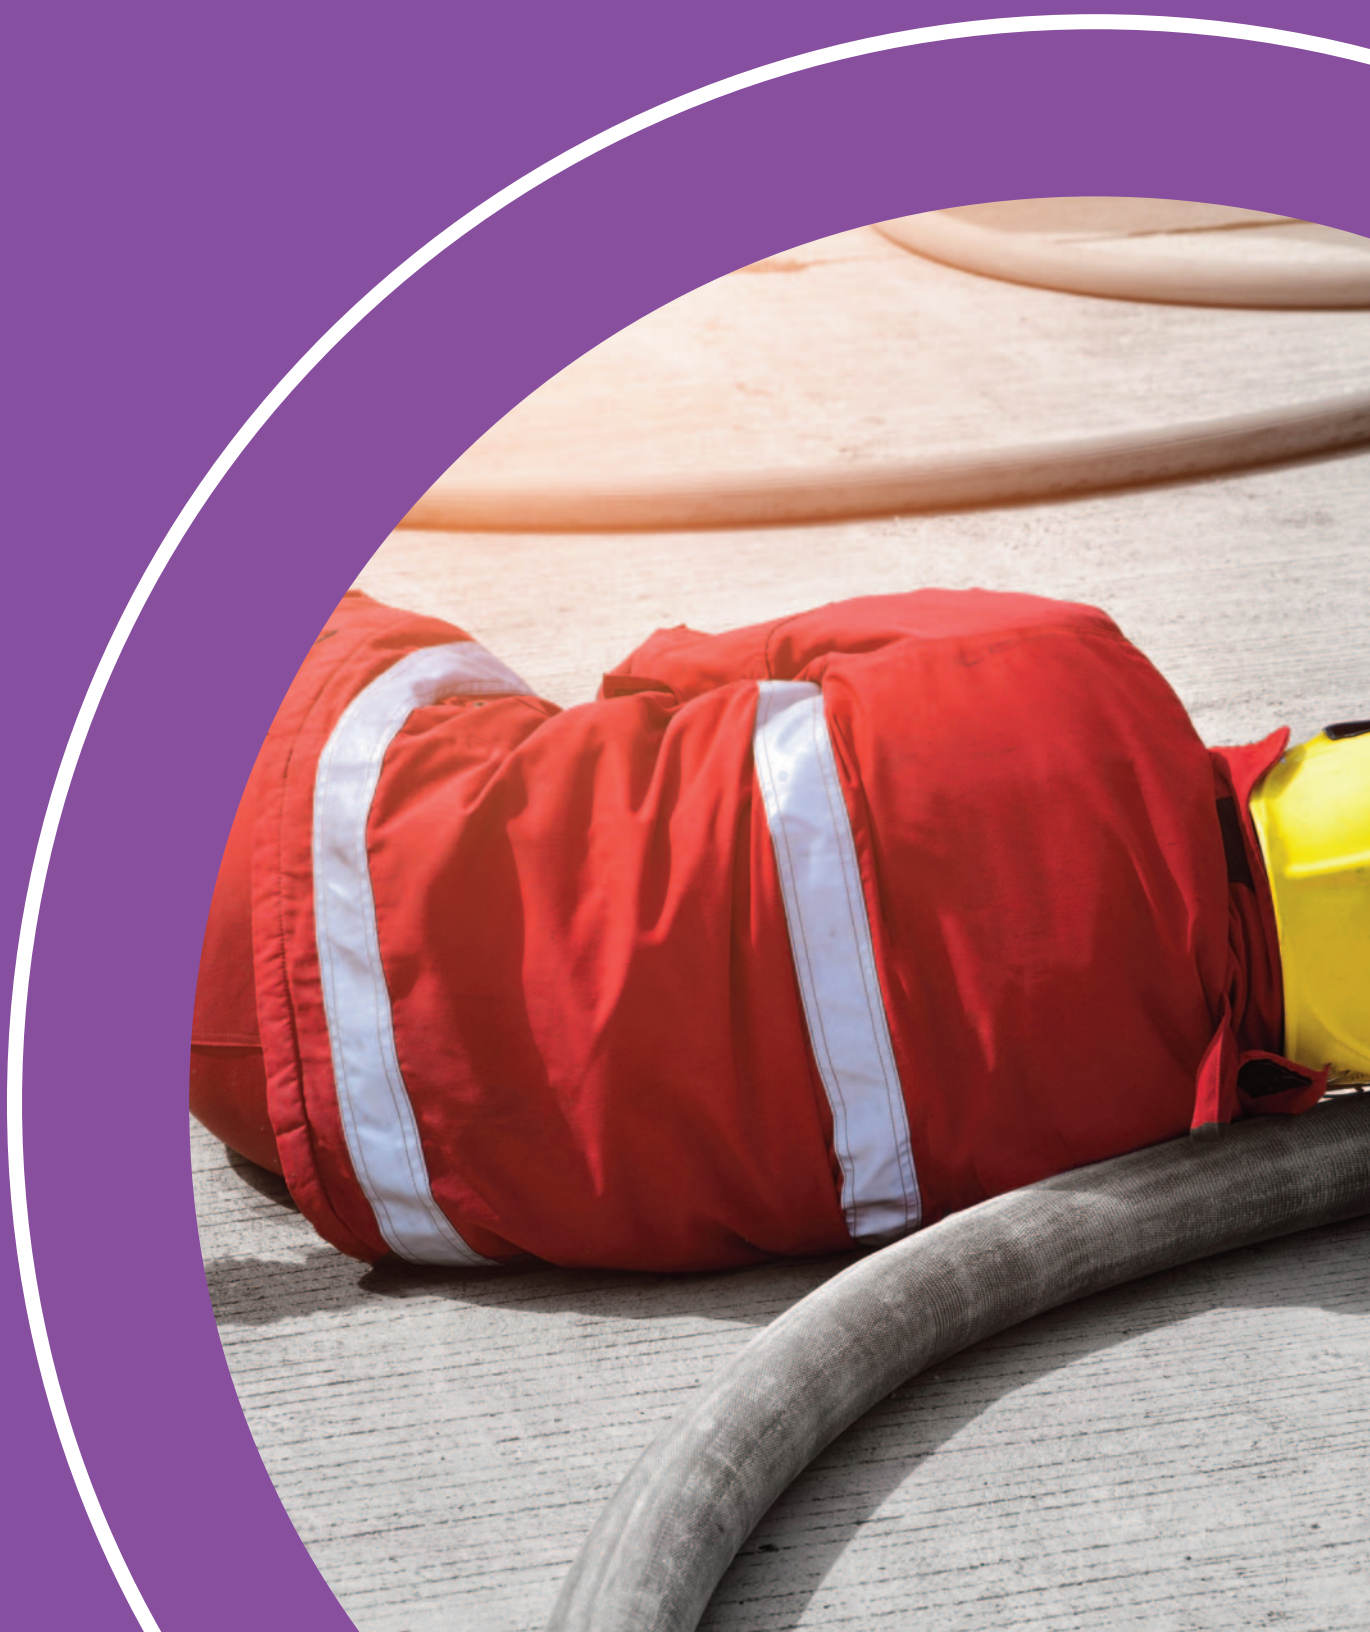
Two stevedores were in the cargo hold finishing their job. It was morning, and having started their shift the previous evening, they had been working for more than 12 hours. To exit the cargo hold they had to first climb up a vertical ladder, then ascend a spiral staircase and for the last 2.5 metres climb up another vertical ladder.

Climbing up the last ladder he only used one hand as he had the tea cup in the other. He was not wearing a safety harness. When he was almost at the top he slipped and fell down. Unfortunately, he did not hit the platform below but fell more than 20 metres and landed at the bottom of the cargo hold.

Damaged ladder

It was later found that a steel bar was missing from one of the lower railings at the beginning of the spiral ladder. The railing was most likely damaged during the loading by one of the crane grabs, or an excavator as it was covered by the cargo when it arrived at the discharge port.

- After both loading and discharging, the Chief Officer should inspect the ladders to ensure they have not been damaged during the cargo operation.
- This accident highlights the minimal effort it takes to do a job safely, and the consequences of not making that effort.
