# Loss Prevention Training Online

## HANDOUTS

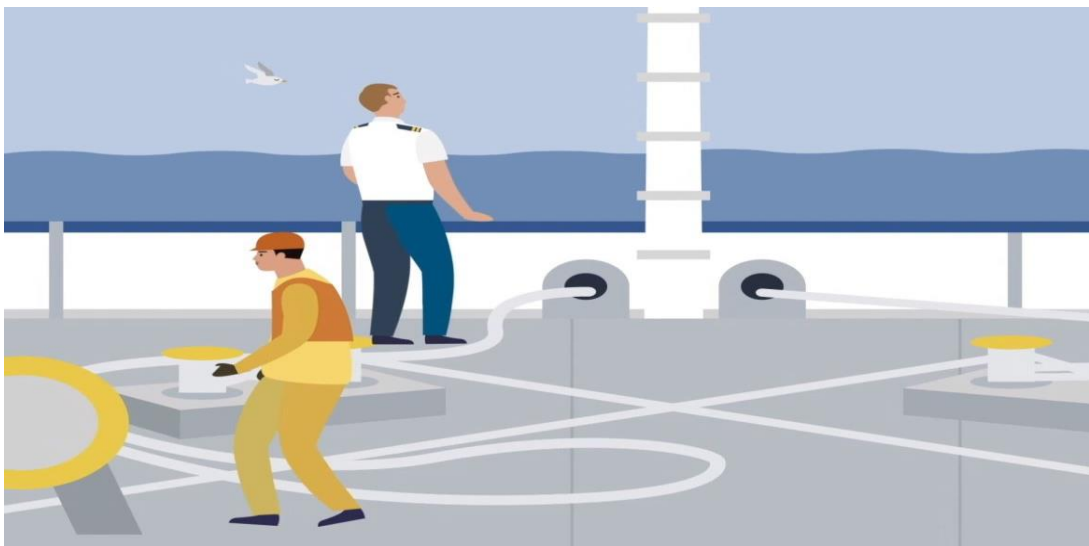
The Chief Officer, who had been by the manifold, came to the stern to assist and took charge of the mooring winch. The Third Officer walked to the stern railing by the fairlead. The linesmen shouted that they were ready to receive the stern lines, so the AB began to lower the stern lines into the water. He was facing the mooring winch and had his back to the Third Officer by the railing. He let the mooring lines run out at a very high speed.

Suddenly the Third Officer started to scream. The AB turned around and could see the Third Officer was caught between the mooring line and the fairlead. The mooring line's speed was now so fast that it cut through the officer's clothes, and he was bleeding badly. The mooring line was actually cutting through the Third Officer's leg which was cut off just below the knee.

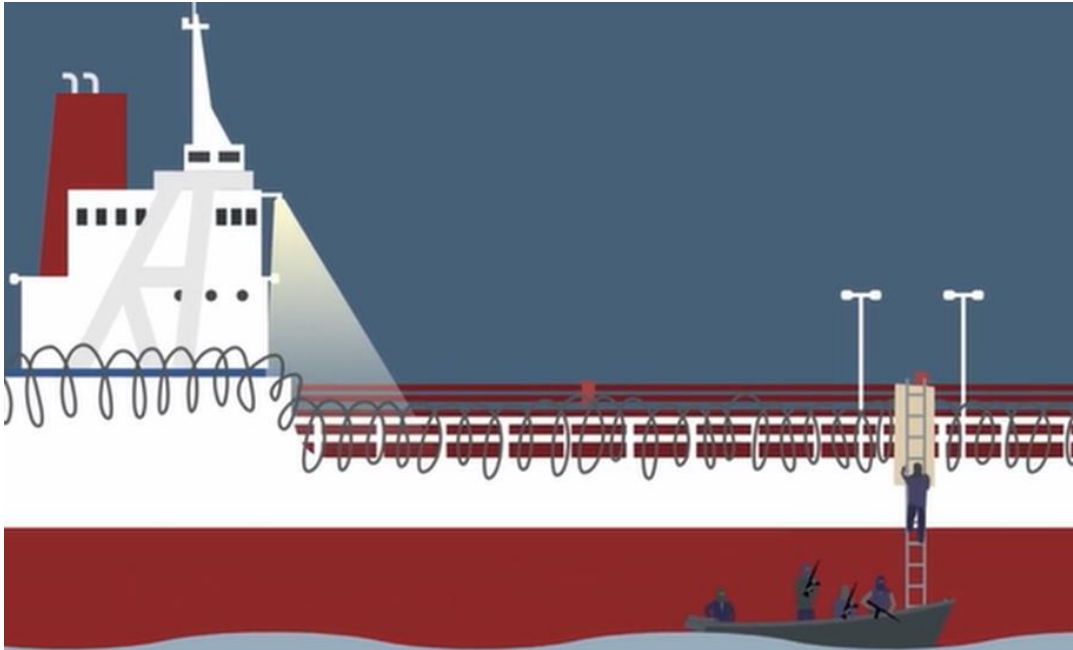
Shortly after midnight, a small boat slowly approached the vessel. It stopped amidships by the broken lights where the freeboard was only 2 metres. A ladder was put on the railing, this had a carpet attached to protect from the barbed wire, and five men climbed on board.

None of the ABs saw the small boat approaching. The boat did not give a stable echo reading on the radar as it was made of wood and the choppy sea interfered.

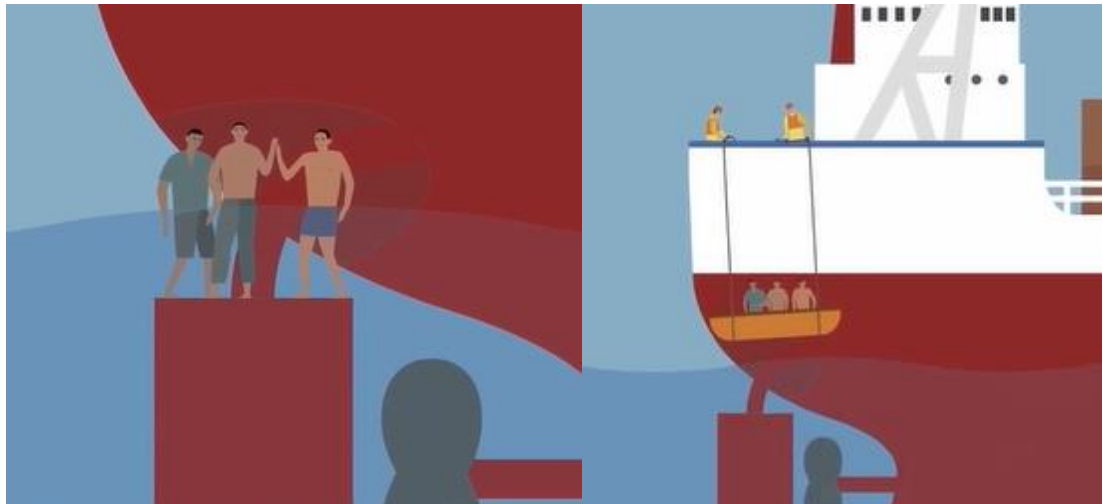
The vessel was in open sea, and the Master brought the vessel to a stop. The crew lowered a camera on the stern to see if they could see anything by the rudder. When they recovered the camera and watched what they had filmed they could see three people sitting on the rudder.

The crew lowered the rescue boat and picked up the three men. The stowaways had used a small rowing boat to reach the vessel and had then managed to climb up the rudder and then into the rudder trunk. So that the stowaways could disembark, the vessel had to divert to Cape Town.

- It is extremely unlikely that a person would be able to sit on the rudder and not be washed out of the rudder trunk during a sea passage. If people in the rudder trunk are not found before departure or shortly after departure, they will most likely be lost at sea.
- To prevent stowaways from achieving access, please consider the following if the vessel is in a port with a high risk of stowaways,
  - ✓ If the rudder is above the waterline, using the rescue boat, inspect the rudder and if possible, the rudder trunk before departure.
  - ✓ Install protective grating or steel bars onto the steering gear trunk to prevent access from the rudder.

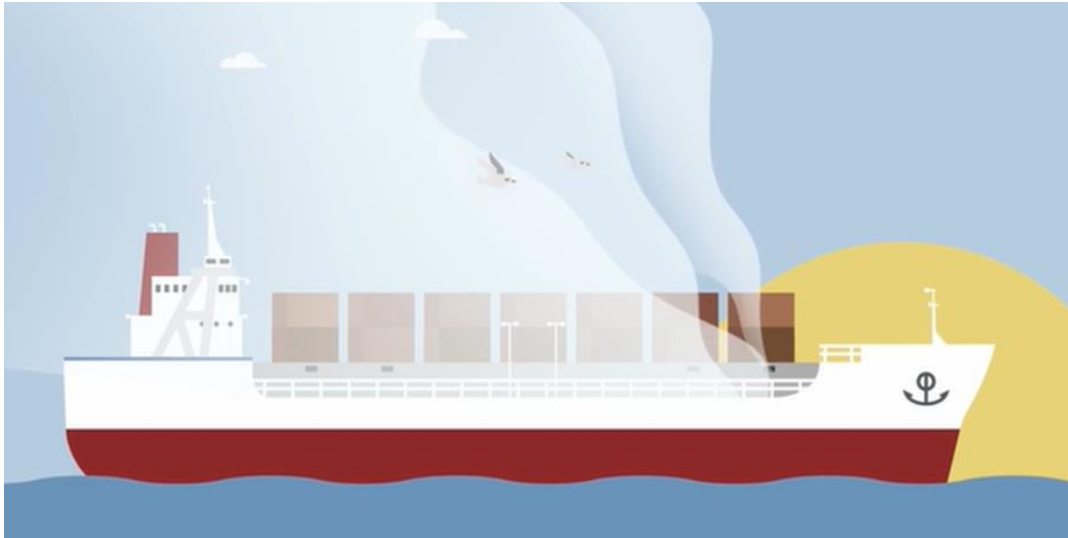
It was early morning, and from the bridge, the Master saw a large cloud of smoke issuing from the forward part of the vessel. At the same time, the fire detection system for cargo hold 3 sounded on the bridge. The Master described the smoke as being white at first and then greyish. The Chief Officer, however, described the smoke as being “dark grey, almost black”.

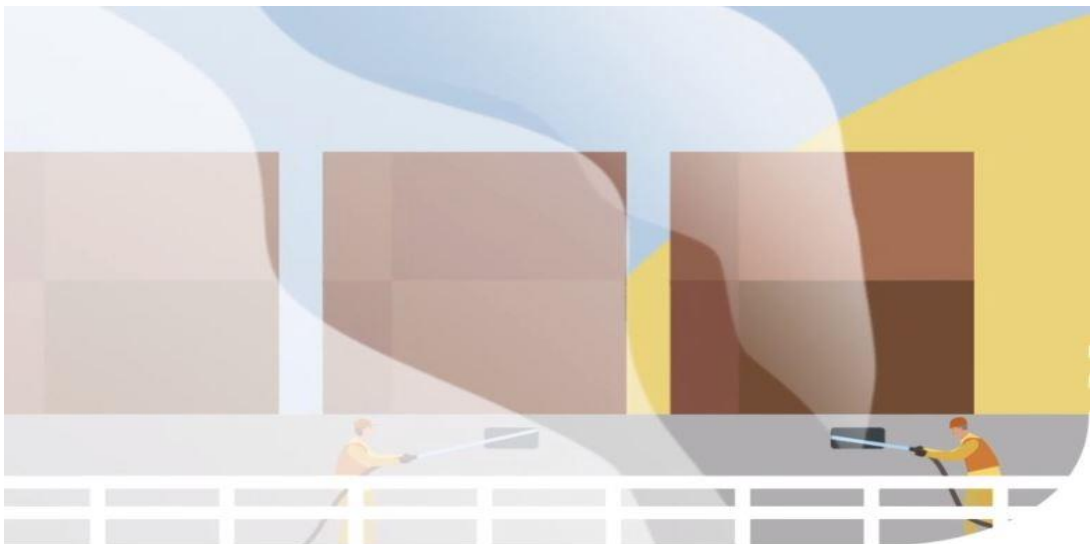
Salvors boarded the vessel the following morning. Shortly before midnight, temperature checks were completed by the vessel's crew indicating that the temperature in cargo hold 3 was rising, so five more CO2 cylinders were released. In the morning another 20 CO2 cylinders were released. The salvors entered cargo hold 2 and measured the temperature of the bulkhead to cargo hold 3 - it was 80°C. It was decided that cargo hold 3 should be filled with water from the fire hydrants. The water filled three container tiers up, and after a couple of hours, the salvors considered the fire to be extinguished.

The container where the fire started was not declared as dangerous cargo but was actually loaded with calcium hypochlorite and had been misdeclared by the shipper. The charterer had loaded the container as per the rules of the IMDG code. As per the manifest, the container was allowed to be loaded in the cargo hold, but as the cargo was calcium hypochlorite, it should not have been loaded below deck or in the position it was stowed in.

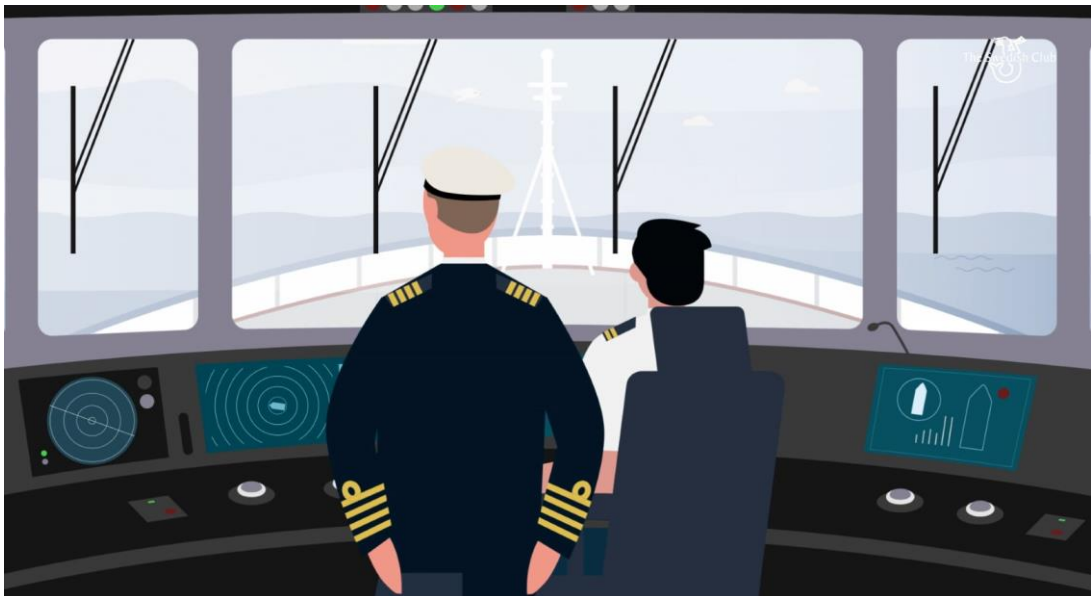
The Master saw a target on the radar and acquired it on the ARPA as vessel B. The target was 10° on the port bow, 4 NM away with a CPA of 0.2 NM. Vessel A was overtaking vessel B. It could be seen that if vessel A maintained this course, it could hit vessel B on the starboard side. Vessel B was also on a course of about 280° and making a speed of 6 knots. The Master started the fog signal.

**C -15 minutes:** Vessel B was on course of 293°, and the CPA was 0.14 NM. Vessel A was maintaining its course and speed.
