Fire!

A guide to the causes and prevention of cargo fires

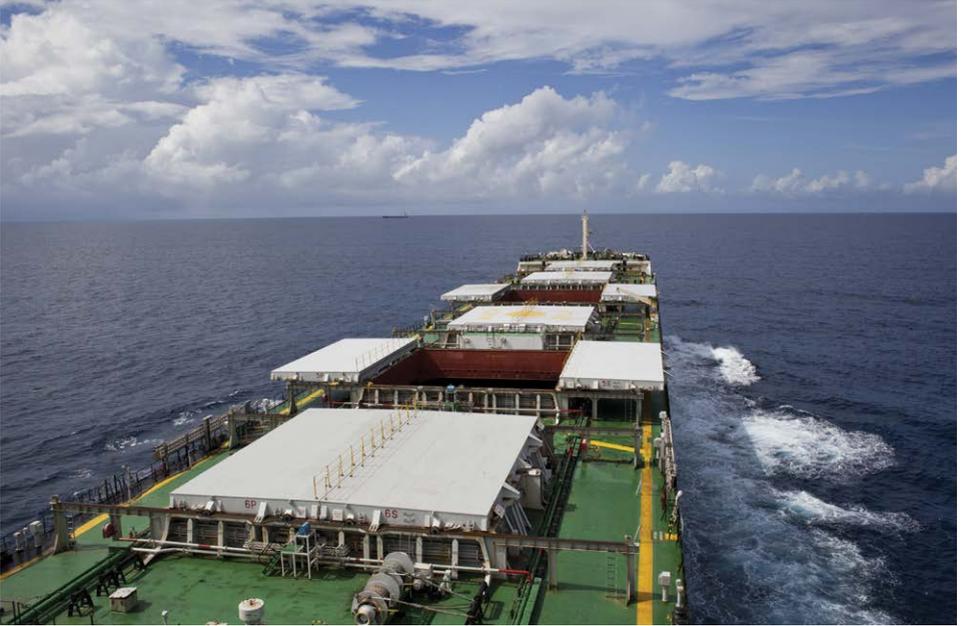
Cargo hold lights Case Study

A bulker had loaded sugar beet pellets in all three cargo holds with the operation taking 27 hours. When loading was completed the ventilation hatches and all other access points to the cargo holds were secured. In cargo hold 1 there were two metres of space between the cargo and the cargo hatch. In cargo holds 2 and 3 the cargo was almost up to the bottom of the hatch coaming.

The top layer of cargo in hold 2 had been burned. About four metres below the cargo surface the cargo was in good condition. It was discovered that the cargo in hold 3 had been damaged by condensation and tainted by smoke. There were clear burn marks around the floodlights and distinct burn marks by the coaming at the same locations where the hot spots had been discovered. The floodlights were situated 1m below the cargo surface in holds 2 and 3 and there was black, burned cargo covering the floodlights.

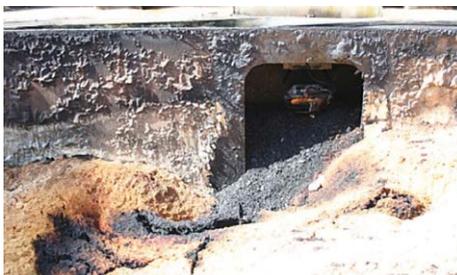
There were two floodlights fitted in cargo hold 1, port and starboard and four floodlights fitted in both cargo holds 2 and 3. All the floodlights were installed in recesses in the hatch coaming. The floodlights were protected by round bars preventing crane hooks, grabs etc from hitting them, but these bars do not prevent cargo like sugar beet pellets from

covering the lights. The floodlights were controlled from the bridge on a panel with four key-switches. These switches were marked 1, 2, 3 and 4 respectively. No drawings or legends were attached clarifying which areas these key-switches served.

The subsequent investigation revealed that the cargo floodlights were not connected according to the approved 'as built' circuit diagrams delivered with the vessel.

It was not clear on board which lights were controlled by which key-switch. The fire was caused because a number of cargo lights were operating while cargo covered them, so the lights ignited the cargo. There was a lack of information on board about how the light circuits were connected and how the light system should be operated. There was also a lack of records concerning use of the lights.
