Claims at a Glance

Statistics updated January 2016

2016

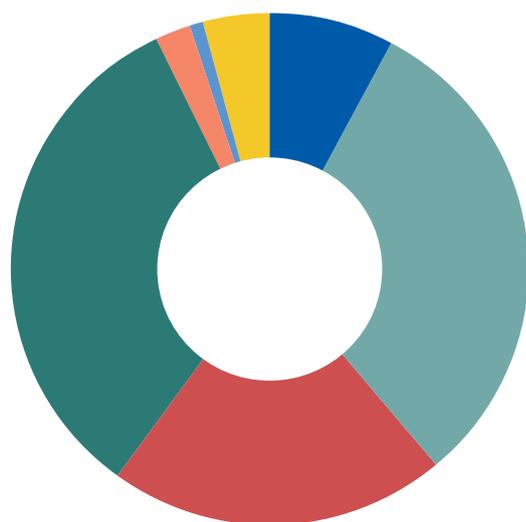
Graph 1.1: P&I – all insured vessel types as per 1 January 2016

- Dry Cargo
- Container
- Tanker
- Bulker
- Passenger/Ferry
- Miscellaneous
- Roro

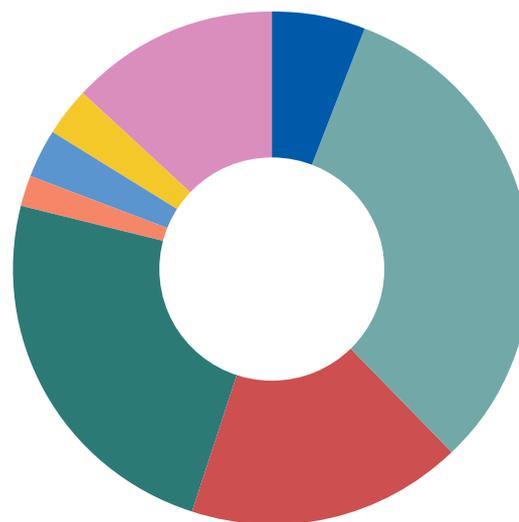
Graph 1.2: H&M – all insured vessel types as per 1 January 2016

- Dry Cargo
- Container
- Tanker
- Bulker
- Passenger/Ferry
- Miscellaneous
- Roro
- Offshore

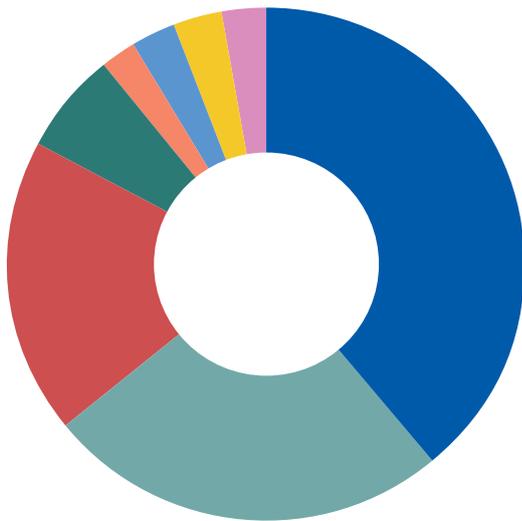
Claims 5,000-3,000,000 (USD)

Period: 2011-2015
 Vessel type: Bulk carrier, container & tanker
 Types of claims: All claim categories
 As per 29/12/2015

● Cargo	39.11%
● Illness	25.07%
● Injury	18.69%
● Other PI	6.53%
● Collision	2.06%
● Contact	2.75%
● Stowaways	3.09%
● Pollution	2.70%

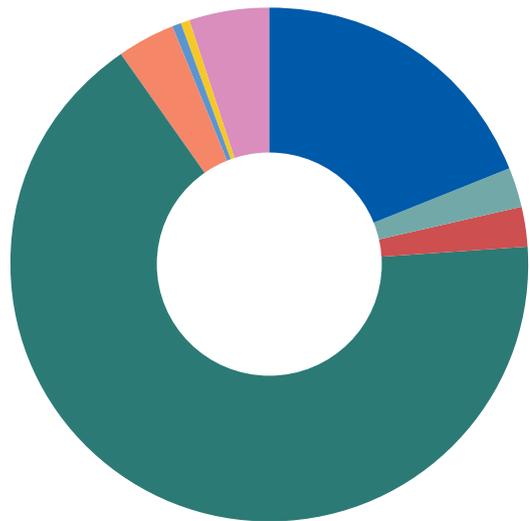
Graph 2.2: Claims distribution, cost

Claims 5,000-3,000,000 (USD)

Period: 2011-2015
 Vessel type: Bulk carrier, container & tanker
 Types of claims: All claim categories
 As per 25/12/2015

● Cargo	19.00%
● Illness	2.50%
● Injury	2.60%
● Other PI	66.40%
● Collision	3.60%
● Contact	0.60%
● Stowaways	0.30%
● Pollution	5.00%

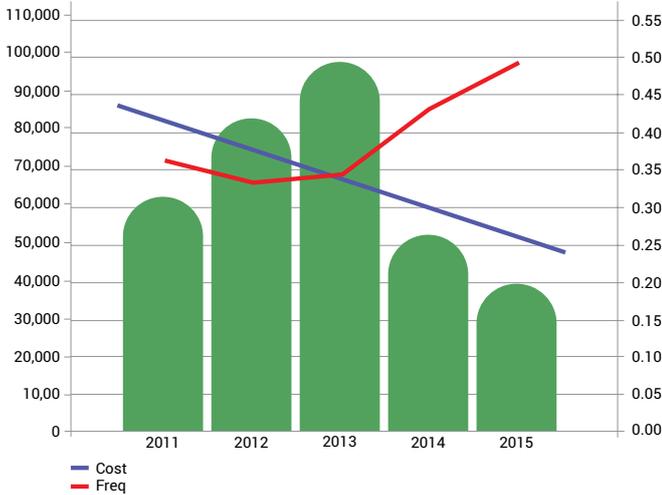
Graph 2.3: Average claims costs & frequency (capped)
 Claims 5,000–3,000,000 (USD)

Period: 2011-2015
 Types of vessel: Bulk carrier, container and tanker
 Type of claims: Cargo, illness and injury
 As per 29/12/2015

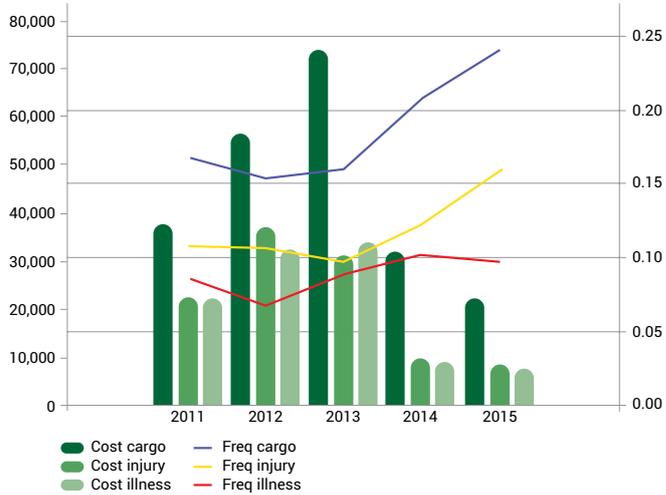
Graph 2.4: Average claim cost & frequency per category
 Claims 5,000–3,000,000 (USD)

Period: 2011-2015
 Types of vessel: **Bulk carrier, container and tanker**
 Type of claims: Cargo, illness and injury
 As per 29/12/2015

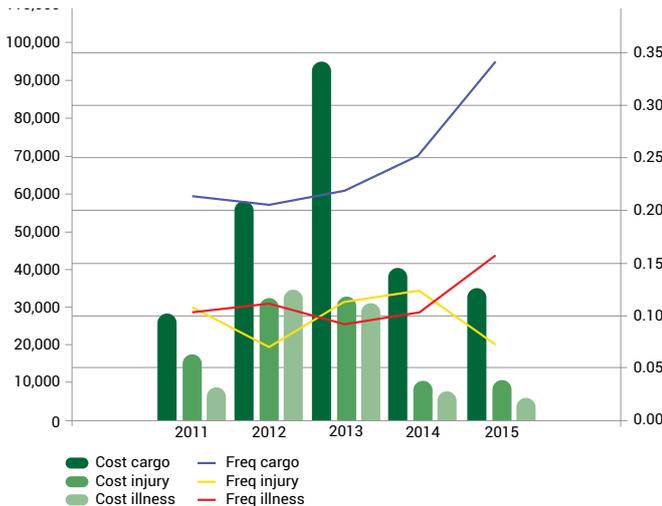
Graph 2.5: Average claim cost & frequency per category
 Claims 5,000–3,000,000 (USD)

Period: 2011-2015
 Types of vessel: **Bulk carrier**
 Type of claims: Cargo, illness and injury
 As per 29/12/2015

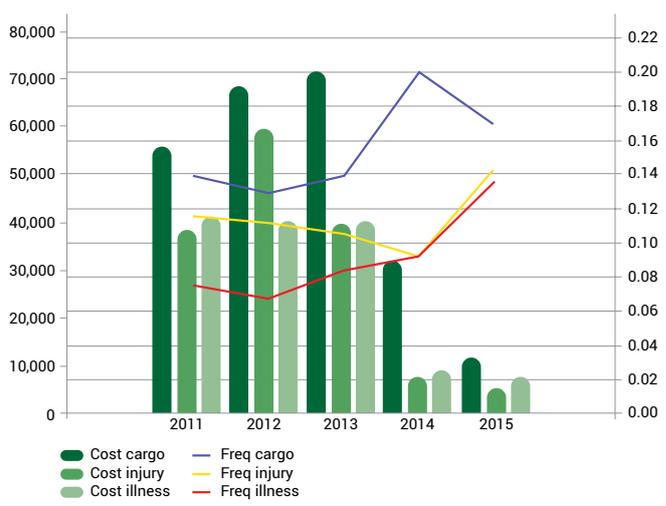
Graph 2.6: Average claim cost & frequency per category
 Claims 5,000–3,000,000 (USD)

Period: 2011-2015
 Types of vessel: **Container**
 Type of claims: Cargo, illness and injury
 As per 29/12/2015

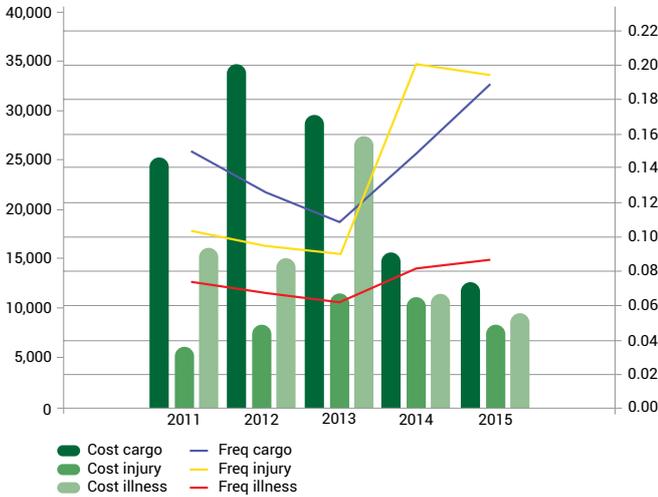
Graph 2.7: Average claim cost & frequency per category
 Claims 5,000–3,000,000 (USD)

Period: 2011-2015
 Types of vessel: **Tanker**
 Type of claims: Cargo, illness and injury
 As per 29/12/2015

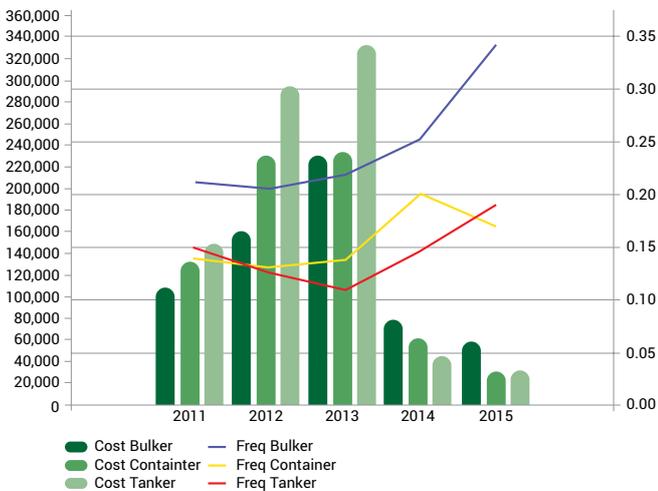
Graph 2.8: Average claim cost & frequency per vessel type
 Claims 5,000–3,000,000 (USD)

Period: 2011-2015
 Types of vessel: Bulk carrier, container and tanker
 Type of claims: Cargo
 As per 29/12/2015

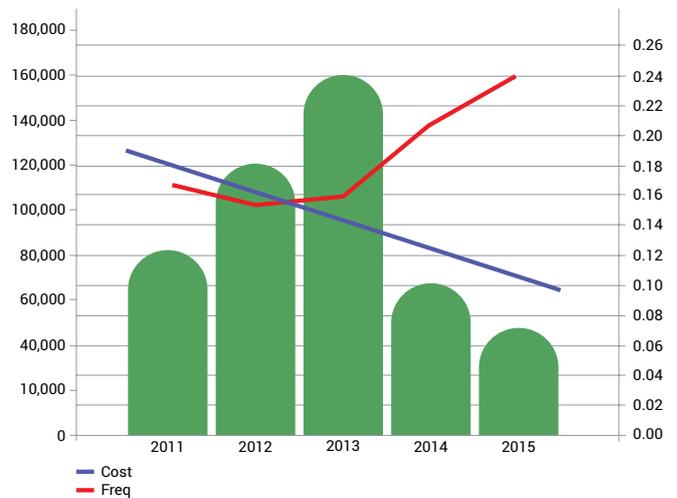
Graph 2.9: Average claim cost & frequency (capped)
 Claims 5,000–3,000,000 (USD)

Period: 2011-2015
 Types of vessel: Bulk carrier, container and tanker
 Type of claims: Cargo
 As per 29/12/2015

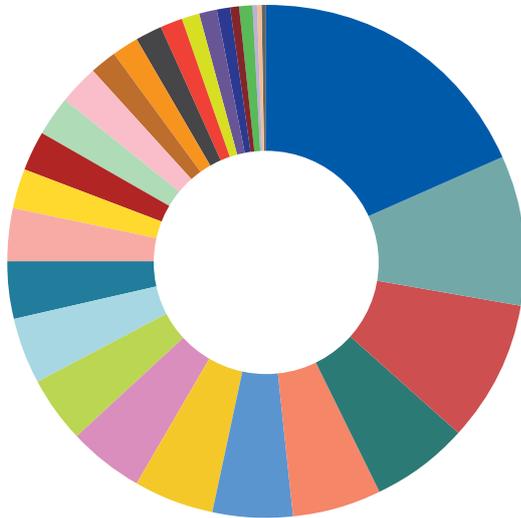
Graph 2.10: Immediate cause, frequency per loss code
 Claims 5,000–3,000,000 (USD)

Period: 2011-2015
 Types of vessel: Bulk carrier, container and tanker
 Type of claim: Cargo
 As per 29/12/2015

● Improper cargo handling, shore-side	18.56%
● Poor tally	8.23%
● Improper cargo handling, ship-side	9.47%
● Inherent vice	6.17%
● Damage prior loading	6.04%
● Multiple causes	5.90%
● Leaking hatch covers	5.35%
● Heavy weather	4.39%
● Error in calculation	4.25%
● Flooding of hold	3.29%
● Insufficient cleaning	2.61%
● Leaking container	2.61%
● Damage post discharge	2.61%
● Poor stowage	2.33%
● Reefer mechanical failure	1.92%
● Insufficient lashing/securing by shipper	1.92%
● Insufficient lashing/securing by stevedore	1.92%
● Collision	1.78%
● Grounding	1.78%
● Leaking vents	1.65%
● Poor monitoring/maintenance of reefer unit	0.82%
● Fire	0.82%
● Leaking pipes	0.82%
● Loading heavy containers on top of light	0.69%
● Blocked bilges	0.55%
● Leaking cargo	0.41%
● Insufficient lashing/securing, ship-side	0.27%
● Contact	0.27%

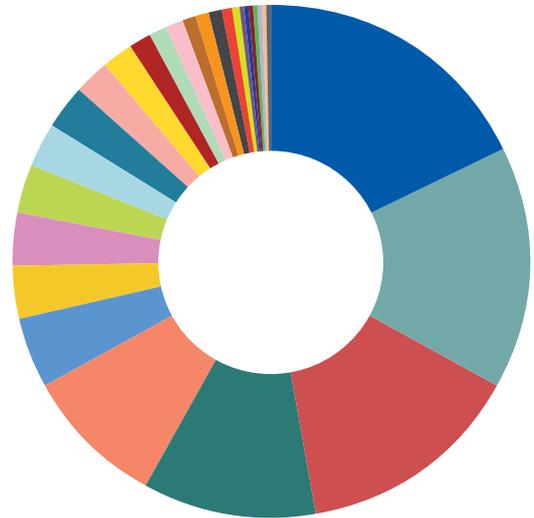
Graph 2.11: Immediate cause, cost per loss code
 Claims 5,000–3,000,000 (USD)

Period: 2010-2014
 Types of vessel: Bulk carrier, container and tanker
 Type of claim: Cargo
 As per 29/12/2015

● Inherent vice	17.91%
● Collision	15.36%
● Grounding	14.22%
● Fire	10.60%
● Improper cargo handling, shore-side	9.00%
● Leaking hatch covers	4.39%
● Poor tally	3.34%
● Flooding of hold	3.28%
● Improper cargo handling, ship-side	3.27%
● Multiple causes	2.67%
● Insufficient cleaning	2.66%
● Leaking vents	2.41%
● Damage prior loading	1.93%
● Damage post discharge	1.39%
● Heavy weather	1.10%
● Leaking pipes	1.04%
● Poor stowage	0.90%
● Reefer mechanical failure	0.90%
● Error in calculation	0.81%
● Leaking container	0.66%
● Insufficient lashing/securing, ship-side	0.52%
● Insufficient lashing/securing by shipper	0.38%
● Leaking cargo	0.35%
● Insufficient lashing/securing by stevedore	0.28%
● Blocked bilges	0.26%
● Loading heavy containers on top of light	0.22%
● Poor monitoring/maintenance of reefer unit	0.13%
● Contact	0.03%

The top three most expensive categories are inherent vice, collision and grounding. Inherent vice is caused because the cargo was not in a proper condition when it was loaded, emphasising the importance of having proper testing procedures to ensure that cargo is within specification.

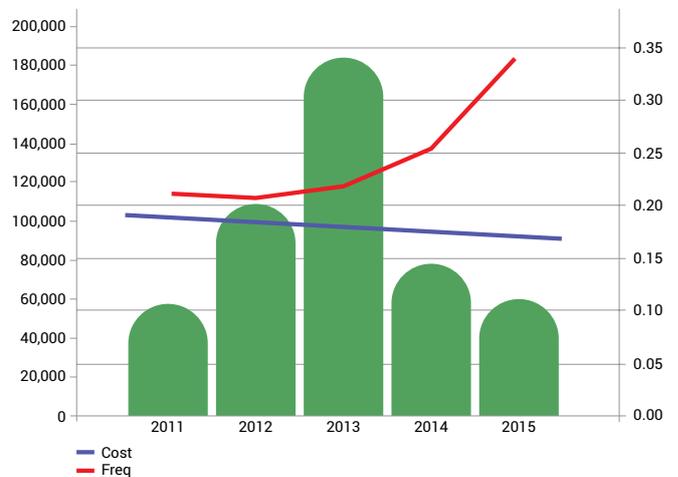
Graph 2.12: Average claim cost & frequency (capped)
 Claims 5,000–3,000,000 (USD)

Period: 2011-2015
 Types of vessel: Bulk carrier
 Type of claims: Cargo
 As per 29/12/2015

The most common claims in this category are shortage and wet damage; and contamination is the most expensive.

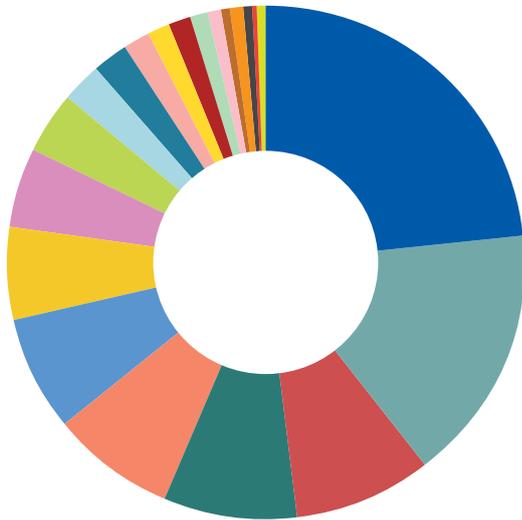
Graph 2.13: Immediate cause, frequency per loss code
 Claims 5,000–3,000,000 (USD)

Period: 2011-2015
 Types of vessel: Bulk carrier
 Type of claim: Cargo
 As per 29/12/2015

● Improper cargo handling, shore-side	23.35%
● Poor tally	16.34%
● Improper cargo handling, ship-side	8.56%
● Multiple causes	8.17%
● Leaking hatch covers	7.78%
● Inherent vice	7.39%
● Error in calculation	5.84%
● Damage prior loading	5.06%
● Poor stowage	3.89%
● Damage post discharge	2.33%
● Insufficient lashing/securing by stevedore	2.33%
● Heavy weather	1.56%
● Grounding	1.56%
● Blocked bilges	1.17%
● Insufficient cleaning	1.17%
● Leaking pipes	0.78%
● Collision	0.78%
● Leaking vents	0.78%
● Fire	0.39%
● Flooding of hold	0.39%
● Insufficient lashing/securing by shipper	0.39%

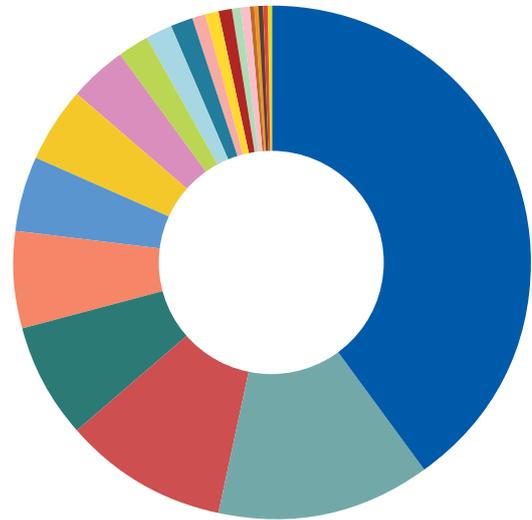
Graph 2.14: Immediate cause, cost per loss code
 Claims 5,000–3,000,000 (USD)

Period: 2011-2015
 Types of vessel: Bulk carrier
 Type of claim: Cargo
 As per 29/12/2015

● Inherent vice	40.00%
● Grounding	13.52%
● Improper cargo handling, shore-side	10.17%
● Poor tally	7.18%
● Leaking hatch covers	6.32%
● Improper cargo handling, ship-side	4.86%
● Multiple causes	4.59%
● Heavy weather	3.77%
● Error in calculation	1.75%
● Leaking pipes	1.74%
● Poor stowage	1.46%
● Fire	0.92%
● Damage prior loading	0.84%
● Damage post discharge	0.81%
● Blocked bilges	0.49%
● Insufficient cleaning	0.44%
● Insufficient lashing/securing by stevedore	0.42%
● Leaking vents	0.36%
● Flooding of hold	0.34%
● Collision	0.17%
● Insufficient lashing/securing by shipper	0.03%

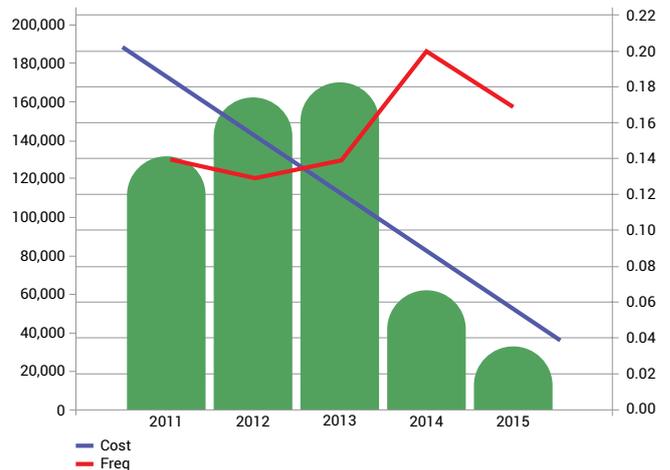
Graph 2.15: Average claim cost & frequency (capped)
 Claims 5,000–3,000,000 (USD)

Period: 2011-2015
 Types of vessel: Container
 Type of claims: Cargo
 As per 29/12/2015

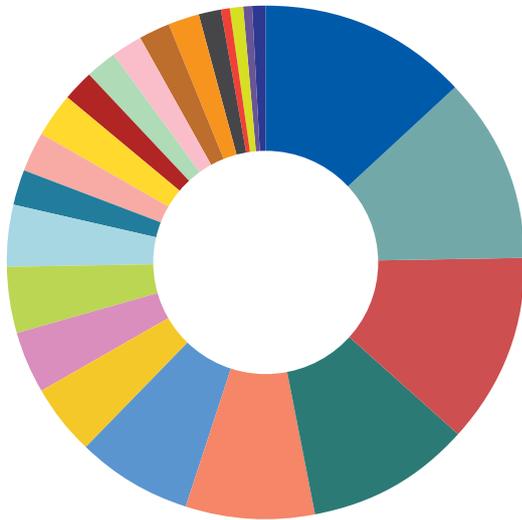
Graph 2.16: Frequency per loss code
 Claims 5,000–3,000,000 (USD)

Period: 2011-2015
 Types of vessel: Container
 Type of claim: Cargo
 As per 29/12/2015

● Flooding of hold	12.99%
● Improper cargo handling, shore-side	11.69%
● Heavy weather	11.69%
● Leaking container	10.39%
● Reefer mechanical failure	7.79%
● Insufficient lashing/securing by shipper	7.14%
● Inherent vice	4.55%
● Improper cargo handling, ship-side	3.90%
● Collision	3.90%
● Poor monitoring/maintenance of reefer unit	3.90%
● Leaking hatch covers	3.25%
● Damage post discharge	2.60%
● Loading heavy containers on top of light	2.60%
● Poor stowage	1.95%
● Insufficient lashing/securing by stevedore	1.95%
● Grounding	1.95%
● Multiple causes	1.95%
● Fire	1.95%
● Leaking pipes	1.30%
● Leaking vents	0.65%
● Insufficient lashing/securing, ship-side	0.65%
● Damage prior loading	0.65%
● Contact	0.65%

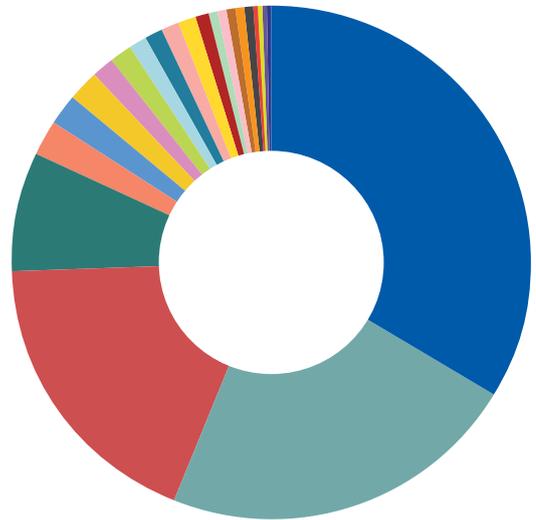
Graph 2.17: Cost per loss code
 Claims 5,000–3,000,000 (USD)

Period: 2011-2015
 Types of vessel: Container
 Type of claim: Cargo
 As per 29/12/2015

● Collision	33.80%
● Fire	22.41%
● Grounding	18.29%
● Flooding of hold	7.67%
● Leaking hatch covers	2.09%
● Reefer mechanical failure	1.97%
● Improper cargo handling, shore-side	1.97%
● Leaking container	1.41%
● Heavy weather	1.33%
● Inherent vice	1.17%
● Improper cargo handling, ship-side	1.15%
● Insufficient lashing/securing by shipper	1.05%
● Poor stowage	1.00%
● Insufficient lashing/securing, ship-side	0.89%
● Damage post discharge	0.64%
● Multiple causes	0.58%
● Loading heavy containers on top of light	0.54%
● Fire	0.54%
● Leaking pipes	0.47%
● Leaking vents	0.45%
● Insufficient lashing/securing, ship-side	0.33%
● Damage prior loading	0.22%
● Contact	0.03%

Catastrophic navigational claims have a large impact on the cost of cargo claims on container vessels. The frequency of collisions and groundings are around 3% of the cargo claims, but the cost contributes more than 20% and 15% of the total cost respectively.

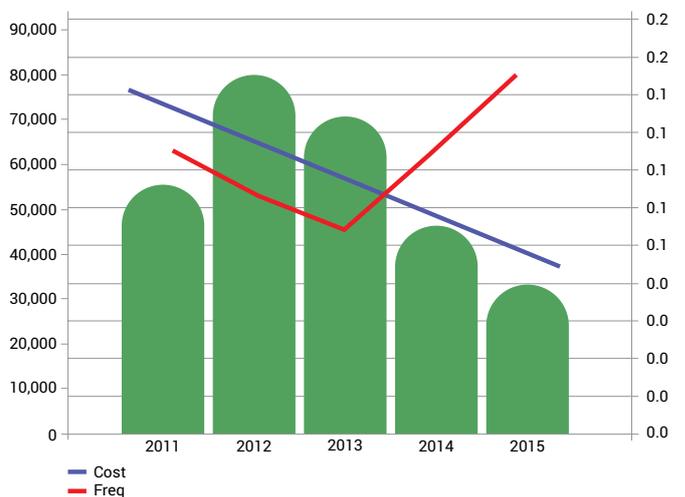
Graph 2.18: Average claim cost & frequency (capped)
 Claims 5,000–3,000,000 (USD)

Period: 2011-2015
 Types of vessel: Tanker
 Type of claims: Cargo
 As per 29/12/2015

Contamination is a major issue for chemical and product tankers as it is both the most frequent and most costly type of claim.

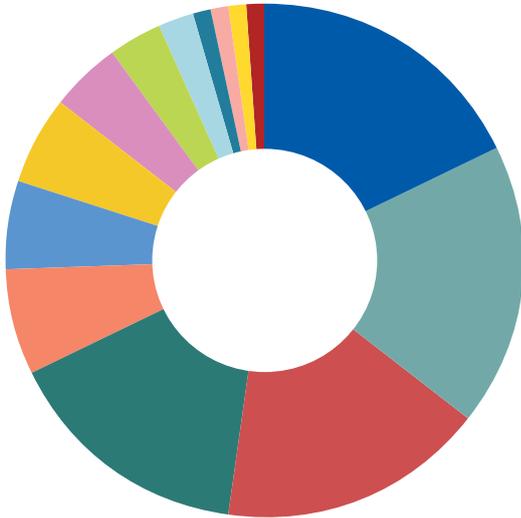
Graph 2.19: Frequency per loss code
 Claims 5,000–3,000,000 (USD)

Period: 2011-2015
 Types of vessel: Tanker
 Type of claim: Cargo
 As per 29/12/2015

● Insufficient cleaning	17.78%
● Improper cargo handling, ship-side	17.78%
● Improper cargo handling, shore-side	16.67%
● Damage prior loading	15.56%
● Error in calculation	6.67%
● Inherent vice	5.56%
● Poor tally	5.56%
● Leaking vents	4.44%
● Damage post discharge	3.33%
● Leaking cargo	2.22%
● Multiple	1.11%
● Grounding	1.11%
● Heavy weather	1.11%
● Fire	1.11%

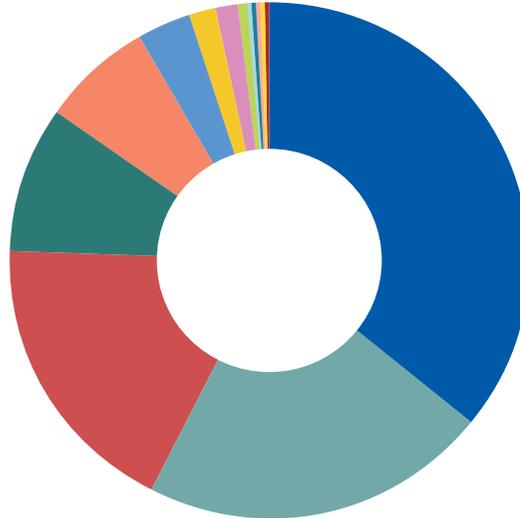
Graph 2.20: Cost per loss code
 Claims 5,000–3,000,000 (USD)

Period: 2011-2015
 Types of vessel: Tanker
 Type of claim: Cargo
 As per 29/12/2015

● Improper cargo handling, shore-side	35.80%
● Leaking vents	21.83%
● Insufficient cleaning	18.02%
● Improper cargo handling, ship-side	9.17%
● Damage prior loading	6.99%
● Damage post discharge	3.22%
● Inherent vice	1.66%
● Poor tally	1.33%
● Error in calculation	1.15%
● Leaking cargo	0.30%
● Fire	0.22%
● Grounding	0.12%
● Multiple	0.10%
● Heavy weather	0.10%

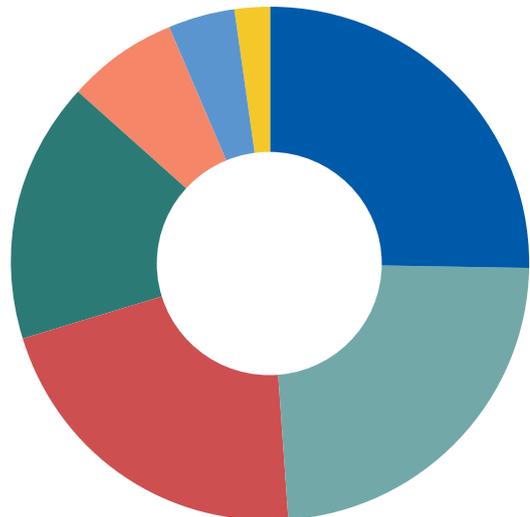
Graph 2.21: Wet damage – frequency per loss code

Type of claim: Cargo

As per 29/12/2015

● Leaking hatch covers	25.51%
● Heavy weather	23.47%
● Flooding of hold	21.42%
● Leaking container	16.31%
● Leaking vents	7.16%
● Leaking pipes	4.09%
● Leaking cargo	2.04%

Wet damage claims make up 19.56% of claims in total.

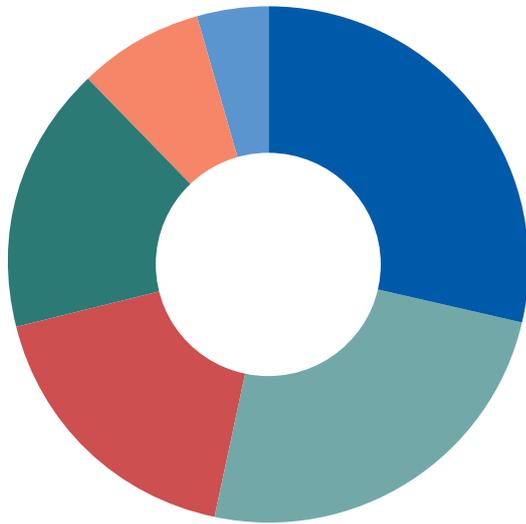
Graph 2.22: Wet damage – cost per loss code Claims 5,000–3,000,000 (USD)

Type of claim: Cargo

As per 29/12/2015

● Leaking hatch covers	28.81%
● Flooding of hold	24.73%
● Heavy weather	17.58%
● Leaking vents	16.78%
● Leaking pipes	7.80%
● Leaking container	4.30%

The cost for wet damage is 13.71% of the total claim cost, and the average claim cost is about USD 105,000.

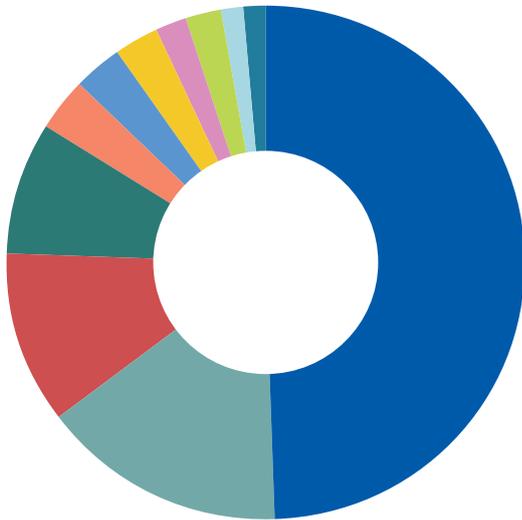
Graph 2.25: Frequency per loss code
 Claims 5,000–3,000,000 (USD)

Period: 2011-2015
 Types of vessel: Bulk carrier, container & tanker
 Type of claim: Cargo
 As per 29/12/2015

● Slips and falls	48.17%
● Struck by falling object	14.62%
● Struck/caught by object(s)	10.63%
● Caught in machinery or equipment	7.97%
● Burns and explosions	6.31%
● Strain by lifting	2.99%
● Strain by pulling or pushing	2.66%
● Strain by carrying	1.99%
● Cut by object	1.99%
● Power tool injury	1.33%
● Chemical exposure	1.33%

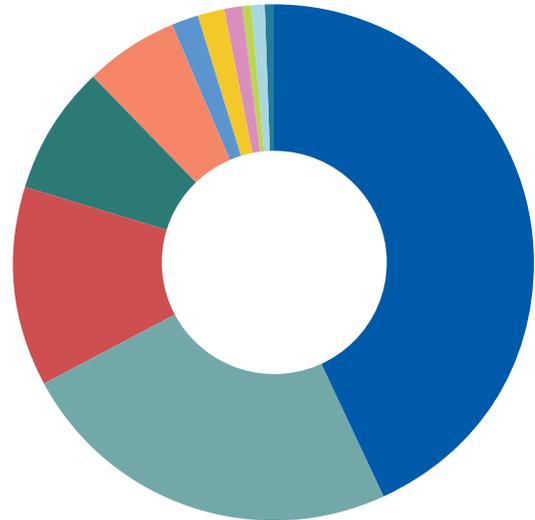
Graph 2.26: Cost per loss code
 Claims 5,000–3,000,000 (USD)

Period: 2011-2015
 Types of vessel: Bulk carrier, container & tanker
 Type of claim: Cargo
 As per 29/12/2015

● Slips and falls	43.18%
● Burns and explosions	24.06%
● Struck by falling object	12.52%
● Struck/caught by object(s)	8.13%
● Caught in machinery or equipment	5.95%
● Strain by carrying	1.71%
● Strain by lifting	1.47%
● Strain by pulling or pushing	1.20%
● Chemical exposure	0.64%
● Cut by object	0.59%
● Power tool injury	0.55%

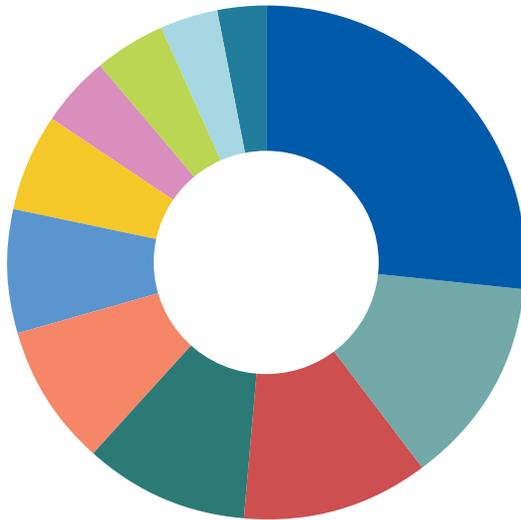
Graph 2.29: Frequency per loss code
 Claims 5,000–3,000,000 (USD)

Period: 2011-2015
 Types of vessel: Bulk carrier, container & tanker
 Type of claim: Cargo
 As per 29/12/2015

● Conditions of the cardiovascular system	26.68%
● Conditions of the genito-urinary system	13.21%
● Conditions of the musculoskeletal system	11.59%
● Infectious and parasitic diseases	10.24%
● Conditions of the digestive system	8.89%
● Appendicitis	8.09%
● Conditions of the respiratory system	5.93%
● Conditions of the skin	4.58%
● Conditions of the nervous system	4.31%
● Mental disorders	3.50%
● Multiple causes	2.96%

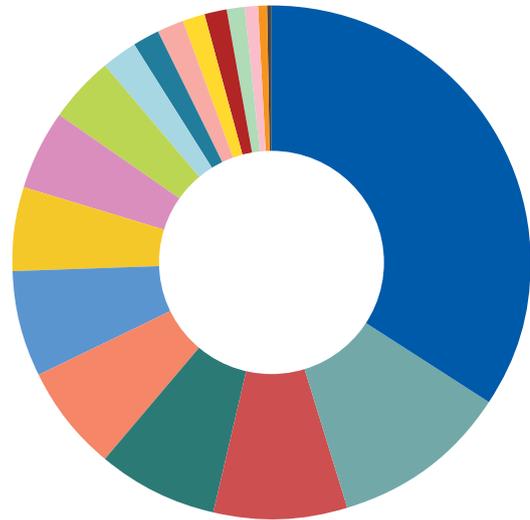
Graph 2.30: Cost per loss code
 Claims 5,000–3,000,000 (USD)

Period: 2011-2015
 Types of vessel: Bulk carrier, container & tanker
 Type of claim: Cargo
 As per 29/12/2015

● Conditions of the cardiovascular system	34.30%
● Conditions of the nervous system	11.13%
● Infectious and parasitic diseases	8.37%
● Conditions of the genito-urinary system	7.36%
● Conditions of the musculoskeletal system	6.65%
● Conditions of the respiratory system	6.64%
● Conditions of the digestive system	5.47%
● Appendicitis	4.89%
● Multiple causes	4.16%
● Conditions of the skin	2.29%
● Neoplasms	1.73%
● Endocrine, nutritional, metabolic and immunity	1.56%
● Eyes	1.40%
● Diseases of the blood and blood-forming organs	1.37%
● Mental disorders	1.30%
● Ears	0.62%
● Hernia	0.54%
● Oral health	0.23%

The most common cause of seafarer illness for all three types of vessels is cardiovascular disease, which is also the most costly. The crew cannot do a great deal once on board to prevent illness from happening apart from focussing on a healthy diet and exercise. It is very traumatising and complicated for the entire crew to deal with seriously ill crew members on board. The importance of ensuring that all crew members are healthy before joining the vessel is the best prevention, and for the company to support and actively try to encourage healthy living and exercise.

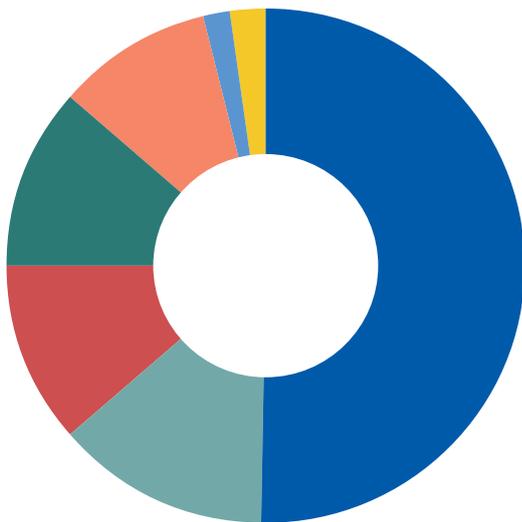
Limit: USD claims >= 10,000 – uncapped

Period: 2011-2015
 Types of vessel: Bulk carrier, container & tanker
 All categories H&M
 As per 4/1/2016

● Machinery or equipment	50.35%
● Contact	13.39%
● Other HM	11.32%
● Collision	11.47%
● Grounding	9.70%
● Fire or explosion	1.69%
● Heavy weather	2.08%

Of all H&M claims, navigational claims (defined as collisions, contacts and groundings) represent approximately 35% of the total and machinery/equipment claims 50%.

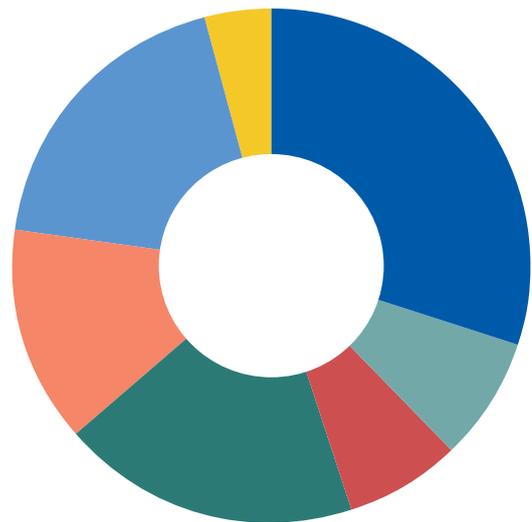
Limit: USD claims >= 10,000 – uncapped

Period: 2011-2015
 Types of vessel: Bulk carrier, container & tanker
 All categories H&M
 As per 4/1/2016

● Machinery or equipment	30.20%
● Contact	7.60%
● Other HM	7.30%
● Collision	18.60%
● Grounding	13.50%
● Fire or explosion	18.70%
● Heavy weather	3.90%

The overall cost for machinery/equipment represents approx. 30% of the claims total and navigational claims, 40%.

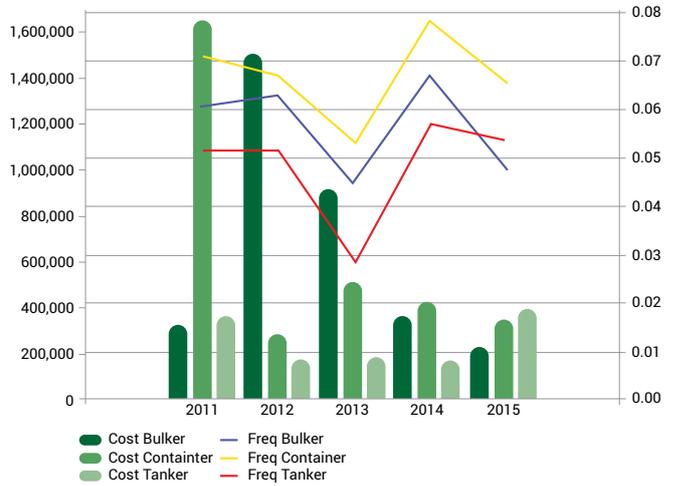
Graph 3.4: Average claim cost & frequency per vessel type Claims 5,000–3,000,000 (USD)

Period: 2011-2015
 Types of vessel: Bulk carrier, container and tanker
 Type of claims: **Collision, contact & grounding**
 As per 4/1/2016

Over the last five years container vessels have the demonstrated the highest claims frequency and cost followed by bulk carriers and tankers.

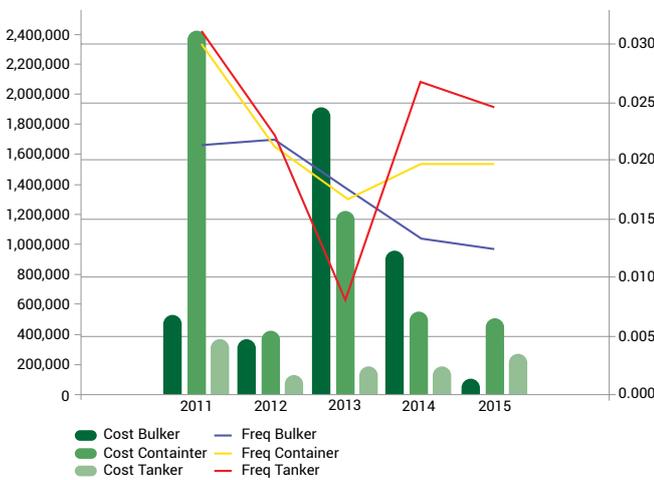
Graph 3.5: Average claim cost & frequency per vessel type Limit: USD claims >= 10,000 – uncapped

Period: 2011-2015
 Types of vessel: Bulk carrier, container and tanker
 Type of claims: **Collision**
 As per 4/1/2016

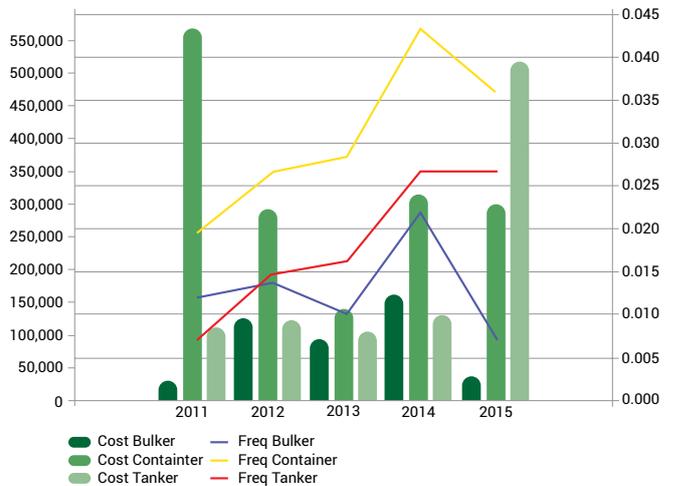
Graph 3.6: Average claim cost & frequency per vessel type Limit: USD claims >= 10,000 – uncapped

Period: 2011-2015
 Types of vessel: Bulk carrier, container and tanker
 Type of claims: **Contact**
 As per 4/1/2016

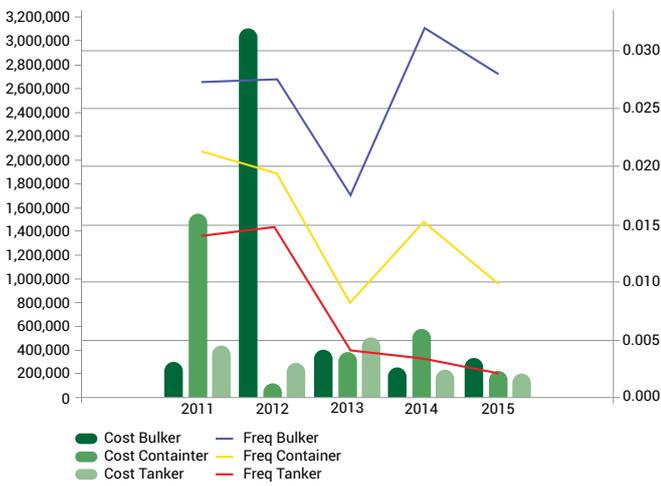
Graph 3.7: Average claim cost & frequency per vessel type Limit: USD claims >= 10,000 – uncapped

Period: 2011-2015
 Types of vessel: Bulk carrier, container and tanker
 Type of claims: **Grounding**
 As per 4/1/2016

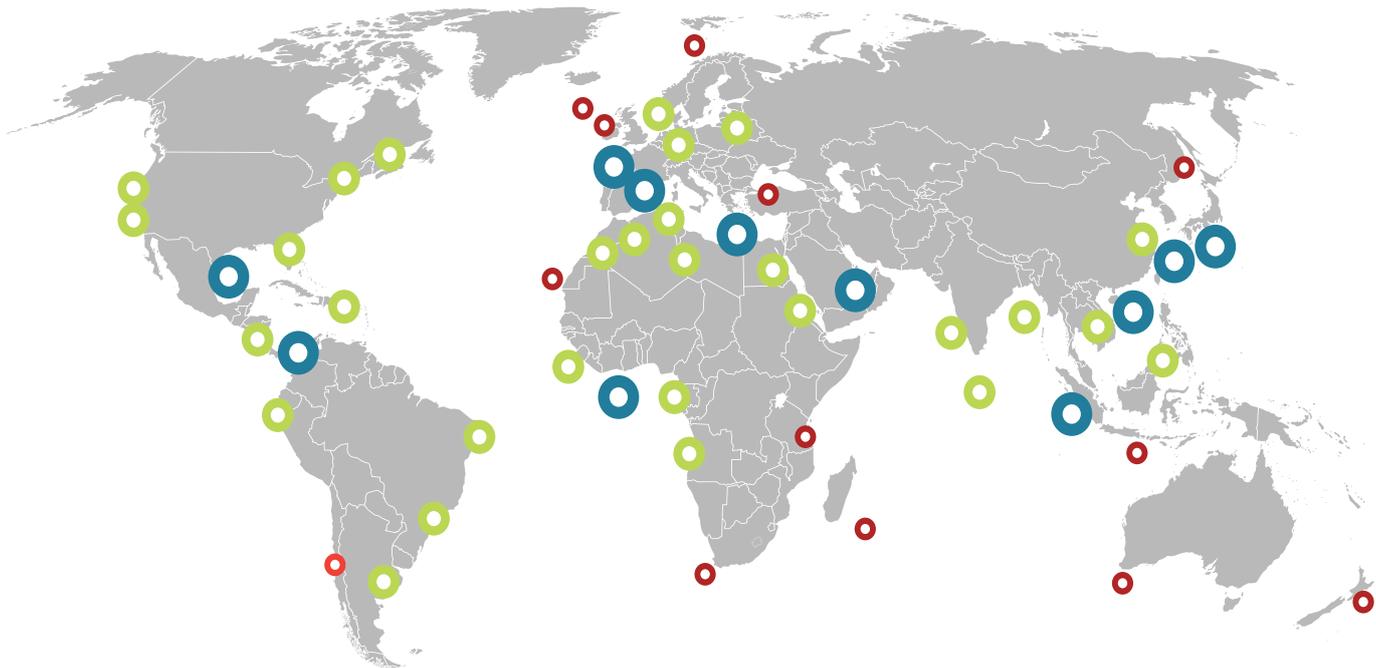
Graph 3.14: World map of contacts

Types of vessel: Bulk carrier, container & tanker

As per 4/1/2016

Number of Collisions: ● >= 10 ● = 2-9 ● = 1

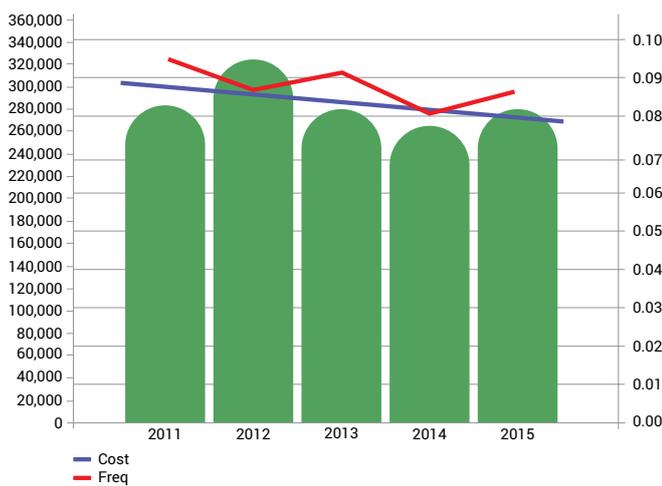
Graph 3.15: Average claim cost & frequency (capped)

Limit: USD claims >= 10,000 – uncapped

Period: 2011-2015
 Types of vessel: Bulk carrier, container and tanker
 Type of claims: Machinery or equipment
 As per 4/1/2016

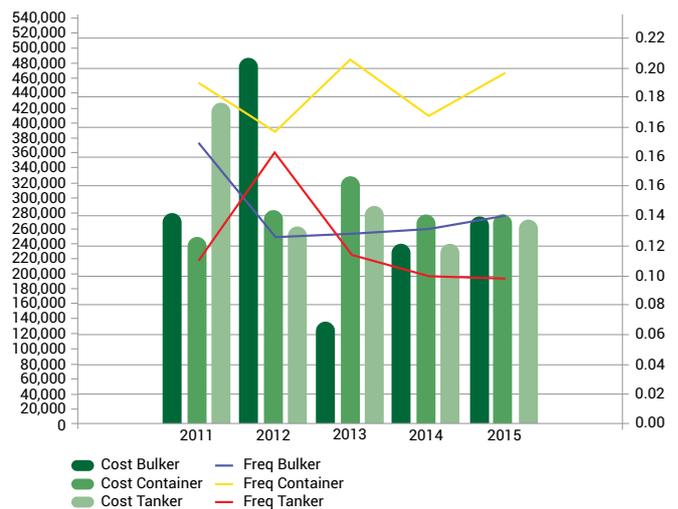
Graph 3.16: Average claim cost & frequency per vessel type

Limit: USD claims >= 10,000 – uncapped

Period: 2011-2015
 Types of vessel: Bulk carrier, container and tanker
 Type of claims: Machinery or equipment
 As per 4/1/2016

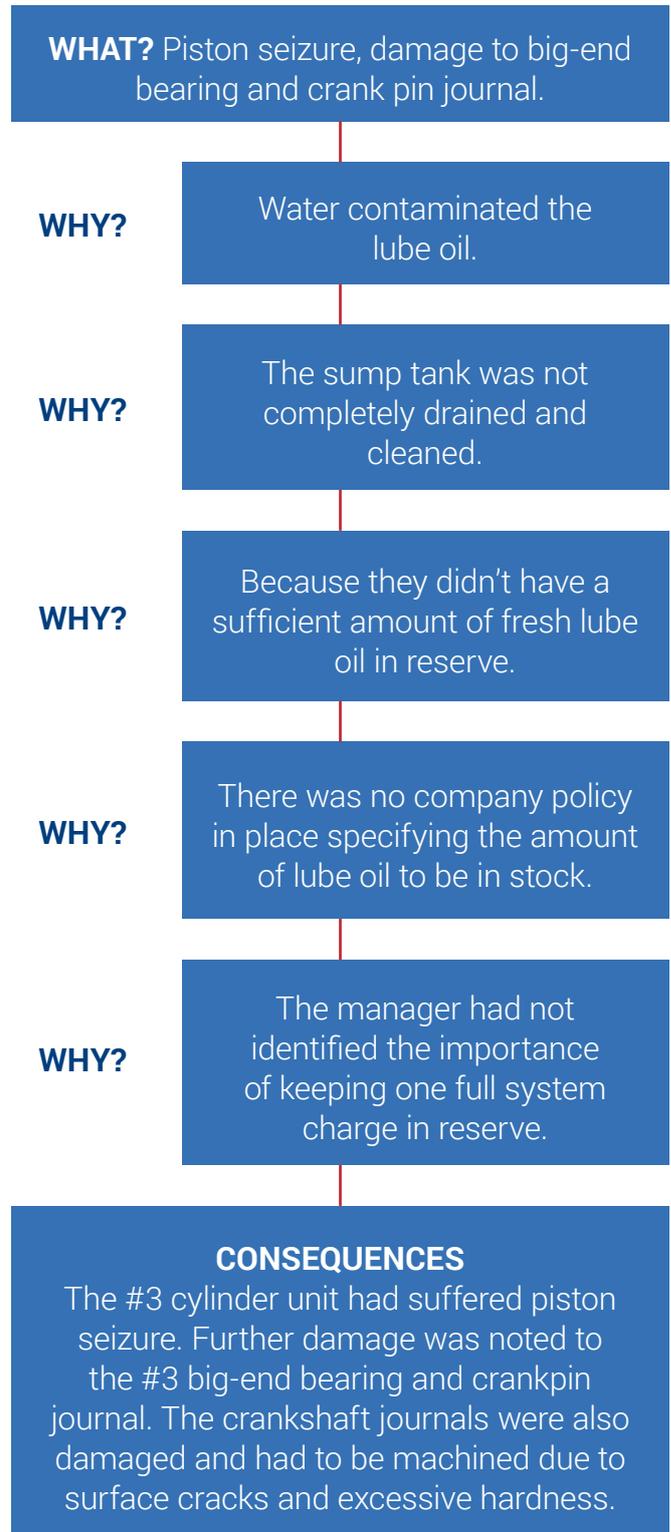
IRCA: Main engine damaged by contaminated lube oil

It was found that the #2 cylinder head was leaking coolant from a loosened guide bolt on the inlet valve crossbar and cooling water had contaminated the lube oil system. The cylinder head was replaced with a spare unit.

The investigation by the crew did not reveal any abnormalities and the engine was restarted.

Shortly after the pilot embarked, the crankcase oil mist alarm was triggered and a banging noise was heard from the engine. The engine was stopped. A tug provided assistance and the vessel anchored. A couple of hours later it was decided that the vessel should be berthed with tug assistance.
