The Swedish Club

## Navigational Claims

2020

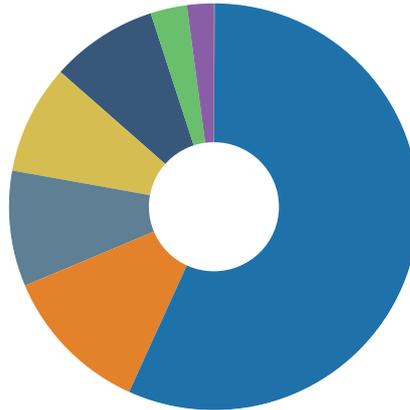
**H&M: number of claims (2014 – 2018)**  
*Claims cost > USD 10,000 – non capped*  
*All vessel types*  
*As per 4/2/2019*

● Machinery or equipment	57%
● Contact	12%
● Other HM	9%
● Collision	9%
● Grounding	8%
● Fire or explosion	3%
● Heavy weather	2%

The most common H&M claims are machinery or equipment claims, which make up 57% of all H&M claims. Navigational claims make up 30%.

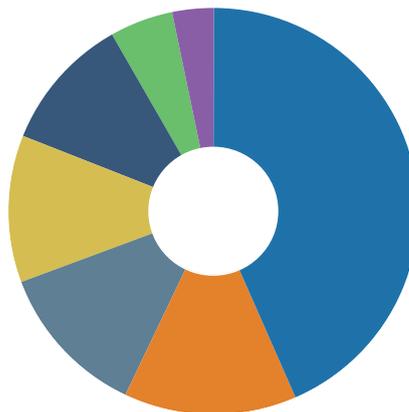
**H&M: total cost (2014 – 2018)**  
*Claims cost > USD 10,000 – non capped*  
*All vessel types*  
*As per 4/2/2019*

● Machinery or equipment	43%
● Fire or explosion	14%
● Grounding	12%
● Collision	12%
● Contact	11%
● Other HM	5%
● Heavy weather	3%

The overall costliest claim category for claims over USD 10,000 is machinery and equipment at 45%. Navigational claims stand for 33% of the overall claims cost. In our previous study the cost for machinery and equipment claims was 31% and navigational claims 52%.

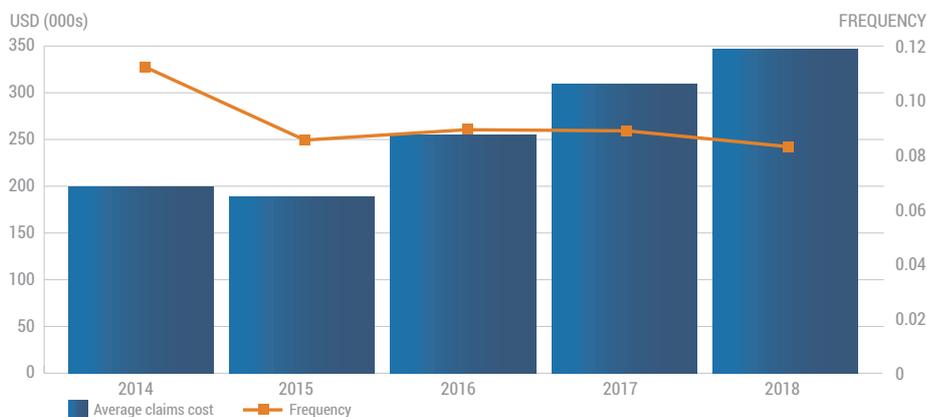
GRAPH 3  
**Average claims cost & frequency of navigational claims (2014 - 2018)**  
*Claims cost > USD 1 - non capped*  
*All vessel types*  
*As per 8/2/2019*

The frequency for navigational claims decreased from 0.11 in 2014 to 0.085 in 2018 i.e. 8.5% of all insured vessels suffered a navigational claim in 2018. This means that the total amount of navigational claims has fallen since the previous report.

However, the Club has seen the average claim cost rising as there were some unusually expensive claims between 2016-2018. In 2016 there was a complicated collision, in 2017 there were two claims, a grounding and a contact. Finally, in 2018 there were two claims, a contact and a collision. These claims have had an average cost of more than USD 20 million.

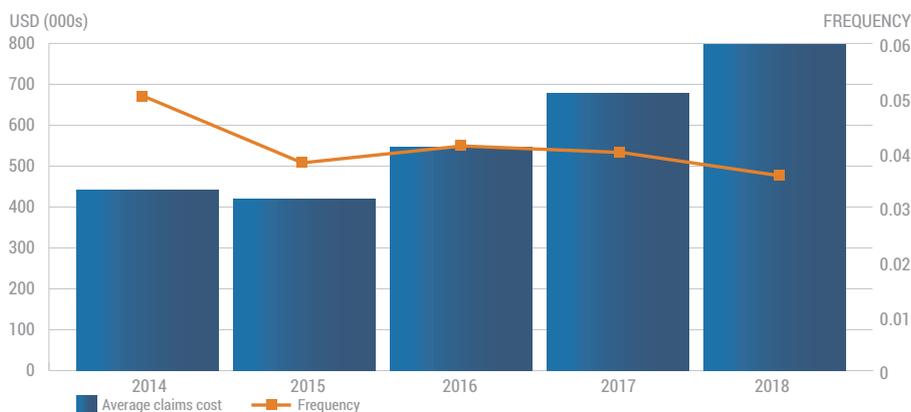
GRAPH 4  
**Average claims cost & frequency of navigational claims (2014 - 2018)**  
*Claims cost > USD 10,000 - non capped*  
*All vessel types*  
*As per 8/2/2019*

The frequency of claims from USD 10,000 is decreasing. For 2018 the frequency was 0.036 i.e. 3.6% of insured vessels suffered a navigational claim which cost more than USD 10,000. The number of claims in this more expensive bracket is also falling, however there is a rise in the average claims cost due to the reasons detailed earlier.

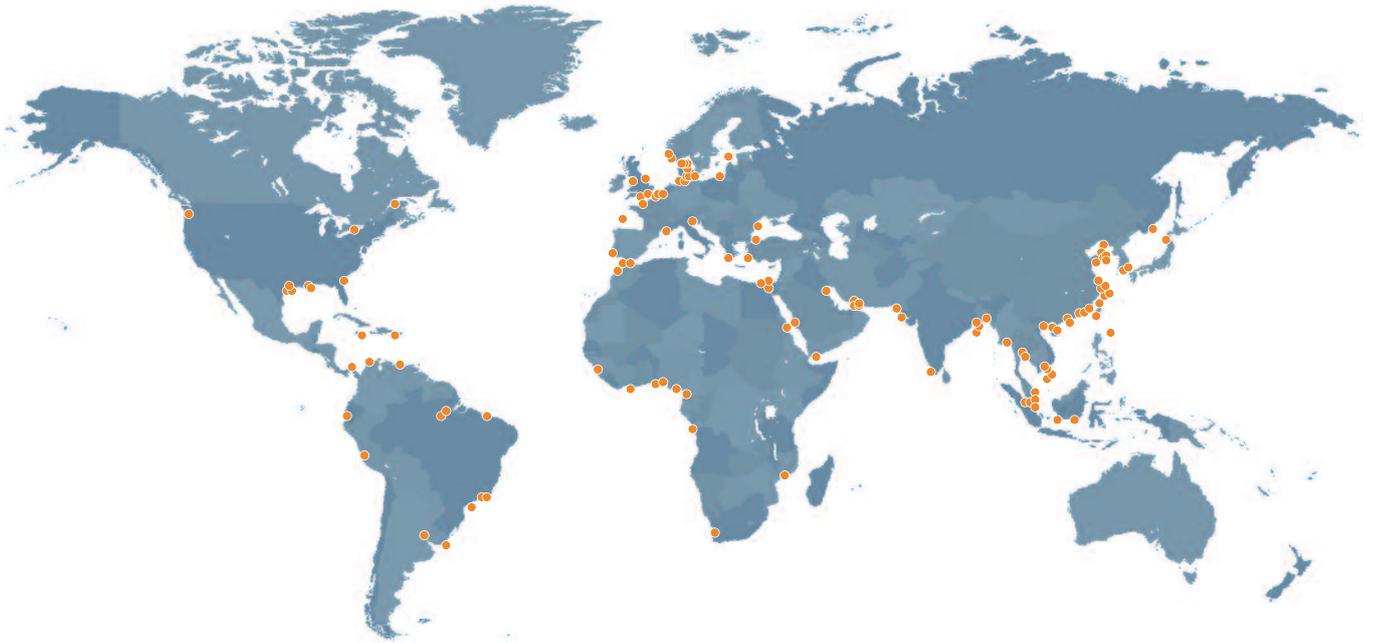
The collision map shows the location of collision claims between 2014-2018

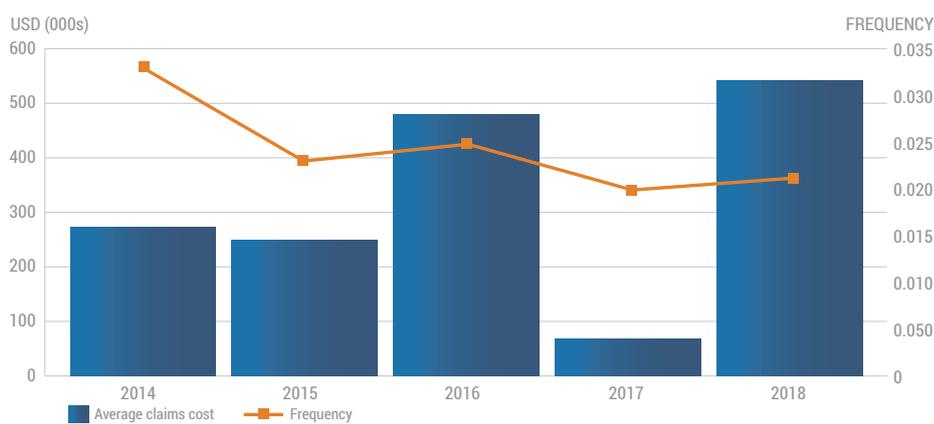
GRAPH 6

### H&M collision: Average claims cost & frequency (2014 - 2018)

All vessel types

As per 8/2/2019

Over the last five years the frequency of claims has been decreasing. However we have seen that the average claims cost is more volatile due to a few expensive claims.

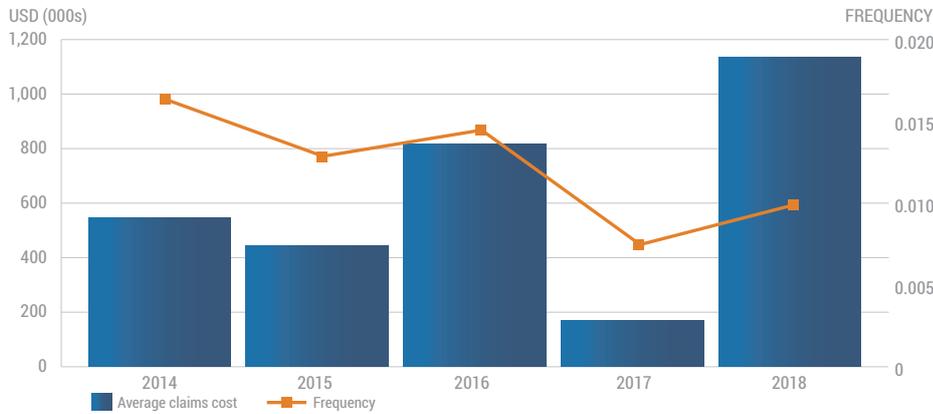
GRAPH 7

All vessel types

As per 8/2/2019

In the more expensive bracket from USD 10,000 we can see that the frequency has decreased since 2016.

The average cost for a collision claim in the =>USD 10,000 bracket for this period is over USD 500,000. In our previous publication the cost was over USD 900,000. If we consider inflation the average at the time of the previous publication would have been even higher.

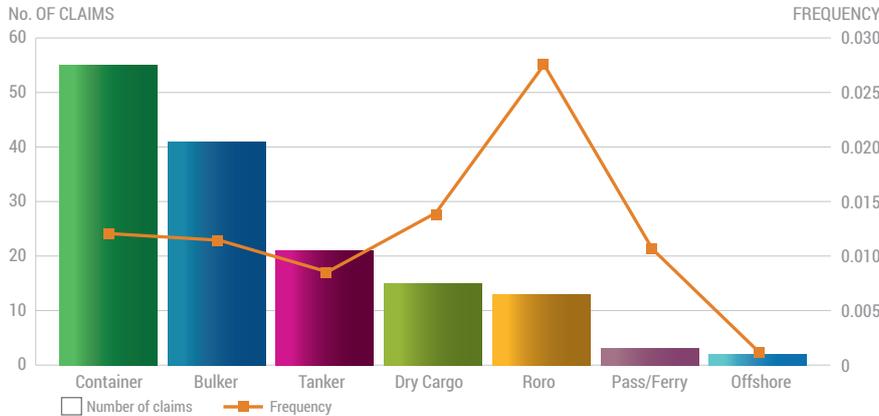
GRAPH 9

Claims cost > USD 10,000 – non capped

As per 8/2/2019

The number of claims is the highest on container vessels and for bulk carriers and tankers. However, the frequency is highest on RoRos. Our statistics show that most collisions happened within the port area and RoRo vessels mostly trade short distances between specific ports, which means that they have more port of calls than the more conventional merchant vessels such as containers, bulkers and tankers.

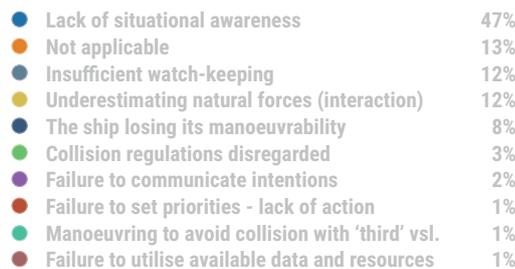
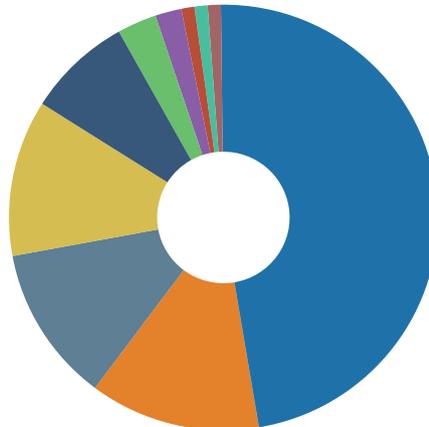
GRAPH 10

**H&M collision: Most common immediate causes (2014 - 2018)**

All vessel types

As per 4/2/2019

There may be a number of factors contributing to an incident – for example an officer with incomplete situational awareness might also be on a bridge with insufficient watch-keeping. The main contributing factor is used to determine the immediate cause.

The most common immediate cause is lack of situational awareness and it is also one of the costliest.

The ‘Not applicable category’ covers situations which do not fit any pre-determined immediate cause e.g. the vessel being hit by another vessel when at anchor or alongside.

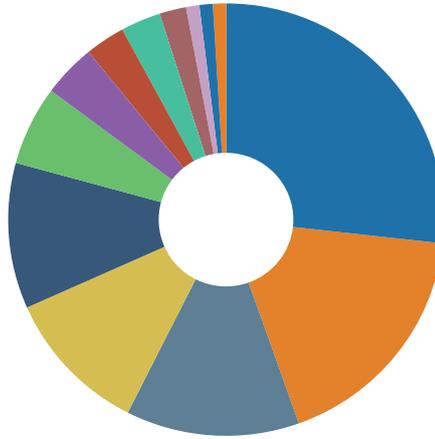
*Claims cost > USD 10,000 – non capped  
All vessel types  
As per 4/2/2019*

● Port	27%
● Anchorage area	18%
● Port approach	13%
● Coastal water, within 12nm	11%
● Open sea, inside EEZ, 12-200nm	10%
● Canal	6%
● River	4%
● Open sea, inside EEZ, >200nm	3%
● Traffic Separation Scheme	3%
● Unknown	2%
● Lock	1%
● Archipelago	1%
● Shipyard	1%

About 70% of all collisions occur in congested waters. We define these as those encountered when departing or approaching the port, or navigating in the port, canal, river or by an anchorage. If we also include coastal waters, this figure increases to about 80%.

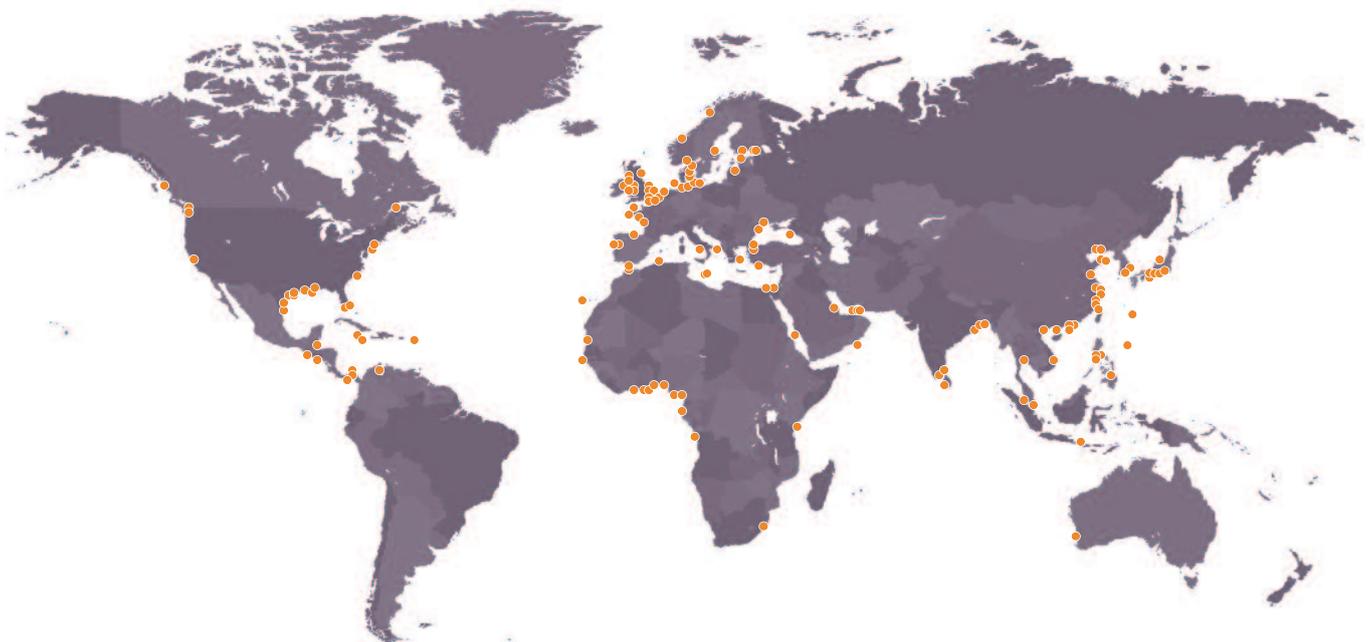
*The contact map shows the location of contact claims between 2014-2018*

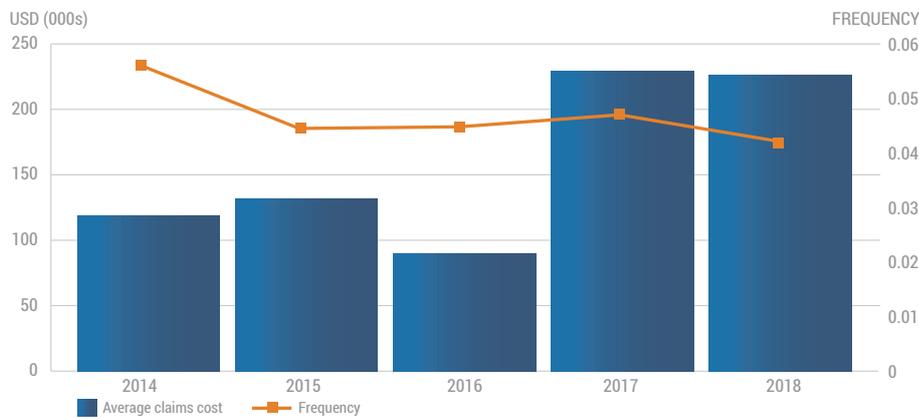
GRAPH 13

**H&M contact: Average claims cost & frequency (2014 - 2018)***Claims cost > USD 1 – non capped**All vessel types**As per 4/2/2019*

We can see from the profile that the frequency of claims has decreased from 0.057 in 2014 to 0.043 in 2018. However, the average claims cost >USD 1 – non capped has increased since 2016. This was caused by two expensive claims, one in 2017 and another in 2018.

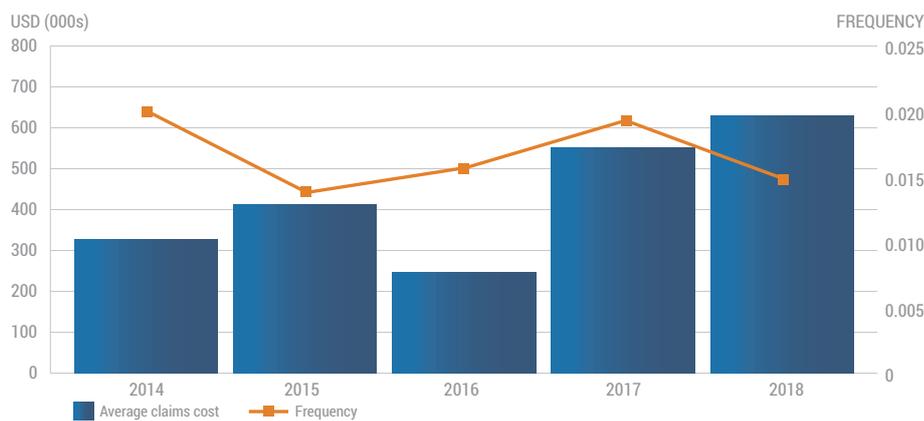
GRAPH 14

**H&M contact: Average claims cost & frequency (2014 - 2018)***Claims cost >USD 10,000 – non capped**All vessel types**As per 4/2/2019*

We can see that the average claims cost for claims over USD 10,000 has increased considerably. This is due to two expensive claims in 2017 and 2018. The average claim cost for 2018 was USD 650,000. Over the five-year period the average claim cost was USD 430,000.

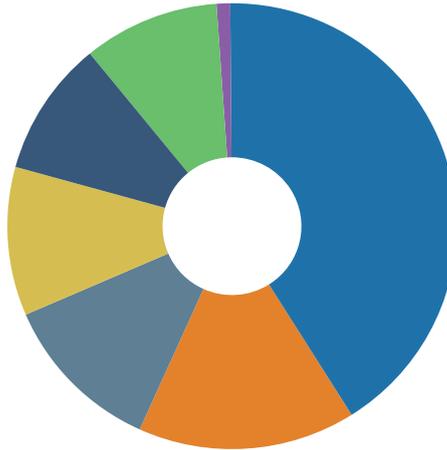
GRAPH 15

**H&M contact:**  
**Most common vessel types (2014 - 2018)**  
*Claims cost > USD 10,000 - non capped*  
*All vessel types*  
*As per 4/2/2019*

● Container	41%
● Bulker	16%
● Tanker	12%
● Dry Cargo	11%
● Pass./Ferry	10%
● Roro	9%
● Offshore	1%

Container vessels are responsible for about 42% of all contact claims followed by bulk carriers at 16% and tankers at 12%.

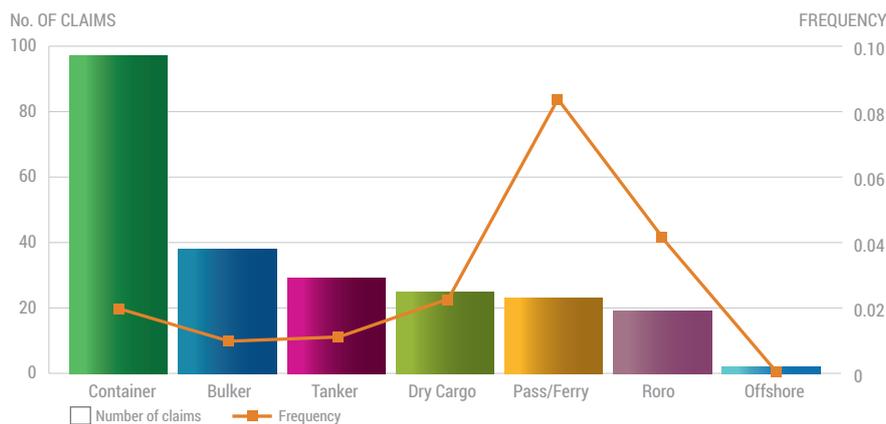
GRAPH 16

**H&M contact: Number of claims and frequency by vessel type (2014 - 2018)**  
*Claims cost > USD 10,000 - non capped*  
*As per 4/2/2019*

Container vessels experience most contact claims followed by bulkers and tankers. Passenger ferries and RoRos show the highest frequency which is similar to collision graph 8. It is no surprise that the risk for a contact will increase for a vessel the more it sails in and out of port, and this has been highlighted in our statistics. Some RoRo and passenger ferries depart and arrive at a port several times a day.

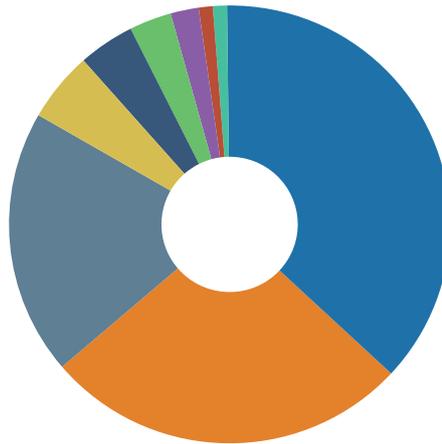
GRAPH 17

**H&M contact:**  
**Most common immediate cause (2014 - 2018)**  
*Claims cost > USD 10,000 - non capped*  
*All vessel types*  
*As per 4/2/2019*

● Underestimating natural forces (interaction)	37%
● Navigational error from Master/Officer	27%
● Navigational error from Pilot	20%
● The ship losing her manoeuvrability	5%
● Not applicable	4%
● Losing control of vessel	3%
● Vessel dimensions excessive	2%
● Manoeuvring to avoid collision with other ship	1%
● Navigational error from tug	1%

The most common cause of contact, at 36% of all claims, is an underestimation of the environmental factors such as wind and current by the bridge team. This often happens because the bridge team, including the pilot, has planned for one set of conditions and has been caught by surprise. The pilot's local knowledge regarding currents and winds need to be discussed at the pilot briefing. It is also the responsibility of the officers on the bridge to monitor how the vessel is setting, the impact of the currents and wind, and to ensure that the entire bridge team is advised.

However, navigational error can be seen as the biggest cause overall - at 46% - if errors by both the pilot and the Master are combined. Of course this immediate cause is very broad, as it will include mistakes that were made by the bridge team, excessive speed when approaching and the bridge team not communicating effectively between themselves and third parties.

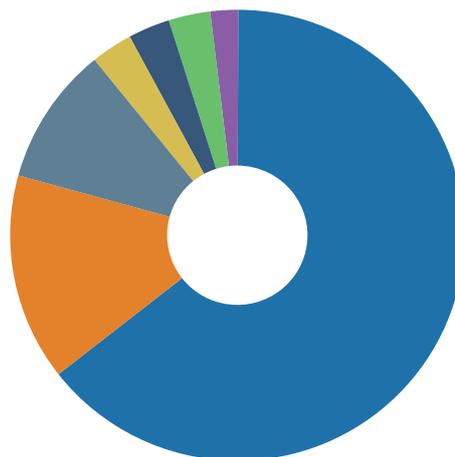
**H&M contact:**  
**Most common location (2014 - 2018)**  
*Claims cost > USD 10,000 - non capped*  
*All vessel types*  
*As per 11/2/2019*

● Port	65%
● Lock	15%
● Port approach	10%
● River	3%
● Coastal water, within 12 NM	3%
● Anchorage area	3%
● Single mooring buoy, SMB	1%

It should be remembered that a claim is classed as a contact claim when the vessel makes contact with an object that is not a vessel e.g. a quay, buoy, fenders or a crane. It is not often, therefore, that a contact claim will happen outside a port area.

There is no surprise that a pilot is on board in 68% of all contact claims as we can see from Graph 17 that 65% of contacts happen in port, 15% in a lock and 10% when approaching the port. About 88% of all contact claims happen within the port area where it is common that a vessel has a pilot on board.

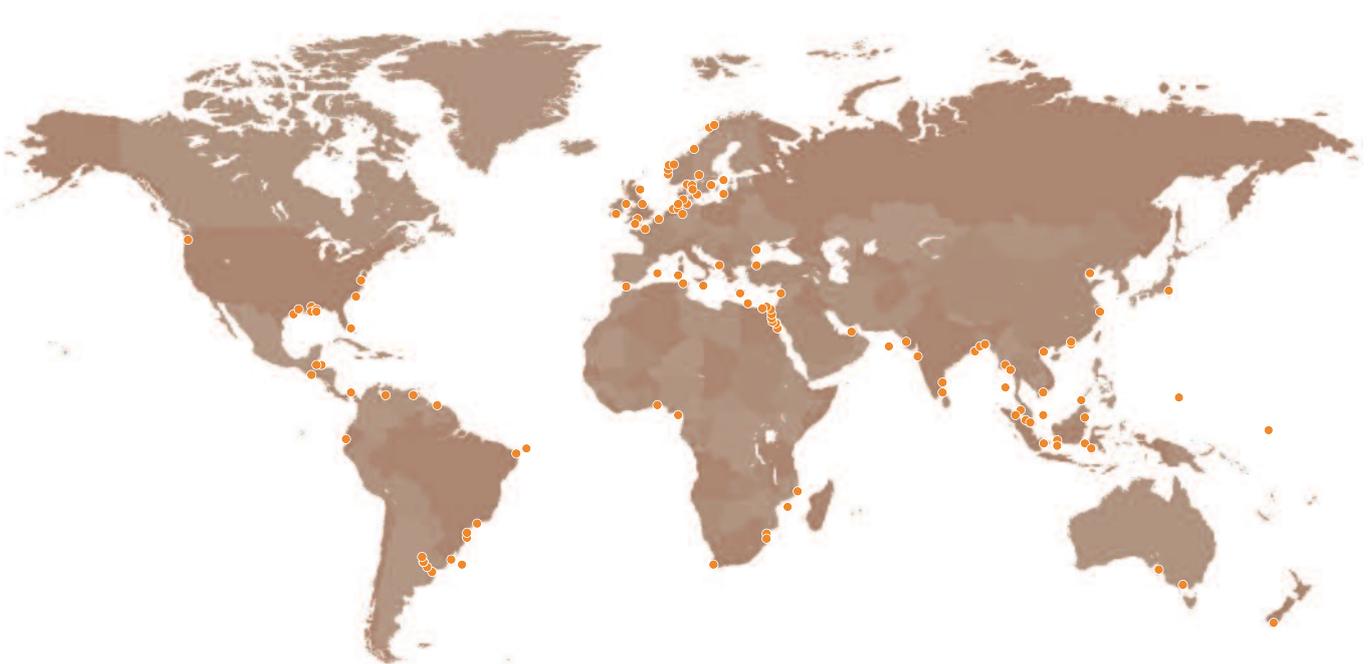
### World map of groundings

*The groundings map shows the location of grounding claims between 2014-2018*

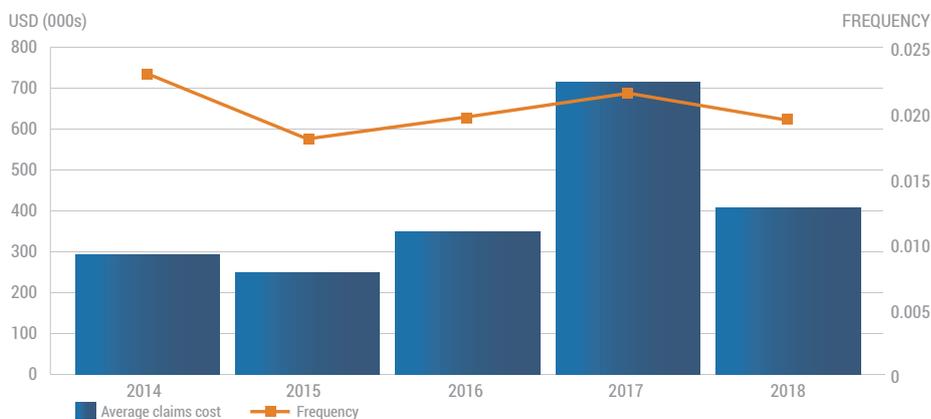
GRAPH 20

**H&M grounding: Average claims cost & frequency (2014 – 2018)***Claims cost => USD 1 – non capped**All vessel types**As per 11/2/2019*

From 2015 to 2017 there was an increase in frequency from 0.018 to 0.02. The average claims cost for 2017 increased considerably due to two unusually costly claims. Looking at specific claim types and especially navigational claims, which are expensive by default, the cost can be volatile hence both frequency and cost decreasing in 2018.

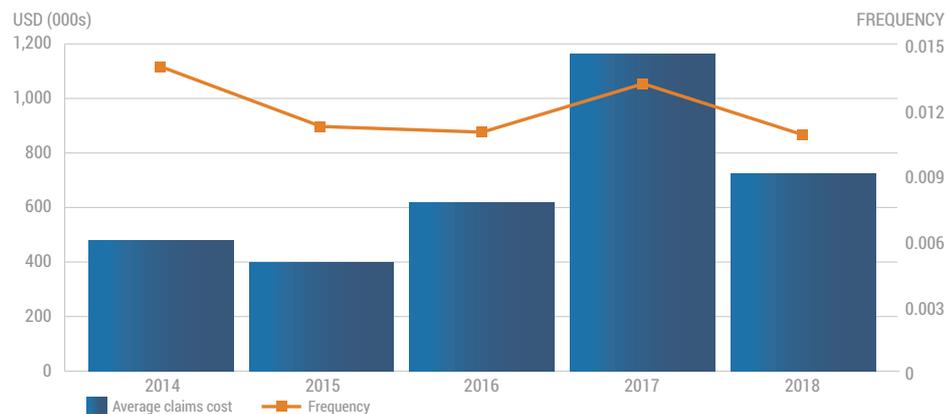
GRAPH 21

**H&M grounding: Average claims cost & frequency (2014 – 2018)***Claims cost >USD 10,000 – non capped**All vessel types**As per 4/2/2019*

In the category >USD 10,000 we can see that both cost and frequency can be volatile – for example, as mentioned previously, 2017 had a high frequency and high average cost caused by two unusually expensive claims. The average claim cost for the five-year period is more than USD 650,000.

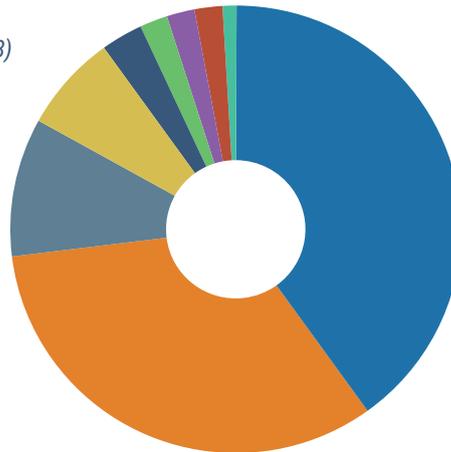
GRAPH 22

**H&M grounding:**  
**Most common vessel types (2014 - 2018)**  
*Claims cost > USD 10,000 - non capped*  
*All vessel types*  
*As per 11/2/2019*

● Bulker	40%
● Container	33%
● Dry Cargo	10%
● Tanker	7%
● Miscellaneous	3%
● Offshore	2%
● Pass./Ferry	2%
● Roro	2%
● Unknown	1%

Bulk carriers are seen to run aground the most often followed by container vessels, dry cargo and tankers.

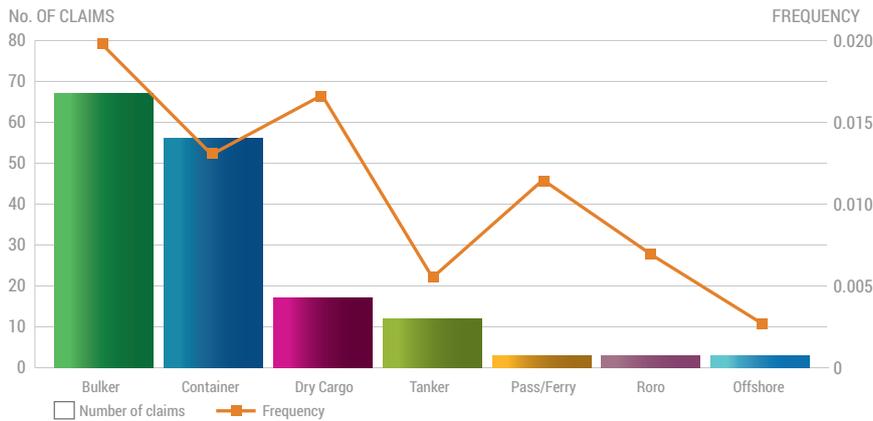
GRAPH 23

**H&M grounding: Number of claims and frequency by vessel type (2014 - 2018)**  
*Claims cost =>USD 10,000 - non capped*  
*As per 11/2/2019*

Most groundings happen on bulk carriers, container vessels and dry cargo vessels, and they also have the highest frequency. Our statistics show that most groundings are caused by a navigational error by the Master or pilot.

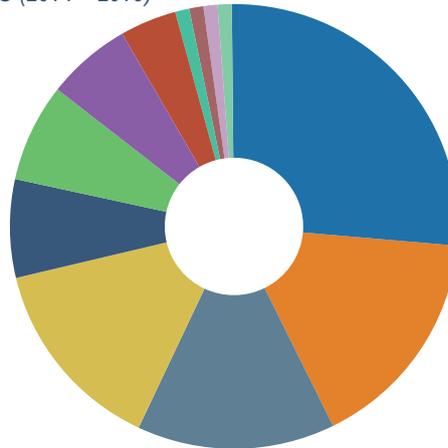
GRAPH 24

**H&M grounding: Most common immediate cause (2014 – 2018)***Claims cost > USD 10,000 – non capped**All vessel types**As per 4/2/2019*

● Navigational error from Master/Officer	27%
● Navigational error from Pilot	17%
● The ship losing her manoeuvrability	14%
● Underestimating natural forces (wind, tidal)	14%
● Not applicable	7%
● Inaccurate charts or nautical publications	7%
● Losing control of vessel	6%
● Manoeuvring to avoid collision with other ship	4%
● Tidal level miscalculated or ignored	1%
● Speed too low i.e. drifting sideways in channel	1%
● Vessel dimensions excessive	1%
● Navigational error from tug	1%

Navigational error contributes to 42% of claims, followed by the vessel losing its manoeuvrability and the bridge team underestimating natural forces.

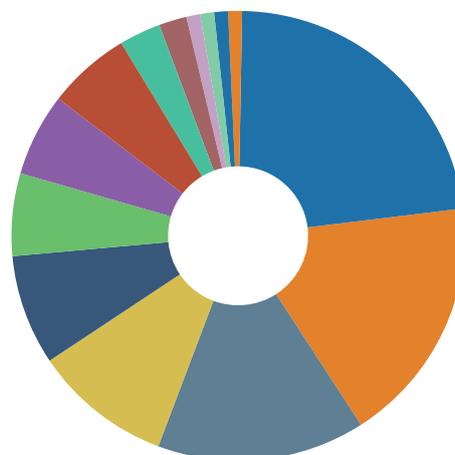
**H&M grounding: Vessel common location (2014 – 2018)***Claims cost > USD 10,000 – non capped**All vessel types**As per 4/2/2019*

● Port approach	23%
● River	18%
● Port	15%
● Coastal water, within 12nm	10%
● Canal	8%
● Open sea, inside EEZ, 12-200nm	6%
● Inland water	6%
● Anchorage area	6%
● Archipelago	3%
● Unknown	2%
● Open sea, outside EEZ, > 200nm	1%
● Lock	1%
● Shipyard	1%
● Traffic Separation Scheme	1%

The main locations for running aground are of no surprise. It is most common to run aground while approaching the port, or in a port, accounting for 38% of all groundings.

A pilot is on board in 53% of all groundings. Graph 25 shows that a total of 38% of all groundings occur in the port area where it is common that the pilot is on board.

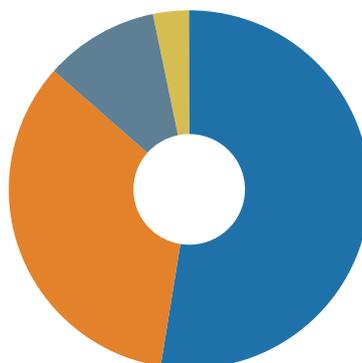
**H&M collision: Pilot on board (2014 - 2018)**  
*Claims cost > USD 10,000 - non capped*  
*All vessel types*  
*As per 4/2/2019*

● No	53%
● Yes	34%
● Unknown	10%
● Not applicable	3%

Most vessels need a pilot when they are approaching or leaving a port. Graph 11 shows the location of most collisions - about 27% happen in a port, 18% in an anchorage area, 13% when approaching the port, 4% in a river and 6% in a canal. About 68% of all collisions happen in or close to the port where it is common that a pilot is on board. As per our statistics about 35% of all collisions occur with a pilot on board.

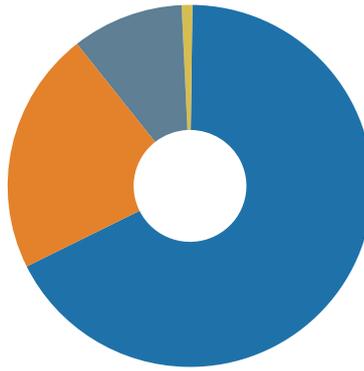
GRAPH 27

**H&M contact: Pilot on board (2014 – 2018)**  
*Claims cost > USD 10,000 – non capped*  
 All vessel types  
 As per 4/2/2019

● Yes	67%
● No	22%
● Unknown	10%
● Not applicable	1%

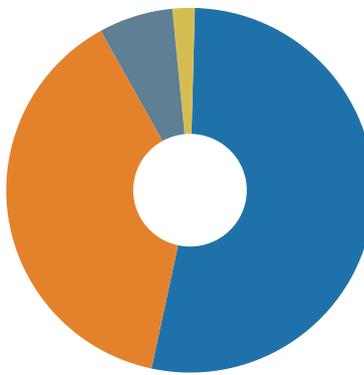
GRAPH 28

**H&M grounding: Pilot on board (2014 – 2018)**  
*Claims cost > USD 10,000 – non capped*  
 All vessel types  
 As per 4/2/2019

● No	53%
● Yes	39%
● Unknown	6%
● Not applicable	2%

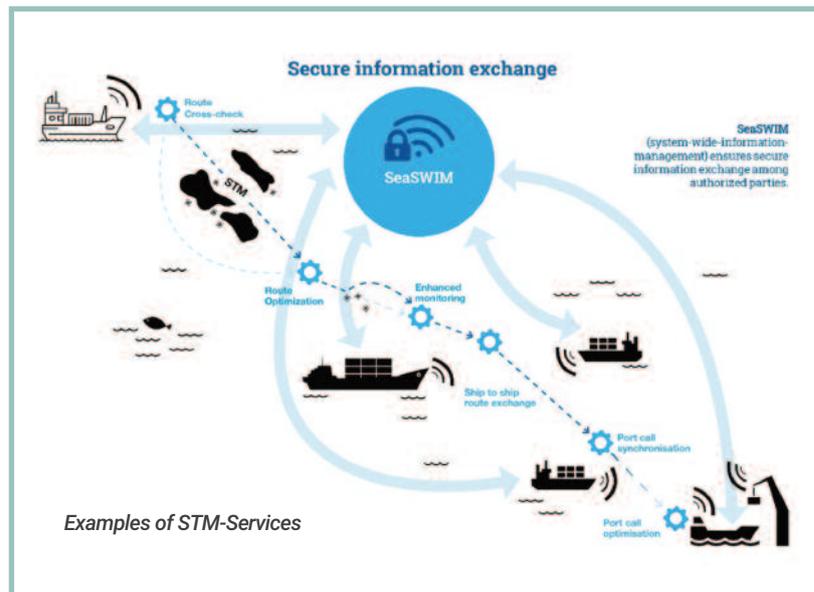
Today's bridge officers use a great deal of digital information to build their situational awareness - GPS, radar, AIS, and ECDIS. However, one important piece of the jigsaw is missing - the intentions of the other ships in the area. Whilst mind reading could come into play, STM uses an easier method: information sharing. The intended route in the ECDIS of the ships is shared over AIS, allowing officers an insight into the intentions of all ships in the vicinity.

As all vessels have access to the same information, a common situational awareness is established. Instead of worrying what others might do, the crew actually knows their planned route, and can choose to receive a notification if other vessels deviate from their plan. In order to avoid information overload, the officer can also choose which ships' intentions to display.
