# Fire!

A guide to the causes and prevention of cargo fires

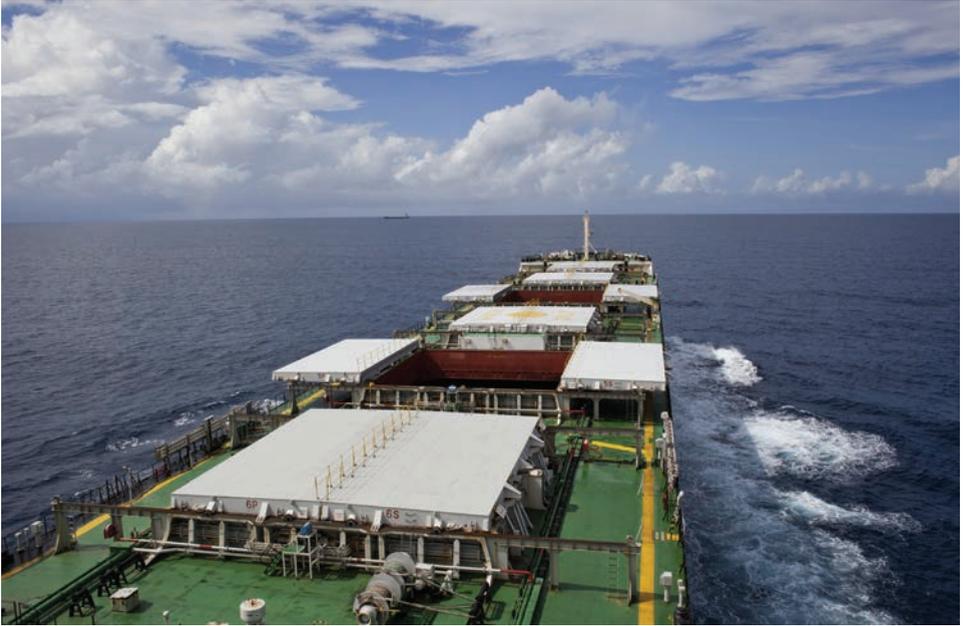
## Cargo hold lights Case Study

A bulker had loaded sugar beet pellets in all three cargo holds with the operation taking 27 hours. When loading was completed the ventilation hatches and all other access points to the cargo holds were secured. In cargo hold 1 there were two metres of space between the cargo and the cargo hatch. In cargo holds 2 and 3 the cargo was almost up to the bottom of the hatch coaming.

The top layer of cargo in hold 2 had been burned. About four metres below the cargo surface the cargo was in good condition. It was discovered that the cargo in hold 3 had been damaged by condensation and tainted by smoke. There were clear burn marks around the floodlights and distinct burn marks by the coaming at the same locations where the hot spots had been discovered. The floodlights were situated 1m below the cargo surface in holds 2 and 3 and there was black, burned cargo covering the floodlights.

It was not clear on board which lights were controlled by which key-switch. The fire was caused because a number of cargo lights were operating while cargo covered them, so the lights ignited the cargo. There was a lack of information on board about how the light circuits were connected and how the light system should be operated. There was also a lack of records concerning use of the lights.

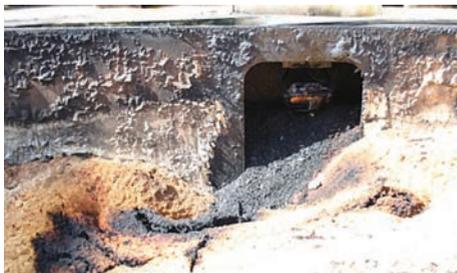
There were two floodlights fitted in cargo hold 1, port and starboard and four floodlights fitted in both cargo holds 2 and 3. All the floodlights were installed in recesses in the hatch coaming. The floodlights were protected by round bars preventing crane hooks, grabs etc from hitting them, but these bars do not prevent cargo like sugar beet pellets from

covering the lights. The floodlights were controlled from the bridge on a panel with four key-switches. These switches were marked 1, 2, 3 and 4 respectively. No drawings or legends were attached clarifying which areas these key-switches served.

The subsequent investigation revealed that the cargo floodlights were not connected according to the approved 'as built' circuit diagrams delivered with the vessel.

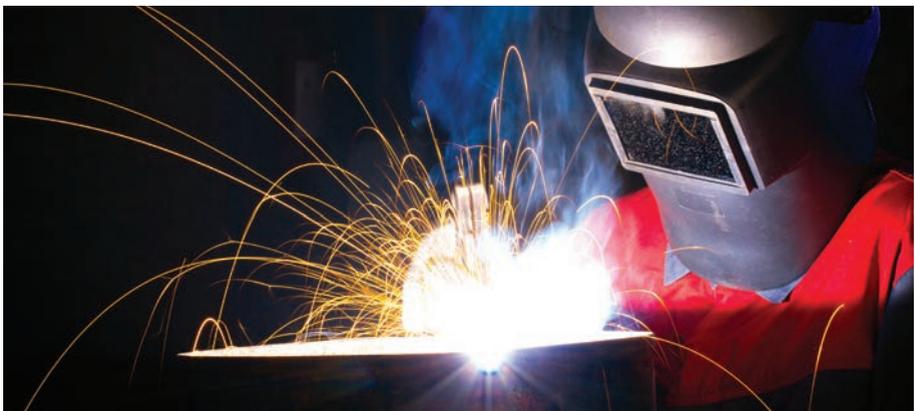
The container that had caught fire was an open top container covered by a tarpaulin and containing cloths, tyres, wooden pallets and machinery.

Some time into the job, the engine fitter began to smell burned rubber, and on investigation saw that a container had caught fire.

The heavy smoke and high temperature made it impossible for the fire team to approach the fire so the Master decided to release the CO<sub>2</sub> system into the cargo hold, which extinguished the fire.

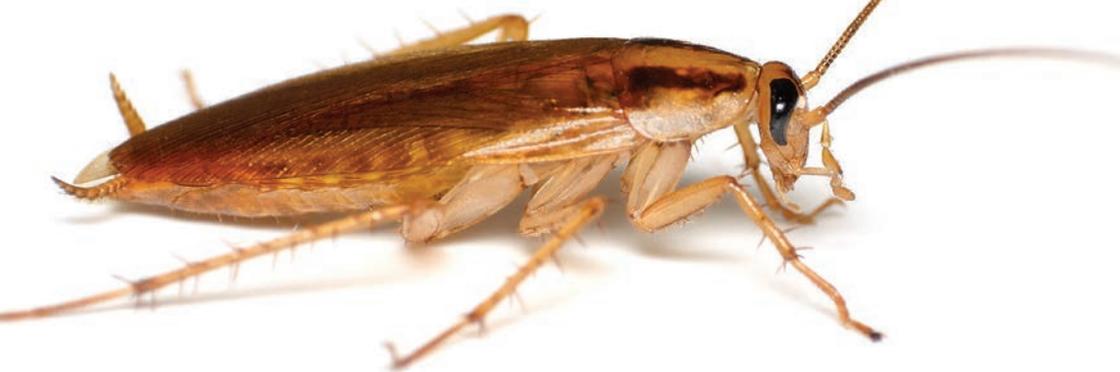
insects. Heat is also given off during the reaction. The solid fumigant may be applied in fabric 'socks' or as pellets on the surface, just before closing holds. Holds are then kept closed for a period before ventilating, and people must keep out of holds that are being fumigated due to the toxic fumigant.

If there is an excessive amount of fumigant in one place, or if the fumigant is contacted by liquid water e.g. from sweating or condensation, then the fumigant can react too quickly. This can evolve excessive heat and lead to ignition of cargo and/or packaging such as bags or paper placed over the top of the cargo. Under certain conditions the fumigant gas itself may ignite, producing an explosion.
