## MONTHLY SAFETY SCENARIO

FEBRUARY 2021

# Lack of cooperation lead to grounding

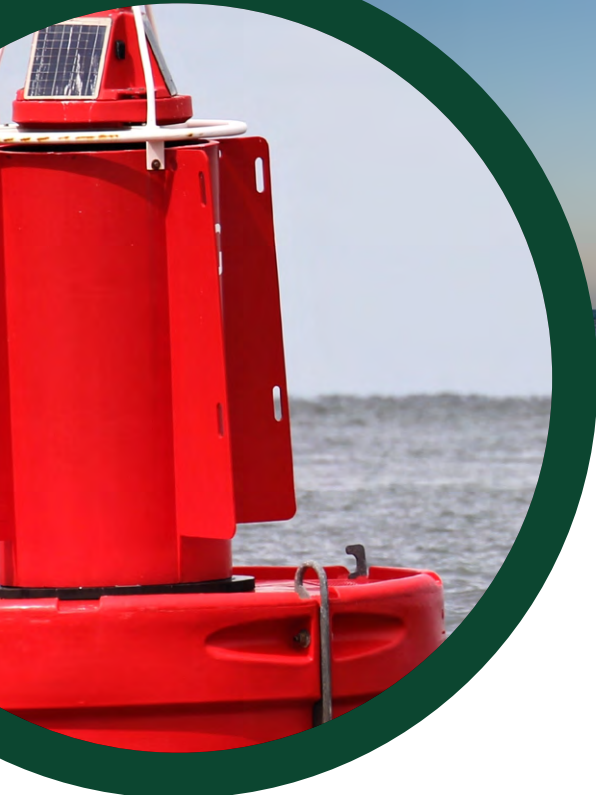
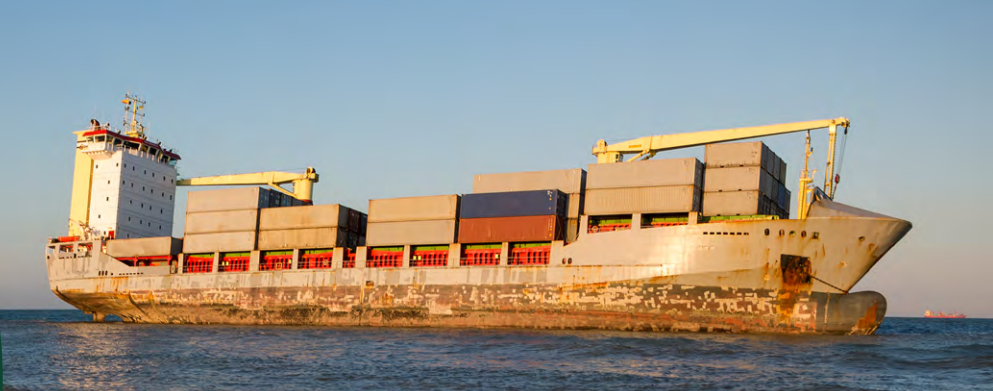
A tug assisted with pushing the vessel on the starboard side. The vessel was now moving astern at 2 knots and towards the opposite side of the fairway, the south side. There were several buoys marking the fairway. The closest buoy was on the starboard quarter about 50 metres away. The wind continued to push the vessel from the portside causing the vessel to drift in a SE direction, further into the fairway. The stern thruster was set full to starboard to

assist the vessel in turning to port. The vessel started to slowly come around with a heading of 291 degrees, but was still drifting SE, towards the buoy.
