High speed caused grounding

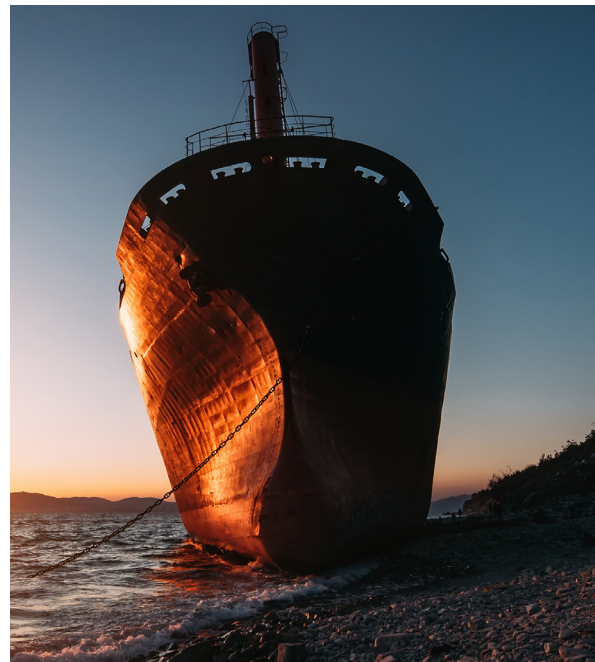
About one hour later the vessel had to alter course to port from 171 degrees to 154 degrees. The pilot ordered port 20 to the helmsman, and the vessel began to alter at a rate of turn of 15 degrees per minute and was rapidly closing the distance to the eastern canal bank at full speed. To counteract this the pilot ordered hard to starboard. This caused the vessel to swing to starboard at a 25 degree rate of turn, and the vessel listed heavily.

The Master ordered hard to port and the vessel just missed the buoys by the centre embankment. The vessel was again heading for the west bank and the Master initially

reduced the engine speed to slow ahead, but realised that he needed to turn more quickly, so he ordered full speed ahead to increase the rate of turn.

Unfortunately, the Master could not avoid the bank and made contact a couple of times before ending up in the middle of the canal where the vessel finally stopped.

- This was a fully laden tanker, and increasing the speed to full ahead in the Suez Canal caused the stern of the vessel to swing towards the near bank (the Bank effect). Neither the pilot or the bridge team discussed this possibility as the pilot increased the speed. It is obvious that the Master was uncomfortable with the pilot's decision, but he still accepted it.
