Fire!

A guide to the causes and prevention of cargo fires

1 Introduction

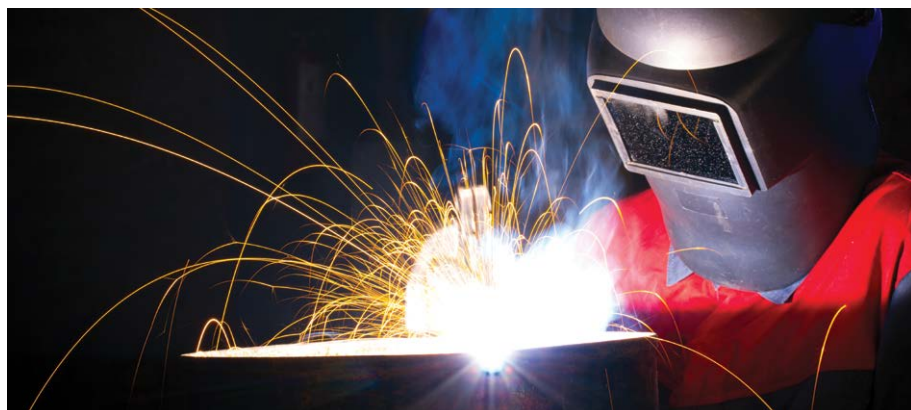
The container that had caught fire was an open top container covered by a tarpaulin and containing cloths, tyres, wooden pallets and machinery.

Some time into the job, the engine fitter began to smell burned rubber, and on investigation saw that a container had caught fire.

The heavy smoke and high temperature made it impossible for the fire team to approach the fire so the Master decided to release the CO₂ system into the cargo hold, which extinguished the fire.

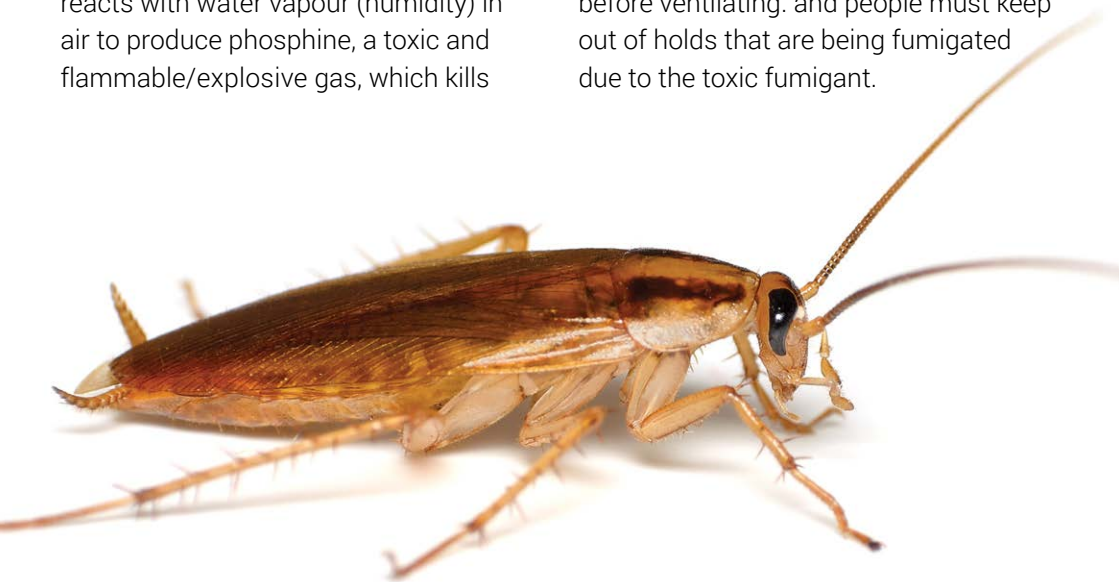
insects. Heat is also given off during the reaction. The solid fumigant may be applied in fabric 'socks' or as pellets on the surface, just before closing holds. Holds are then kept closed for a period before ventilating, and people must keep out of holds that are being fumigated due to the toxic fumigant.

If there is an excessive amount of fumigant in one place, or if the fumigant is contacted by liquid water e.g. from sweating or condensation, then the fumigant can react too quickly. This can evolve excessive heat and lead to ignition of cargo and/or packaging such as bags or paper placed over the top of the cargo. Under certain conditions the fumigant gas itself may ignite, producing an explosion.
