## Bulker focus

Carriage of grains and soya beans

2023

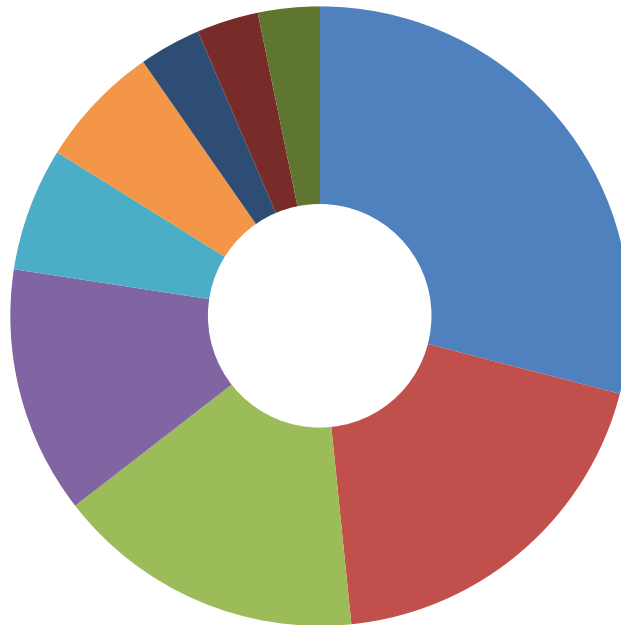
**GRAPH 9***Soya beans - type of claim, number of claims**Claim cost : USD 5,000 – 3,000,000**2018-2022**As per 02/01/2023*

● Shortage	29%
● Spontaneous heating	19%
● Contamination	16%
● Wet damage	13%
● Deterioration	7%
● Physical damage	7%
● Condensation	3%
● Other	3%
● Temperature damage	3%

The most common claim is for shortage at 29%, followed by spontaneous heating at 19% and contamination at 16%.

When compared with grains, shortage makes up a considerably smaller percentage of claims (29% vs 44%). This is partly a trading issue (see *section 2.2*) but in addition the statistics have been influenced by COVID delays.

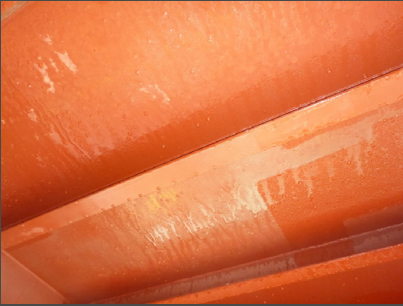
*Image (i) - Ship's sweat  
(Courtesy CWA)*

Ship's sweat can be defined as the consequences from a change in temperature leading to condensation forming on the interior steelwork, which often drips down onto the cargo surface. The condensation forms when the warm humid air in the headspace comes into contact with the relatively cooler steelwork, such as the hatch covers, and then drips back onto the cargo and runs down the sides of the holds, creating a characteristic pattern of damage: the drip lines.

The increase in moisture content of the cargo directly wetted by water dripping creates an environment favourable for mould growth. Mould is alive and its metabolism releases heat into the environment as it grows which in turn creates a favourable environment for self-heating of the cargo. The mould growth exacerbates the rate at which warm moist air is released into the headspace creating a condensation positive feedback loop.

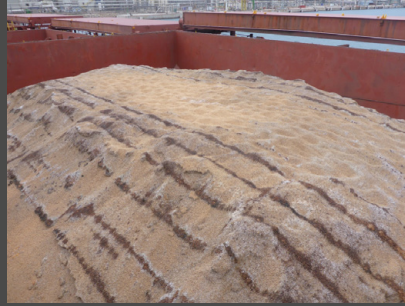
*Image (ii) - Ship's sweat  
(Courtesy CWA)*

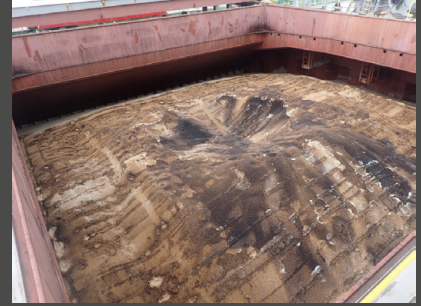
*Image (iii) - Ship's sweat and  
cargo self-heating  
(Courtesy CWA)*

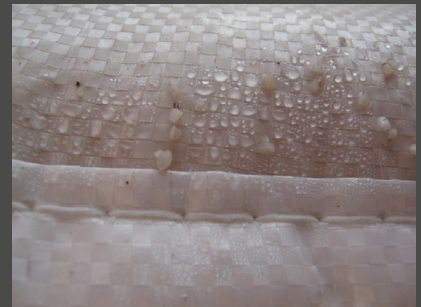
*Image (iv) - Cargo sweat  
(Courtesy CWA)*

Cargo sweat occurs under the same principle as ship's sweat: a change in temperature leads to formation of condensation when warm and humid air encounters a colder surface. In this case however, the cooler surface is not the steelwork but the upper layer of the cargo itself. This will occur if a cargo loaded in a cold climate is exposed to warmer air, either due to the hatch covers being opened or incorrect ventilation of the holds. The water vapour present in the introduced ambient air condenses on the cargo surface, which then leads to mould growth and localised heating in the same manner as ship's sweat.

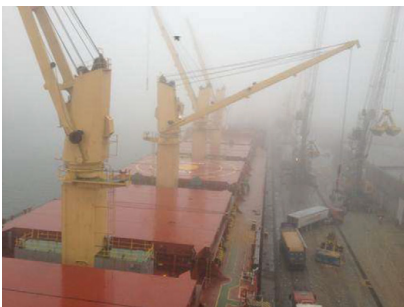
*Image (v) - Loading in poor weather*

- There must be sufficient lighting at night to enable visual inspection of the cargo during loading. It is also essential that the crew monitors weather reports and radar so that the cargo hatch covers can be closed before any rain begins. The log book did not record whether the cargo hatch covers were closed or not during loading.

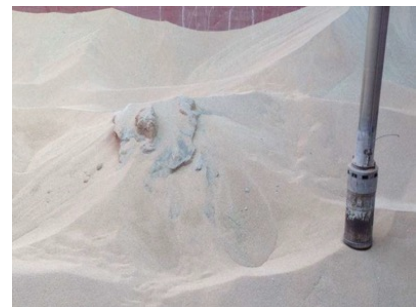
*Image (vii) - Damaged cargo at the discharge port*
