Collision in congested waters

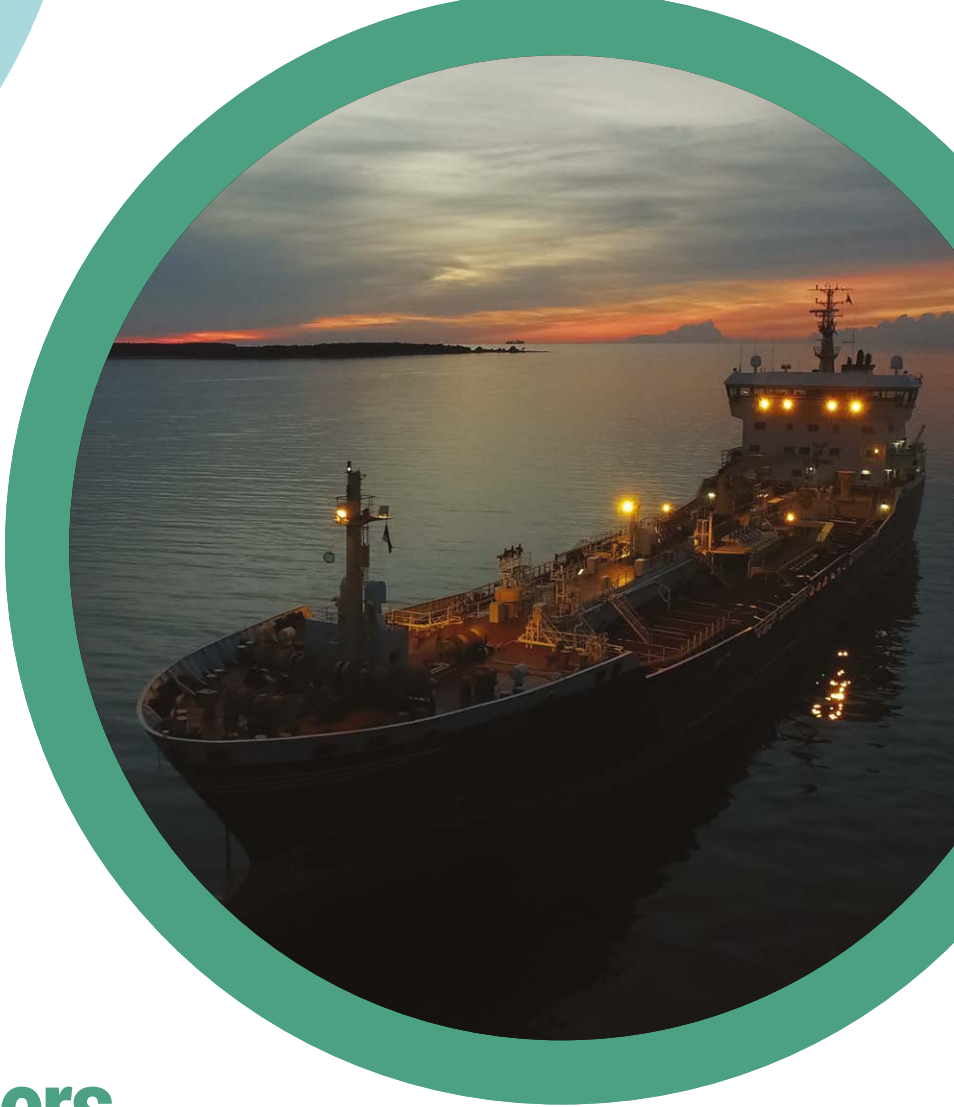
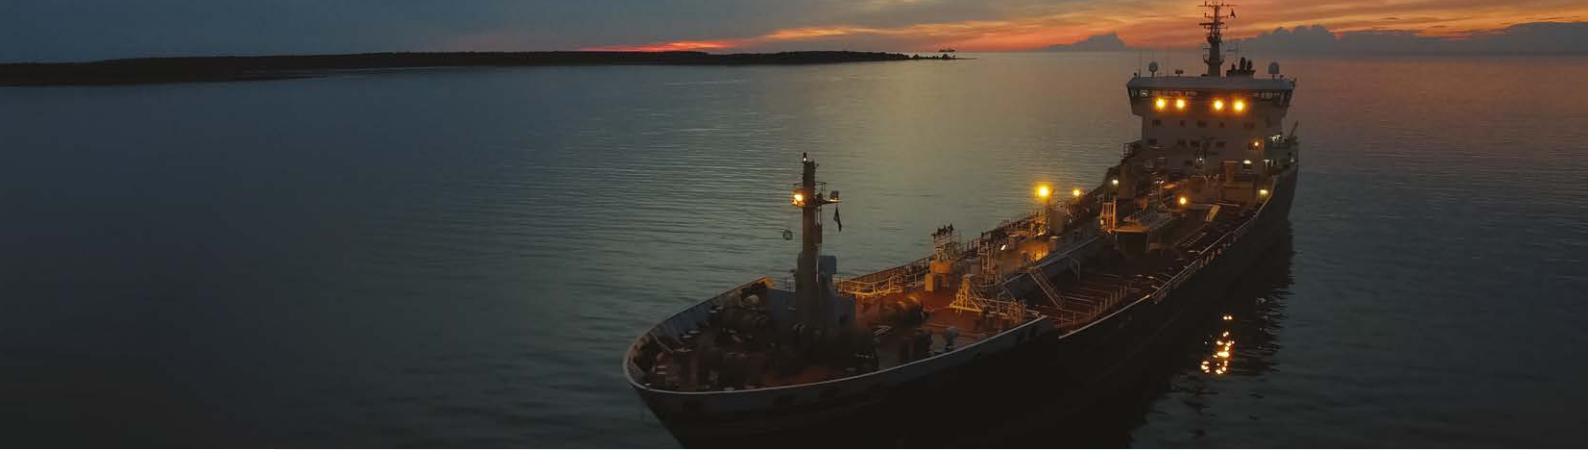
It is the evidence of the Second Officer that at about seven minutes before the collision at 0355 he ordered the lookout to hand steer the vessel as close as possible to the fishing vessels. He believed this would give him more room for

vessel B. At this time the OOW was also handing over the watch to the 4-8 Officer.

The Second Officer ordered starboard 10 and to steer 074 degrees. He was then concerned that this was too close to the fishing vessels and ordered 070. At the same time vessel B's bow collided with the port side of vessel A. The angle between the vessels was about 90°.

Over the next 30 minutes the Second Officer altered the vessel's heading on the autopilot several times. He began plotting Vessel B which was on the portside at a distance

of about 10M. The ARPA data indicated that vessel B would pass astern.

There were also two merchant vessels on his starboard side crossing to port with a CPA of about 0.7M and 1.5M – these were the Second Officer's main focus. These were coupled with an unknown number of fishing vessels in the area that seemed to be stationary. The Second Officer made a number of small alterations on the autopilot to port to stay clear of the fishing vessels.

When vessel B was about 4M away the Second Officer could see its lights. He didn't take any visual bearing but monitored it on the ARPA. Still unconcerned he focused his attention on the fishing vessels and merchant vessels on the starboard side. He did not notice any change in the CPA for vessel B.
