The Swedish Club

MONTHLY SAFETY SCENARIO

Pilot ladder in poor condition

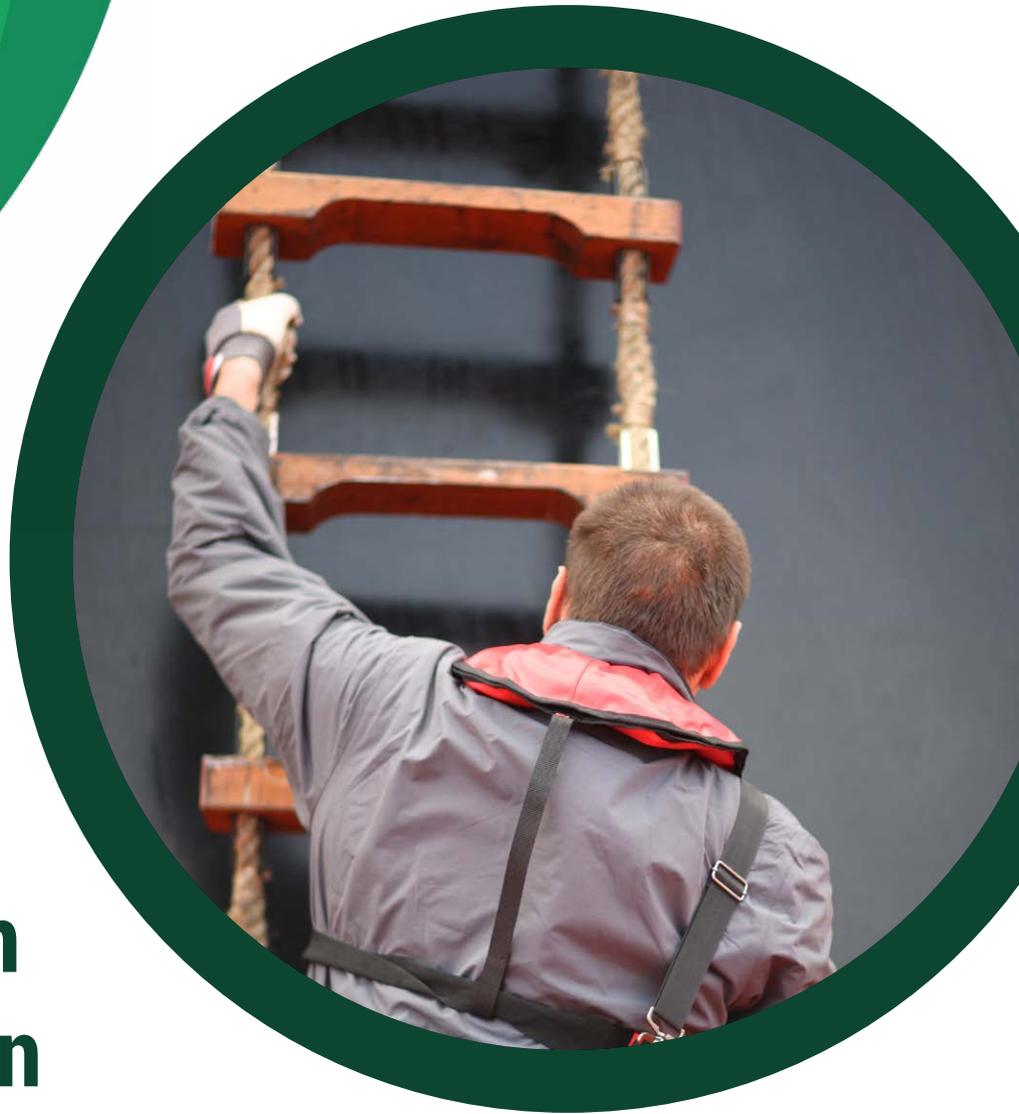
After a couple of steps one of the side ropes broke as it was rotten and the ladder swung heavily forward and aft. This caused the pilot to lose his grip and fall. He fell five meters into the water.

It is important that pilot ladders are not tampered with, that they are inspected correctly, that tape is not used which can hide the condition of the ladder and trap moisture.
