## MONTHLY SAFETY SCENARIO

JANUARY 2022

# Serious injury during inspection

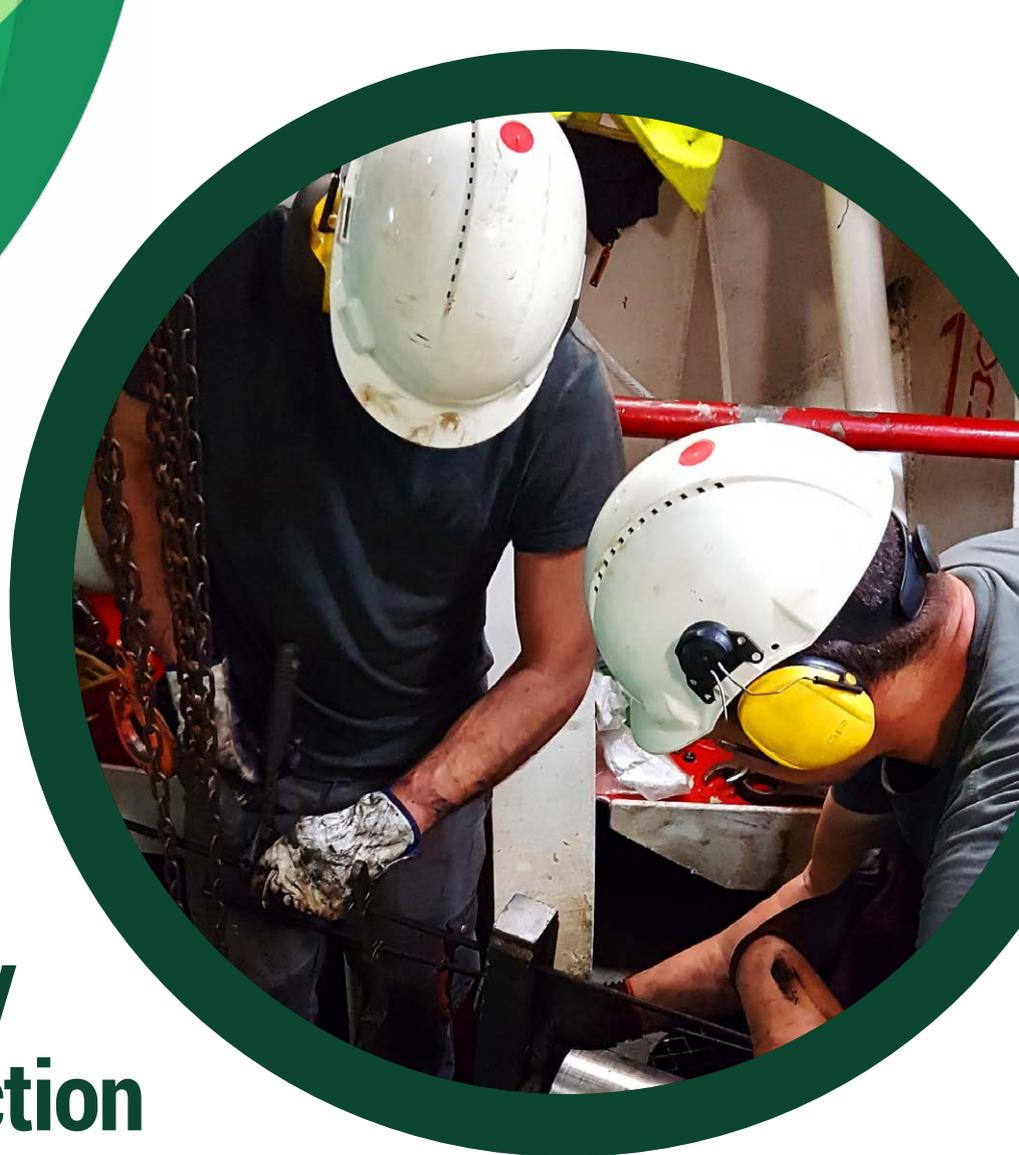
The engineers started to remove the shaft and impeller from the ballast pump. They secured the shaft in a

threaded hole with a chain to an eyebolt. The engineers used a five-tonne safe working load (SWL) chain block, which was secured in a monorail, and the shaft was raised so the engineers could work on it more easily. The chain block was undamaged, certified and approved for the lifted weight.

It was decided that the shaft had to be moved to a larger workbench. To be able to do this, another chain block needed to be attached. The oiler left to find a suitable chain block. While waiting for the chain block, the engineers started to inspect the shaft and rotated it a couple of times when it was hanging over the workbench. Suddenly the shaft was unscrewed from the eyebolt, and the edge of the shaft landed heavily on the Third Engineer's hand, which was severed. The First Engineer was also seriously injured by the shaft, but fortunately, his hand was only crushed instead of severed.
