The Swedish Club

MONTHLY SAFETY SCENARIO

AB fell to his death

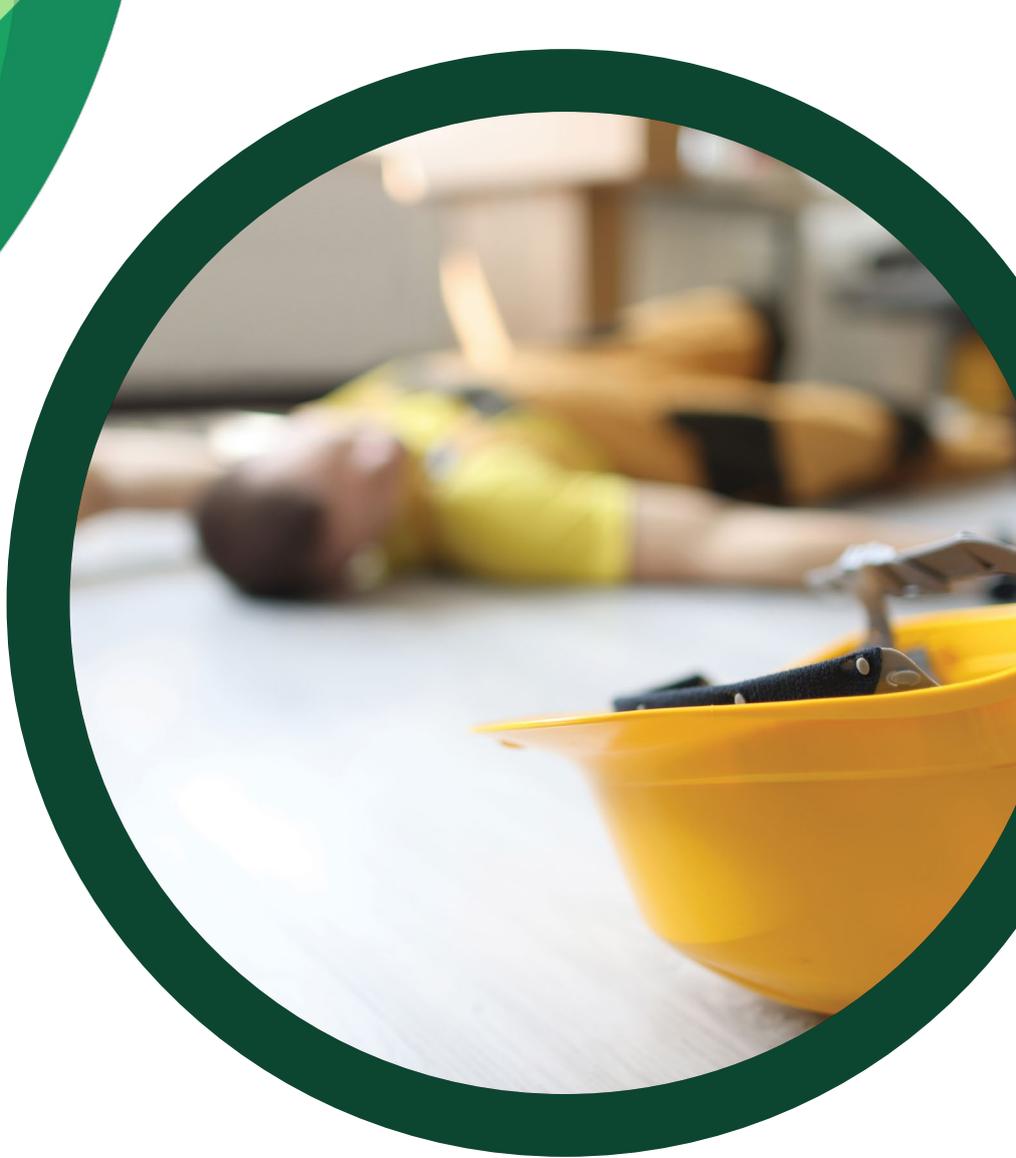
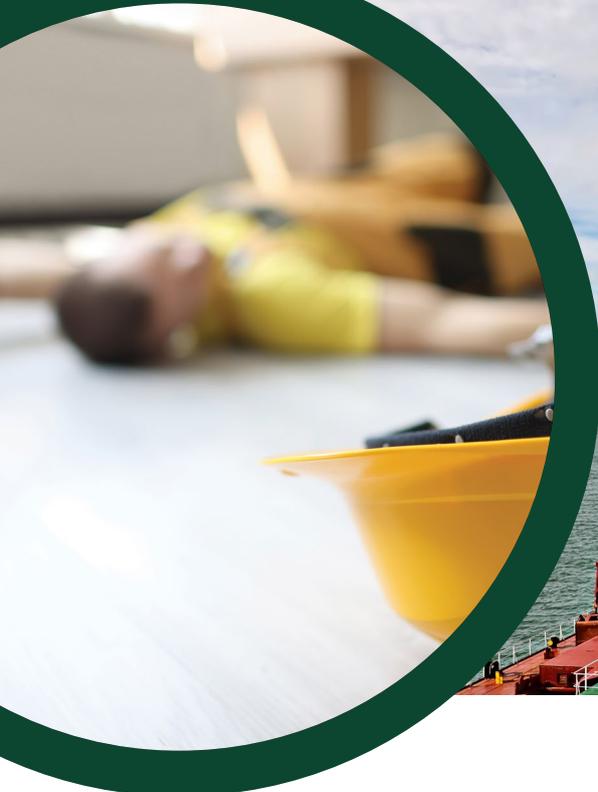
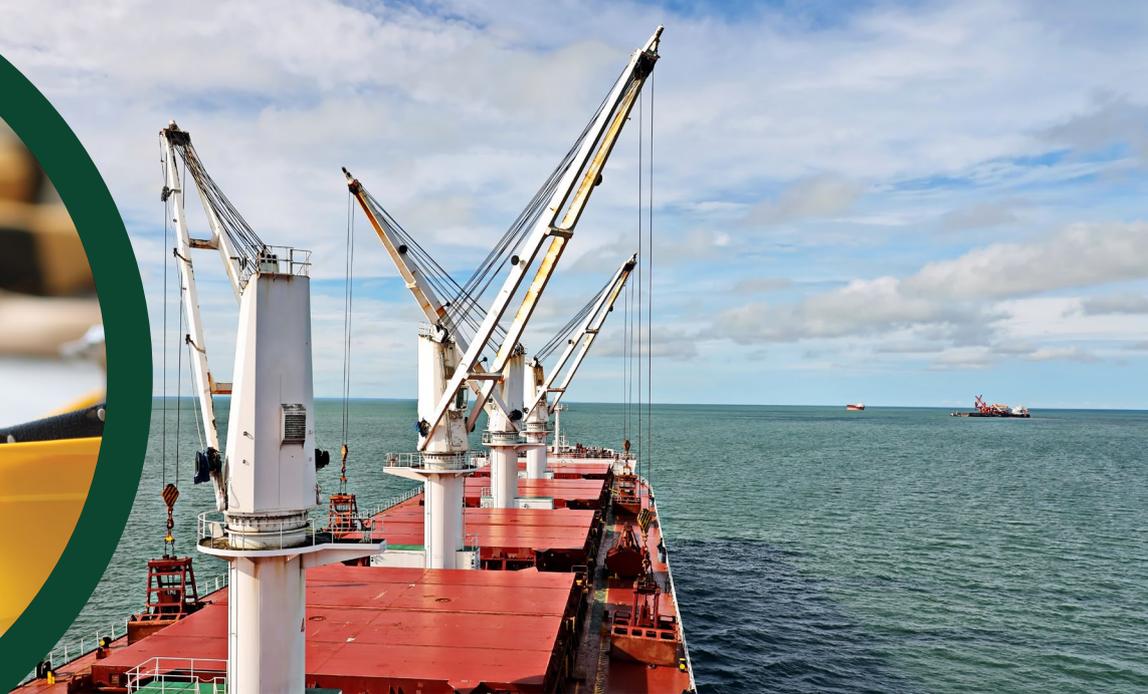
One of the ABs who was up in the crane climbed over the safety railing at the drum storage space and out onto the boom. He sat straddling the boom and used his hands to quickly push himself forward and out onto the boom towards the aft crossbeam where the wire was stuck.

As the Chief Officer was engaged in instructing the crew on the deck, he did not see the AB climbing out onto the boom. The AB apparently acted spontaneously without any instructions to climb out on the boom to try to unhook the wire where it had snagged on the crossbeam.

When the Chief Officer finished instructing the crew on the deck, he turned back to the boom and saw the AB out on the boom at the point where the crossbeam was located. He immediately called out to the AB, saying: "Stop! Please stop! We need to get a rope to fasten it to the wire".

The AB lost his balance and fell onto the hatch cover from a height of about 8 metres.
