Lubrication contamination led to machinery failure

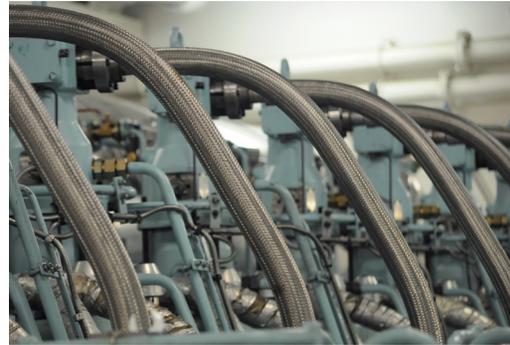
The investigation alongside revealed that the metal parts found in the lubrication oil filters came from piston rings and piston skirts. Three pistons had almost seized. The main engine, a 6-cylinder medium speed type, was severely damaged and the following parts had to be renewed: all the cylinder liners, 3 complete pistons, piston rings on all cylinders, all the main and connecting rod bearings.

The pistons in cylinder units no.1 and 3 were melted down in certain areas and the skirt in no.4 was torn. Liners were scuffed as a result of the above. The cylinder lubrication channels were found clogged wherefore the cylinder lubrication had been inactive. The lubrication oil pump was found to have deteriorated due to the hard impurities in the lube oil system.
