Presented by: Magnus Arvidson RISE (magnus.arvidson@ri.se) Drencher system tests

Comparing the fire control performance with BEV's and ICEV's

<u>L</u>egislative Safety <u>A</u>ssessment for <u>S</u>afety <u>H</u>azards of <u>F</u>ire and <u>I</u>nnovations in <u>R</u>o-Ro Ship <u>E</u>nvironment

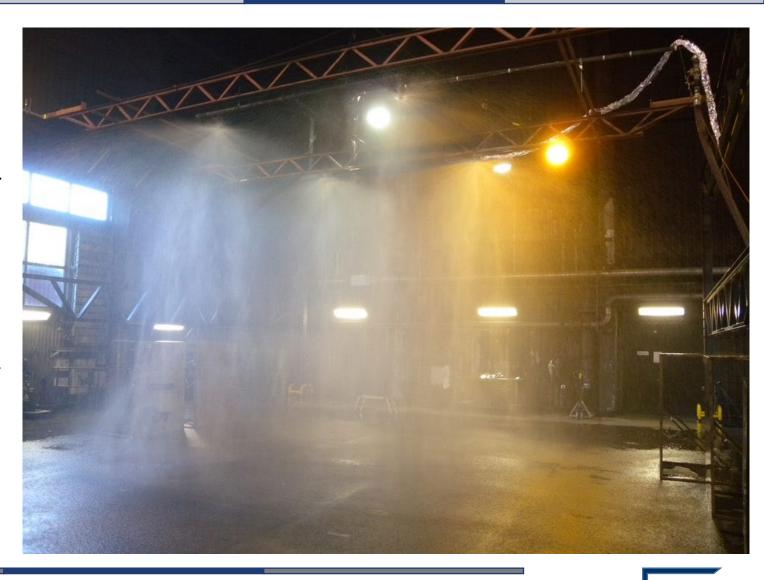
The water spray system

- Four pendent, open water spray nozzles.
- 5 m vertically above the water surface in the tray.
- K-factor: 80,6.
- Operating pressure: 1,3 bar.
- 3,05 m by 3,05 m spacing.
- Total discharge flow: 372 I/min.
- Density: 10 mm/min.

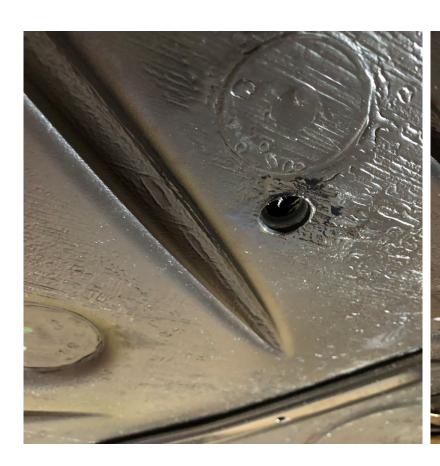
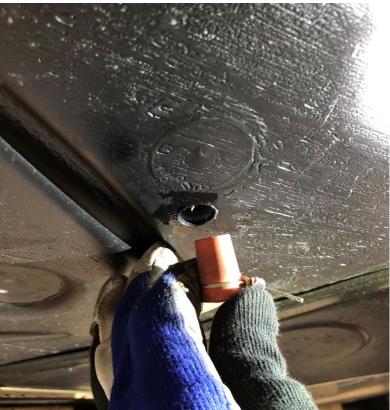
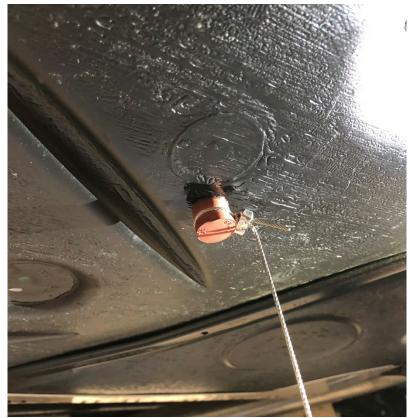
ICEV fire ignition approach

- Fuel tank (plastic) filled to 90 % capacity with gasoline.
- Pre-drilled 15 mm diameter hole with a rubber plug.
- Removal of the plug and ignition of the outflow of gasoline fuel.

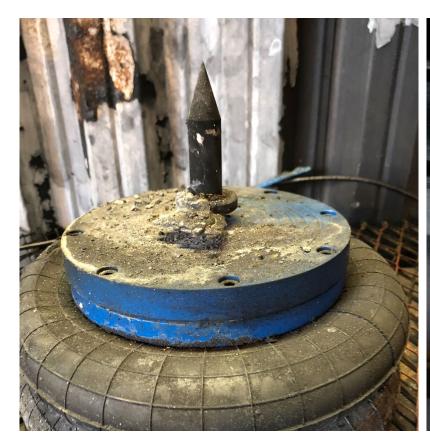
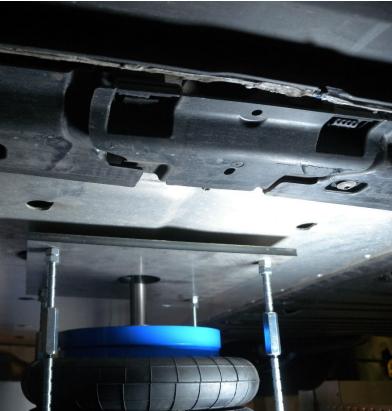
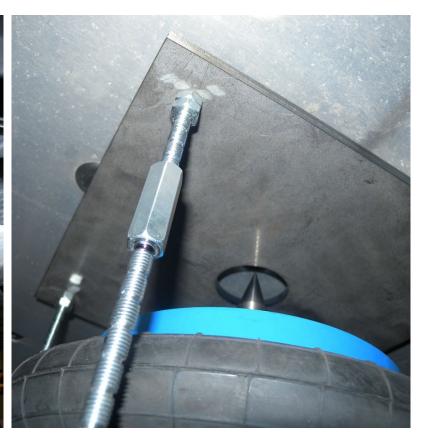
BEV fire ignition approach

- State of charge: 90 %.
- Pre-drilled hole in the protection plate underneath the vehicle.
- Nail penetration from below in one of the battery modules.

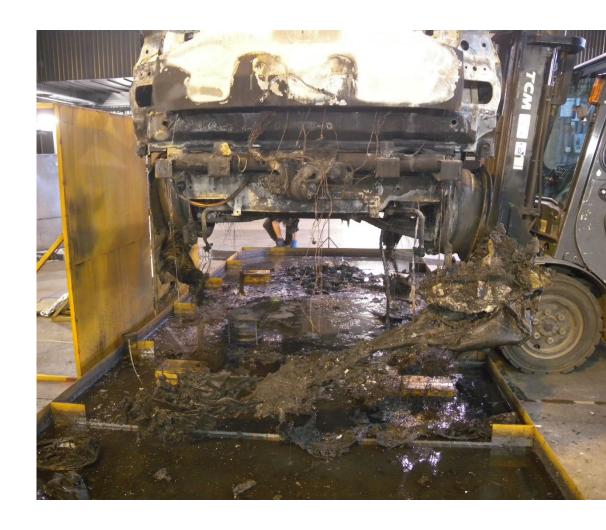
Fire test procedures

- Fire ignition.
- Manual activation of the drencher system at a heat release rate of 1,5 MW.
- Discharge of water for 30 minutes.
- End of discharge.
- Burn-out of the vehicle without any application of water. Approach used for two reasons:
 - Indication of fire control performance of the water spray system.
 - Facilitated scrapping of the vehicles after the test.

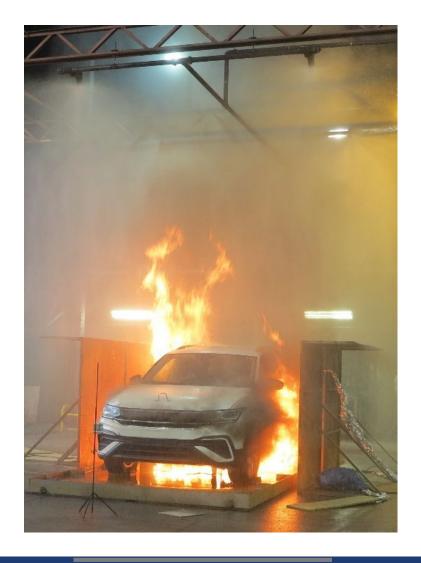
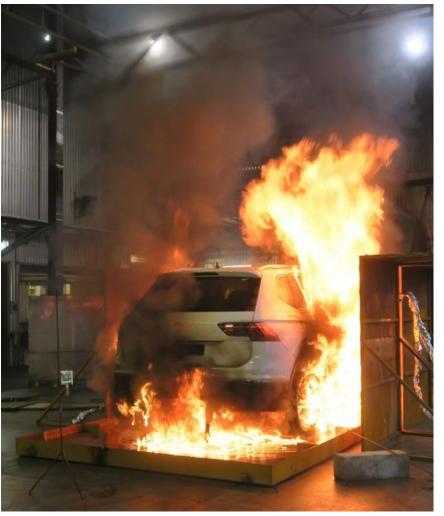
ICEV1: 01:12 (min:s) – start of applic.

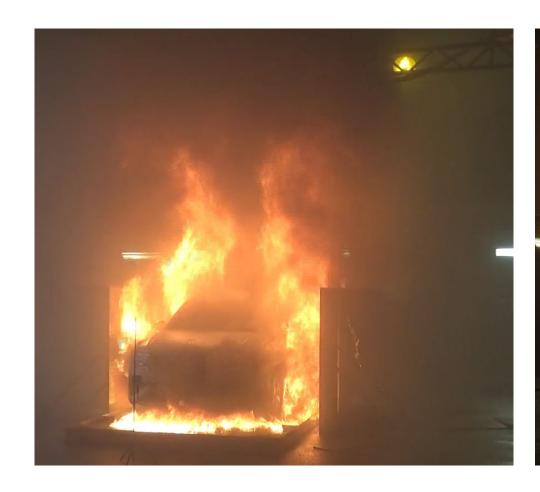
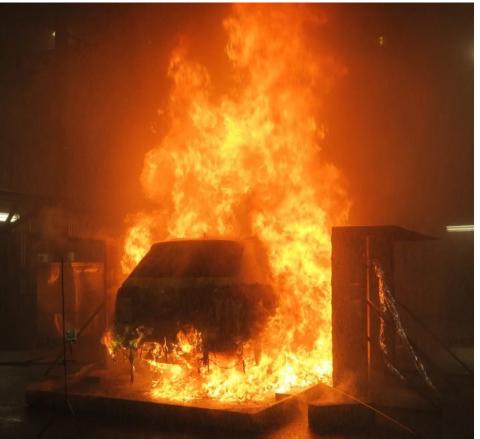
ICEV1: ~03:00 (min:s) – the peak

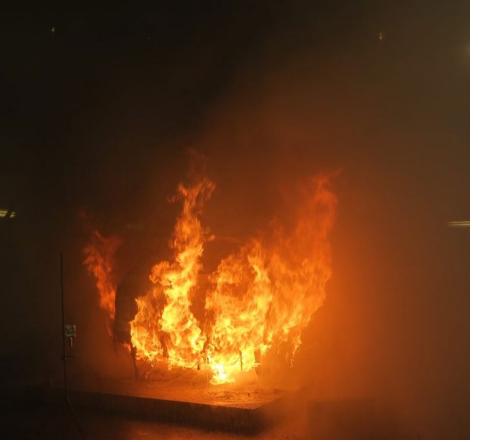
ICEV1: ~06:00 (min:s) – fuel burn-out LASHFIRE

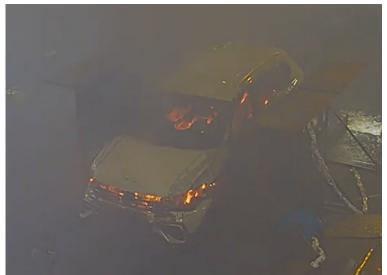
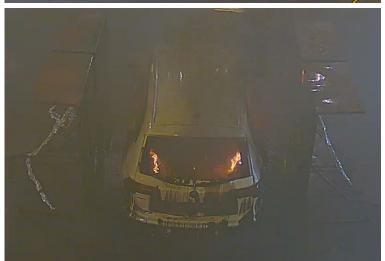
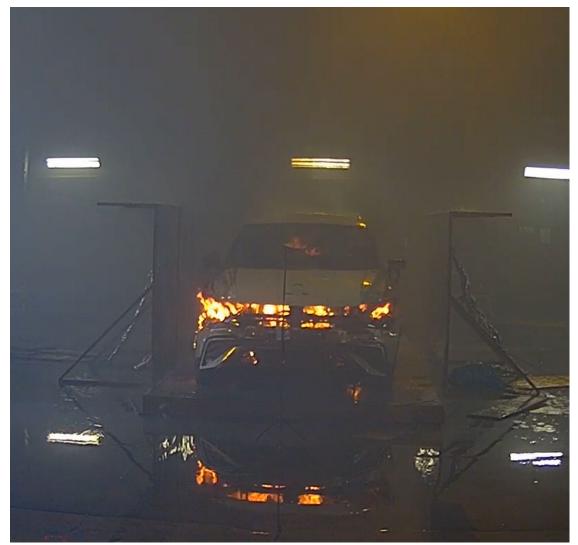
ICEV1: ~ 31:12 (min:s) – end of application

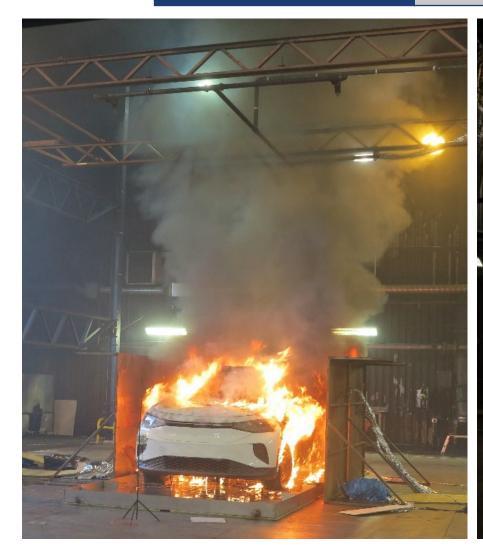
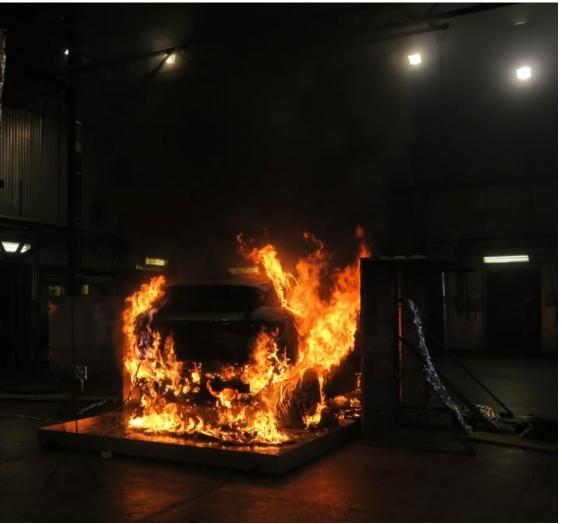
BEV1: 12:40 (min:s) – start of applc.

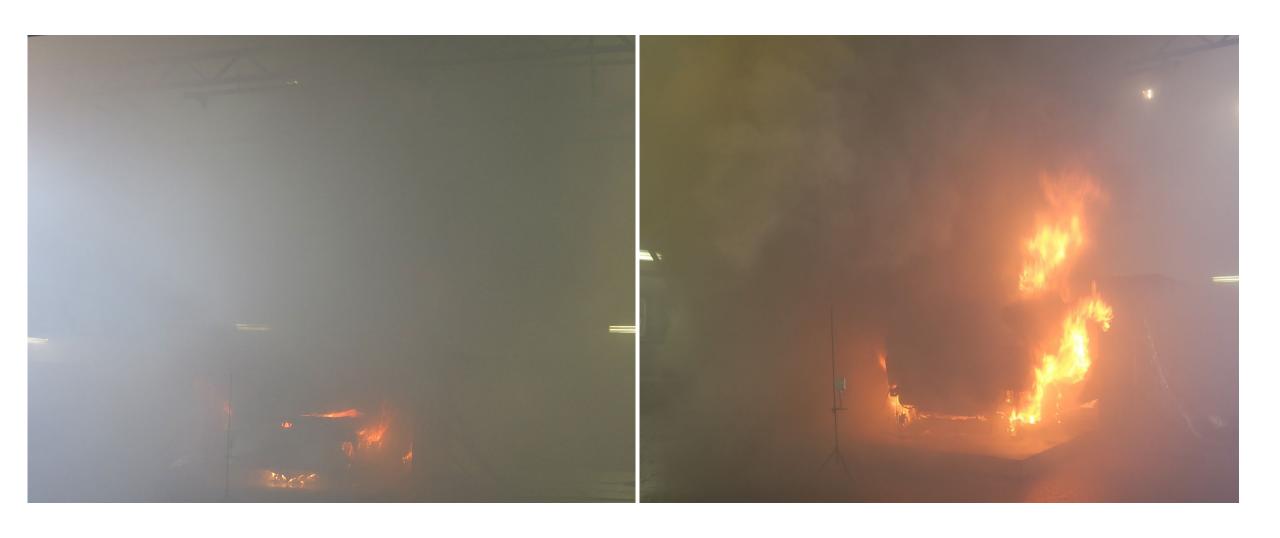
BEV1: ~20:00 (min:s) – peak

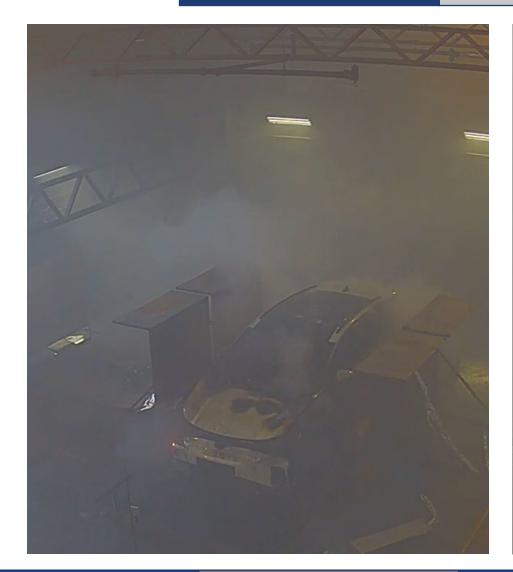
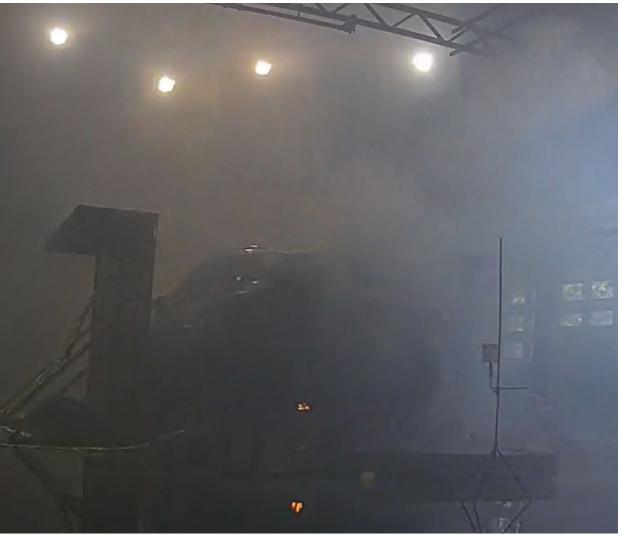
BEV1: ~42:40 (min:s) – end of applic.

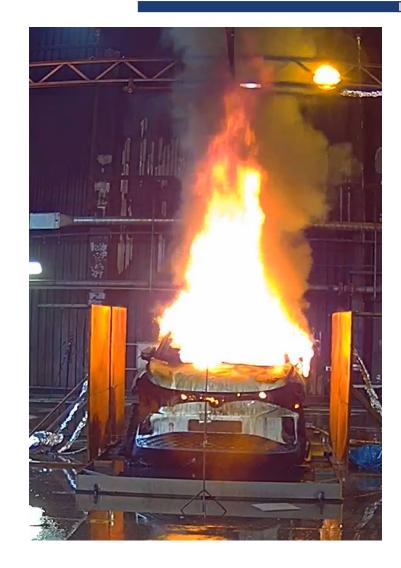
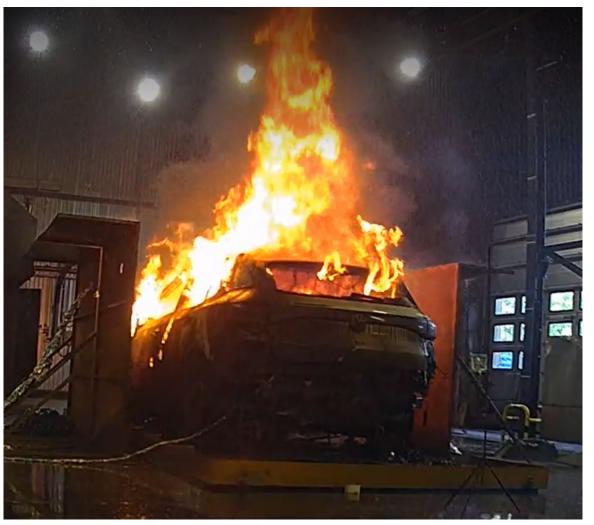
BEV1: ~74:00 (min:s) – post-application peak LASHFIRE

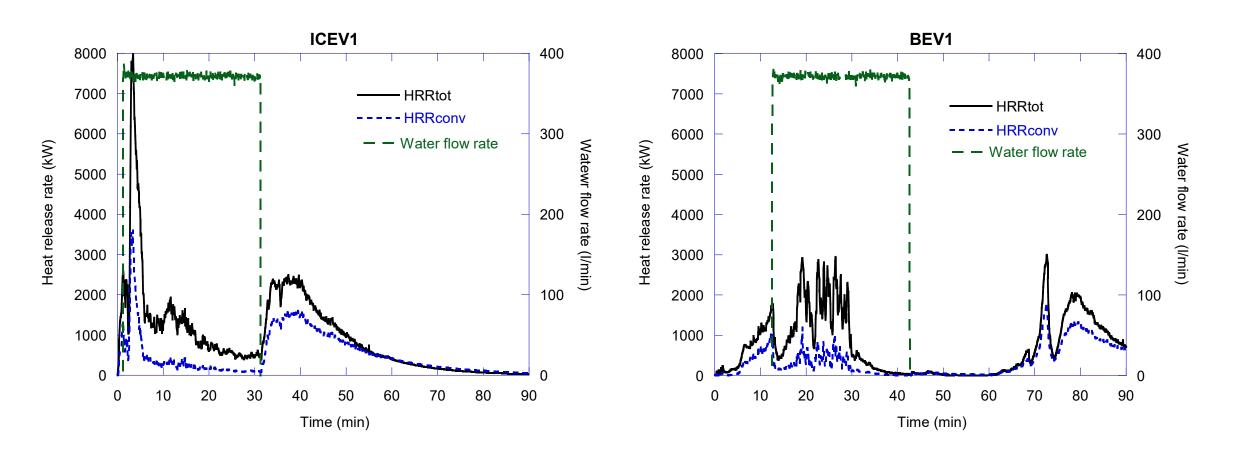
Heat release rates (0 – 90 min)

- Faster initial fire growth rate and higher overall peak heat release rate for the ICEV's.
- Higher peak heat release rate for BEV's during water application. This is partly associated with fire progress in the battery pack.
- Fire re-growth immediately after the termination of the water application, except for BEV1.
- Battery pack burnt out during the time of water application (BEV1) or during and shortly thereafter (BEV2).
- During the post-application stage, the unburnt exterior combustibles (as front and rear parts and paint) and the interior were completely consumed.
- Significant post-application heat release rate peaks observed in all tests.

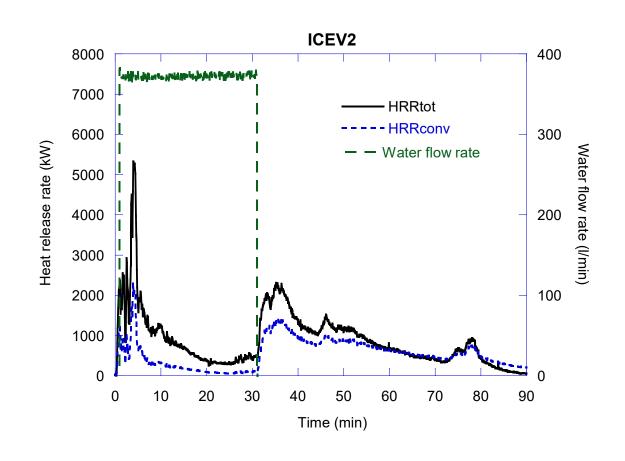
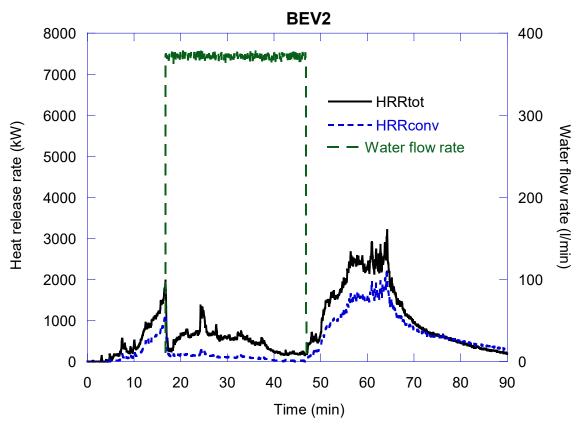
Heat release rates (0 – 90 min)

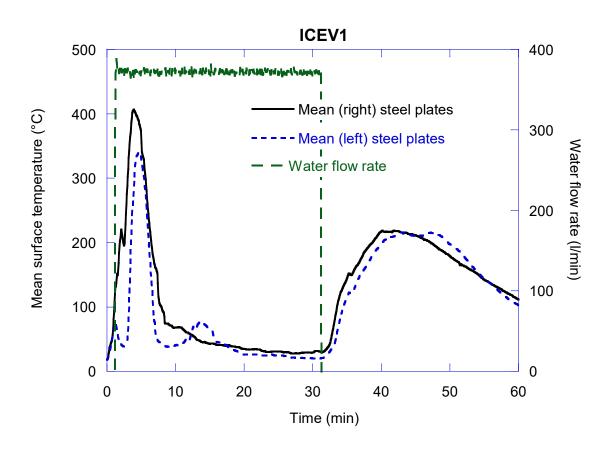
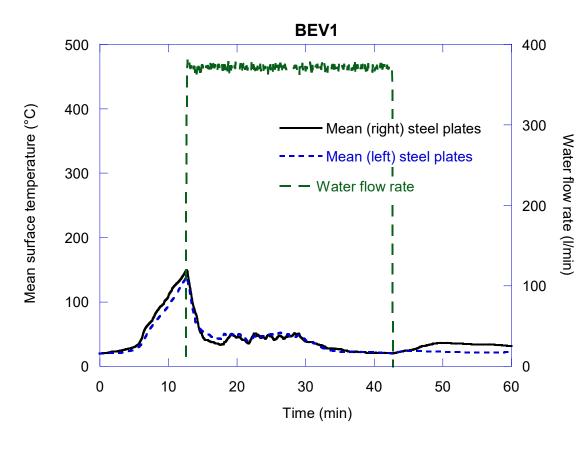
Surface temp. on steel sheet screens (0 – 60 min)

- Clear reduction of:
 - The surface temperature of the steel sheet screens.
 - The gas temperature above the vehicle (data not shown here).
 - The heat radiation (data not shown here).
- The fire re-growth after the termination of the water application is an evidence that the application of water do control the fire.
- Battery electric vehicles does not seem more challenging for the drencher system design in MSC.1/Circ. 1430 than gasoline-fueled vehicles. At least not the way battery electric vehicles are constructed today.

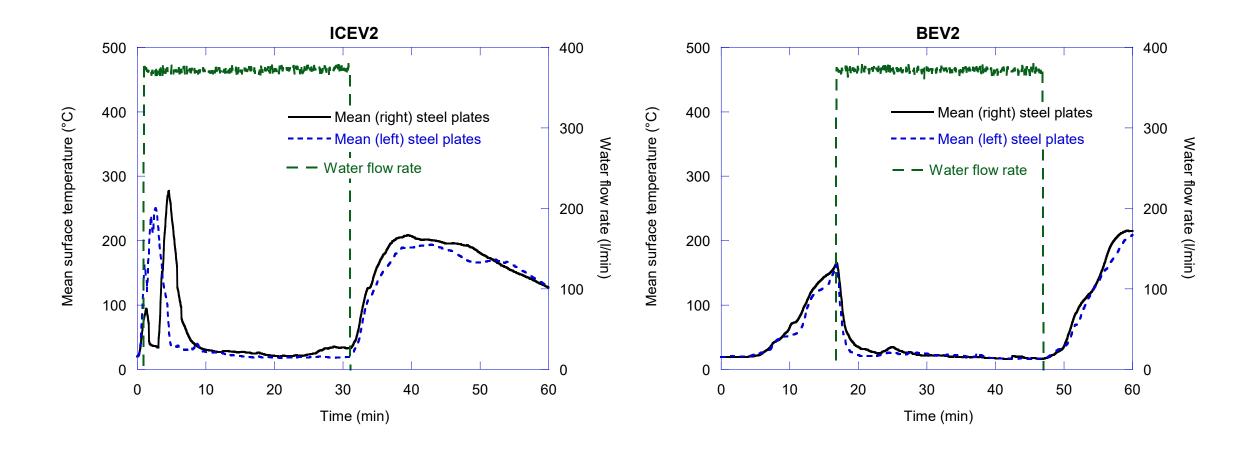
Surface temp. on steel sheet screens (0 – 60 min)
