Heavy weather

8.1

Containers were lost in heavy weather because of stiff vessel

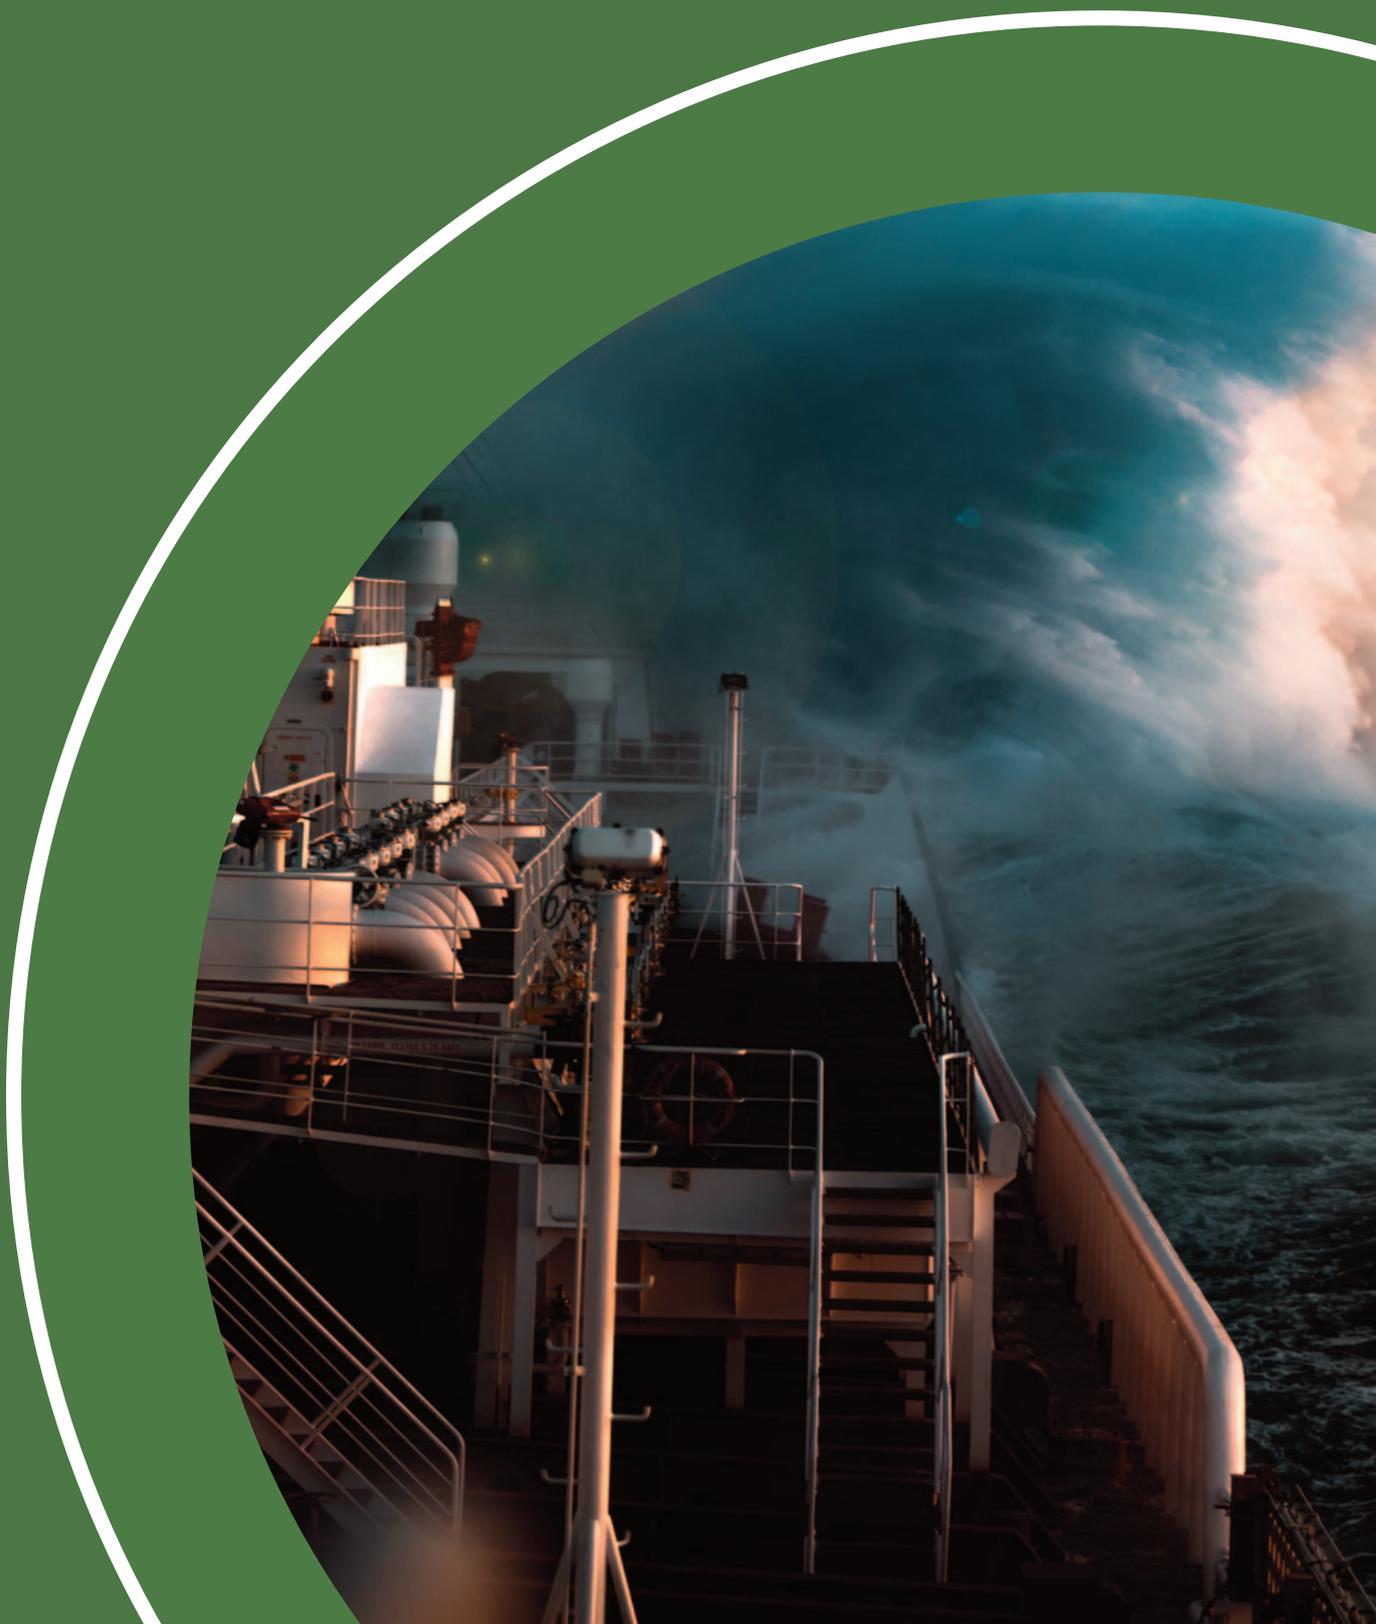
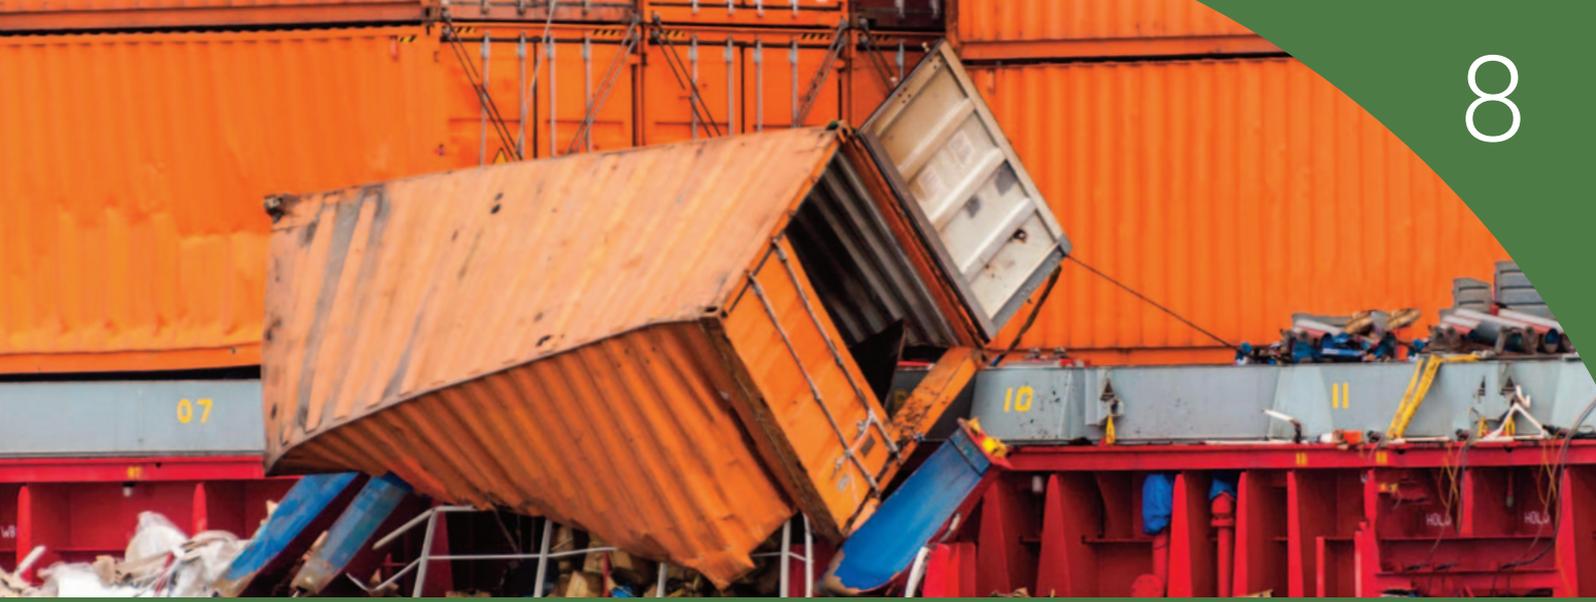
Collapsed containers

During the morning watch, the OOW and the Master were on the bridge. Hearing a loud noise astern of the bridge they looked out of the window and could see that a number of containers had collapsed and some had fallen into empty bays. The collapsed containers were all 20' TEU and were stowed in four bays. The side containers on the starboard side had toppled inboard into an empty space and others had fallen overboard.

The CSM required that the bottom containers on deck were secured by manual twistlocks. However, the twistlocks in the container shoes were unlocked. In accordance with the vessel's procedures, the lashings were to be checked prior to every departure, which the Chief Officer stated he had done. At the loading port the Chief Officer had signed the lashing report without noting any deficiencies.

The vessel had a GM of 11 metres which made it very 'stiff'. This means that the vessel would quickly return to the upright position after being inclined by an external force such as wind or waves.

- The base twistlocks had not been locked as they were found undamaged and still located in the shoe fittings. The combination of unlocked twistlocks and a very stiff vessel sailing through heavy weather led to the collapse of the container stacks.

- The Chief Officer should have ensured that the manual twistlocks were checked before departure.
- The officers should have reduced speed and altered course to ensure the effect of heavy weather was minimised. This was only carried out after the accident had happened.

- A GM of 11 metres was excessive for this vessel. A stiff vessel will affect the top and side containers the most. The top containers collapsed and fell onto other containers which then fell overboard. Principally, the main forces affecting the containers in the lower tiers consisted of:
